## ENGINEERING GEOLOGICAL BEHAVIOUR OF RECENT CONGLOMERATE DEPOSITS IN DAM FOUNDATION. THE CASE OF AGIOKAMPOS DAM IN THESSALY, CENTRAL GREECE

Marinos V.<sup>1</sup>, Lazaridou S.<sup>2</sup>, Perleros V.<sup>3</sup> and Sotiropoulou K.<sup>4</sup>

### Abstract

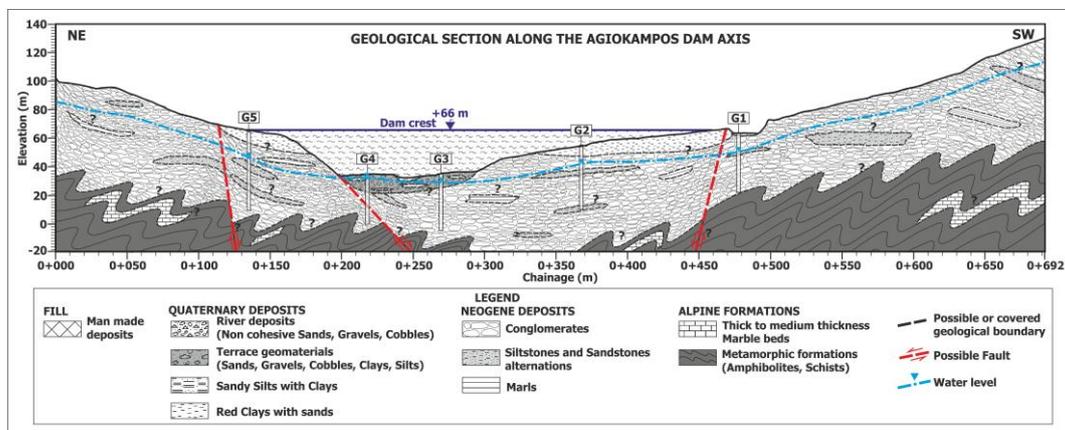
basin forming the basins of lacustrine and continental sediments. The E – W fault system, despite being a secondary one in the region, is greatly expressed forming well-distinguished morphological reliefs. In the foundation zone of the dam it is estimated that the riverbed zone is defined by two faults that have allowed the formation of the steep slopes of the area. The action of these two faults has contributed to a local fracturing of the conglomerates, met in the exploratory drilling. This neotectonic setting is also the reason of the inclination of the Neogene strata.

Figure 2 – Geological section along the axis of Agiokampos Dam.

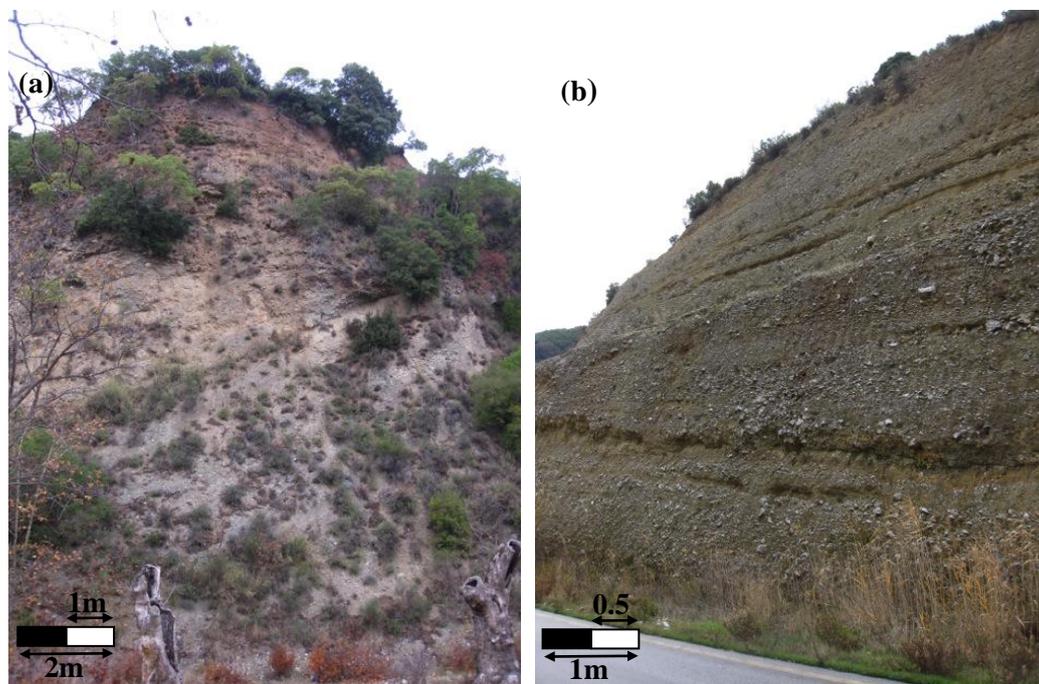
The conglomerates in the left abutment of the dam are found with higher presence of finer silty-sandy materials while more systematic presence of pebbles exists in the right one. A typical stratigraphic image of the left and right abutment is shown in Figures 3a and 3b respectively. The layers present a moderate inclination to the N-NS, without forming however practicable sliding planes. The slopes are generally homogeneous and they do not show clear variations in strength. Although the conglomerates are globally homogeneous, alternations of fine-grained and coarse layers are present. Note that the left abutment, though steeper in slope, presents several phenomena of erosion. On the other hand, at the base of the slope, near the riverbed, the conglomerates occur with increased consistency due to calcitic presence. Conglomerates are not very cohesive close to the surface but soon, in small depth, they become more compact, at an acceptable level for bearing an earth structure of the size of this dam.

**Figure 3 - Typical series of the formation at the left (a) and right (b) abutment of the dam. Conglomerates are met here with a high presence of fine, silty-sandy, materials in the left abutment, while in the right one there is more systematic presence of pebbles. The formations show moderate consistency but good friction angle, due to the interlocking of the granular materials, since they form steep and high slopes.**

Recent deposits, on terraces and of clay nature, are overlying these materials. Terrace deposits are generally soft, of low consistency and they must be removed for the foundation of the dam, while they can be used for the core of the dam.

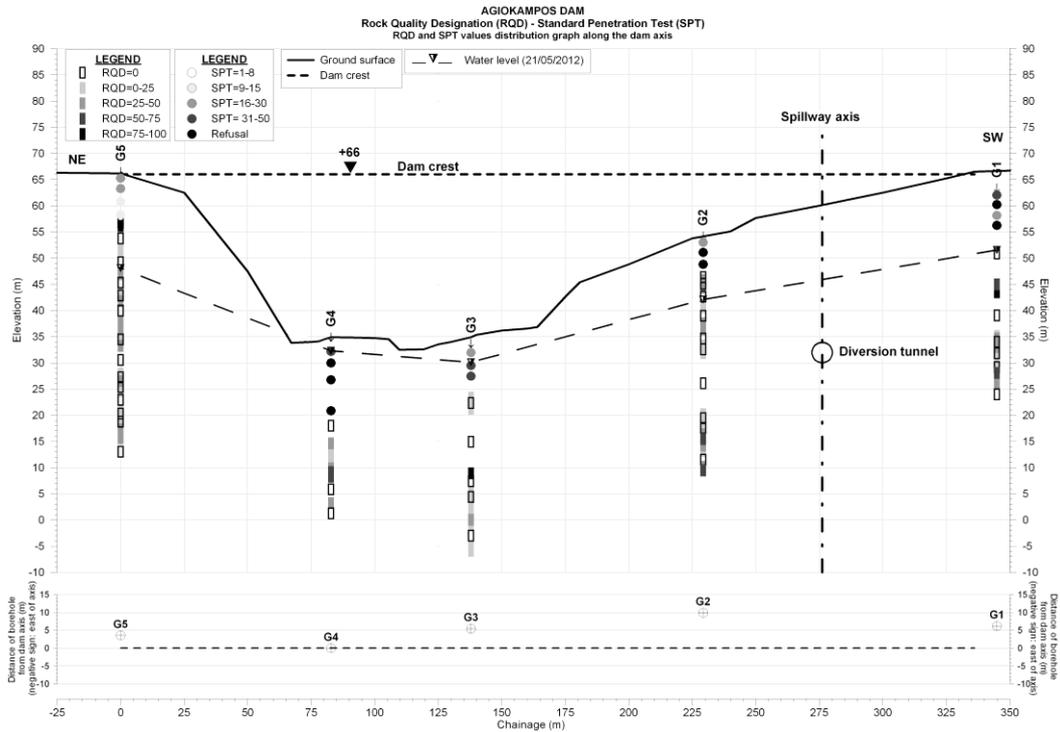
Regarding the assessment of rock mass quality with the RQD index, the following notes must be highlighted. The RQD should be marginally only used for post-alpine formations and for weak rocks which have not been fractured due to tectonism, stress relief or weathering. The RQD values here range from zero up to about 75%, if strictly considered (Figure 4). The "disorganized structure" as shown in the cores is certainly due to the disturbance and washing out of fine material during drilling and sampling, provoking a collapse of the rock mass. Larger values of RQD were recorded mainly in sandstone and mudstone layers within the formation of conglomerates, but these zones are only sporadic. Furthermore, there is no significant change of values with depth. This is normal, as RQD rating does not represent here the logic of reducing the fragmentation due to tectonism or weathering by the increased confinement in depth.

Regarding the distribution of standard penetration test ( $N_{SPT}$ ) values along the axis of the dam (Figure 4), most of these tests have moderate ( $N_{SPT} = 16-30$ ) to high values ( $N_{SPT} = 31-50$ ) or even refusals (Figure 4). These values are typical of the consistency of the formations present, while refusals may be due to the systematic presence of pebbles, gravels and boulders in the conglomeratic mass.

Thus RQD or SPT tests are useless to apply since the recovered cores have very poor structure easily disintegrated ( $RQD's=0$ ) or coarse fractions providing refusals on penetration values. The series of these weak formations are not expected however to be liable to significant compression and subsidence, provided the upper loose zone is defined and removed.

**Figure 4 – RQD and  $N_{SPT}$  values along the Agiakampos Dam axis. The RQD can be marginally used for post-alpine, formations and weak rocks which have not been fractured due to tectonism, stress relief or weathering. The RQD values here range from zero up to about 75%. The "disorganized structure" as shown in the cores is certainly due to the disturbance and washing out of fine material during drilling and sampling provoking a collapse of the rock mass.**

The sampling in these materials must be carefully executed so to allow the maintenance of the sample undisturbed in the form of a core. A double or even triple split core barrel is required for this reason. Exploratory trenches or wells and, in case of major need of information; adits offer a better source in the site investigation procedure.

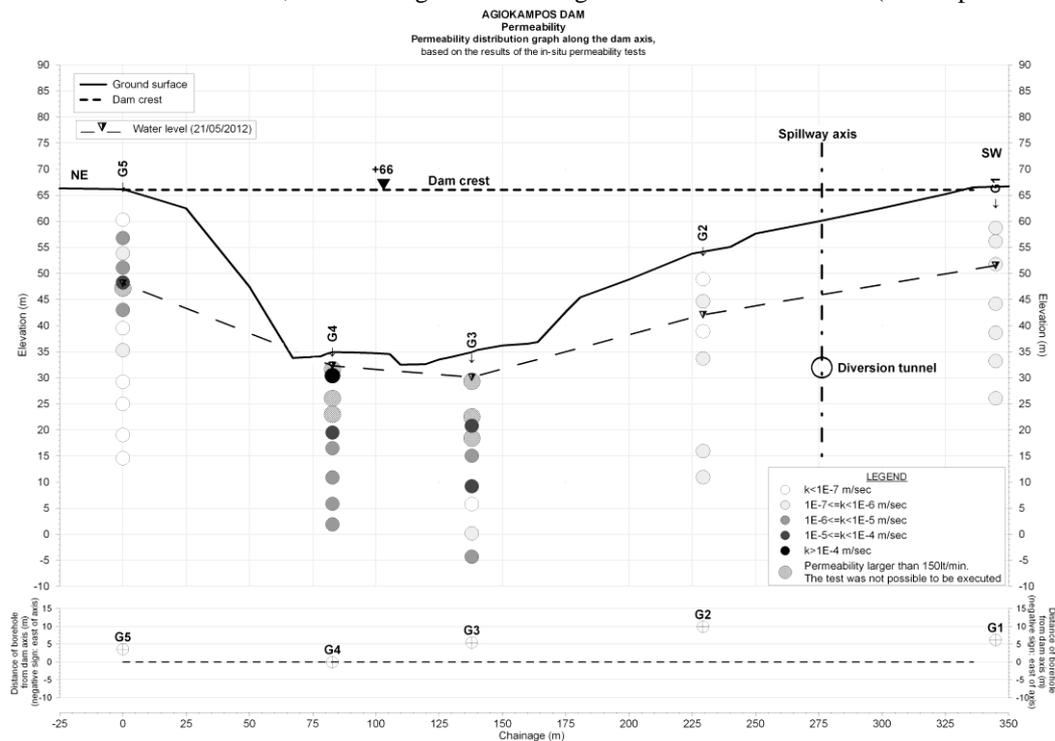
The distribution of permeability values (K) with depth is shown in Figure 7. The higher values ( $\sim 10^{-3}$  m/sec) are found in the riverbed materials to about 10-12m depth, while high values appear in a zone at the left abutment at around 25m of depth. Hence, there is an apparent need to address the high permeability of the bed material by removal. However, locally below the dam axis, there are variations in K values, with the higher ones being in the order of  $10^{-3}$  m/sec (in a depth of 10-

Figure 6 - Distribution of the permeability (K) values along the axis of the dam.

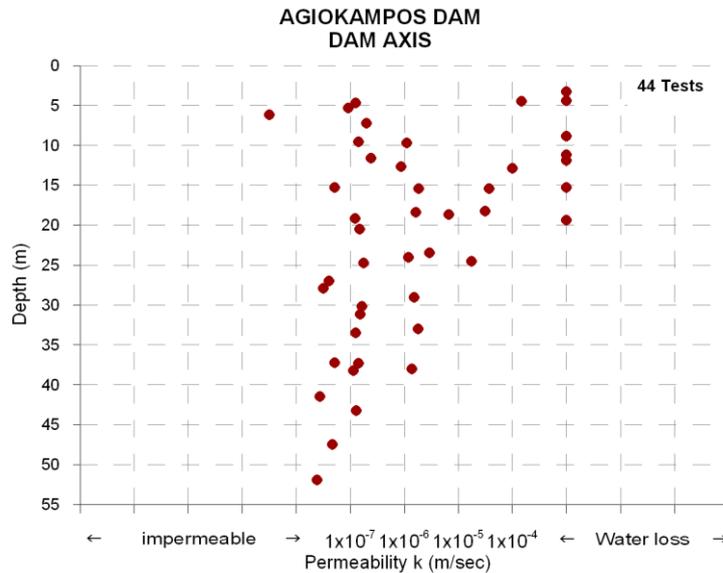
**Figure 7 - Distribution of permeability values (K) with depth.**

20m depth in borehole G5 and of 18-25m in borehole G3). These high values are possibly associated with weak cementation of the rock mass. Thus, based on the results of the in situ permeability tests it is necessary to construct a grout curtain, having although a moderate depth.

Given the variation of consistency and compactness of the conglomerates, the possibility achieving an effective penetration and sealing in all parts under the dam foundation, if grout injections holes are to be used, should be of concern. Thus a combination with a diaphragm wall could be the solution. Finally given the medium cementation, erosion mechanism can develop, under the hydraulic gradient that will develop with the creation of the reservoir. The implementation of a carpet grouting is thus essential.
