PALAEOTECTONIC ENVIRONMENT AND LANDSLIDE PHENOMENA IN THE AREA OF MALAKASA, GREECE

Mourtzas N.D.¹ and Sotiropoulos E.²

Abstract

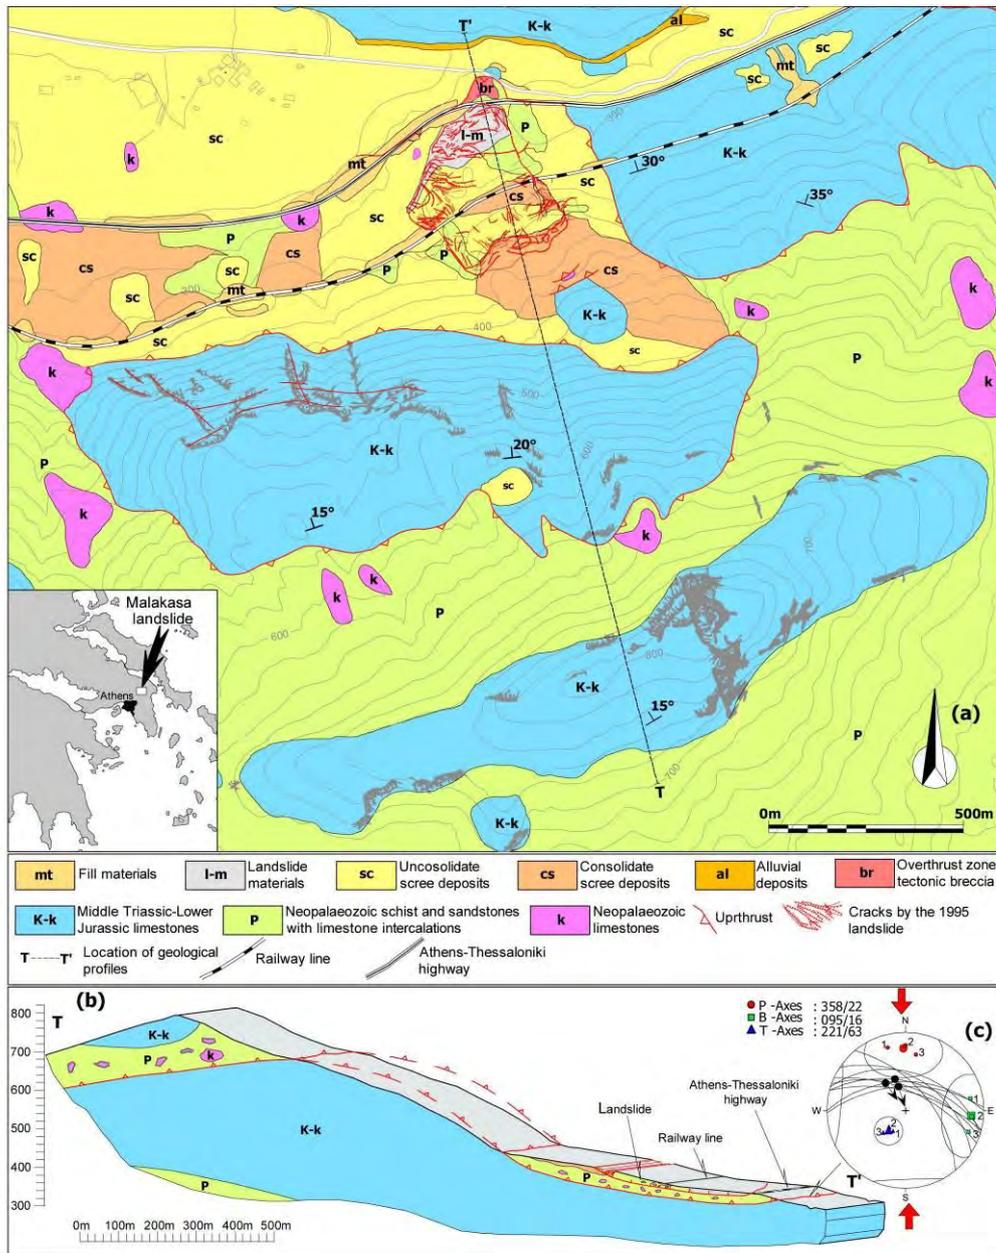
Figure 1 - (a) Location map of Malakasa landslide (b) Detailed geological map of the NE slope of Mt Parnitha in the wider area of Malakasa landslide (c) Geological cross-section along the longitudinal axes of the north-east slope of Mt Parnitha (d) Up-thrust surface data and palaeostress mechanism analysis.

The thrust of the neopalaeozoic formations to the Triassic limestones constitutes the main palaeotectonic structure of the landslide area. This large-scale tectonic movement took place during the first orogenic phase and affected the wider area. It caused strong foliation of the geological formations, with the strike of the main fold axis being NNW-SSE, and the generation of tangential forces that pushed the schist-sandstones towards a SE direction over the carbonate formations of the Sub-Pelagonian geotectonic unit. The following erosion removed significant parts of the tectonically overlying schist-sandstone formations and revealed the younger underlying carbonate bedrock in the form of a “tectonic window”. Also, the erosion caused the fragmentation of the nappes into klippe which lay on the Triassic substratum. The Malakasa landslide occurred in one of these klippe (Figures 1 and 2).

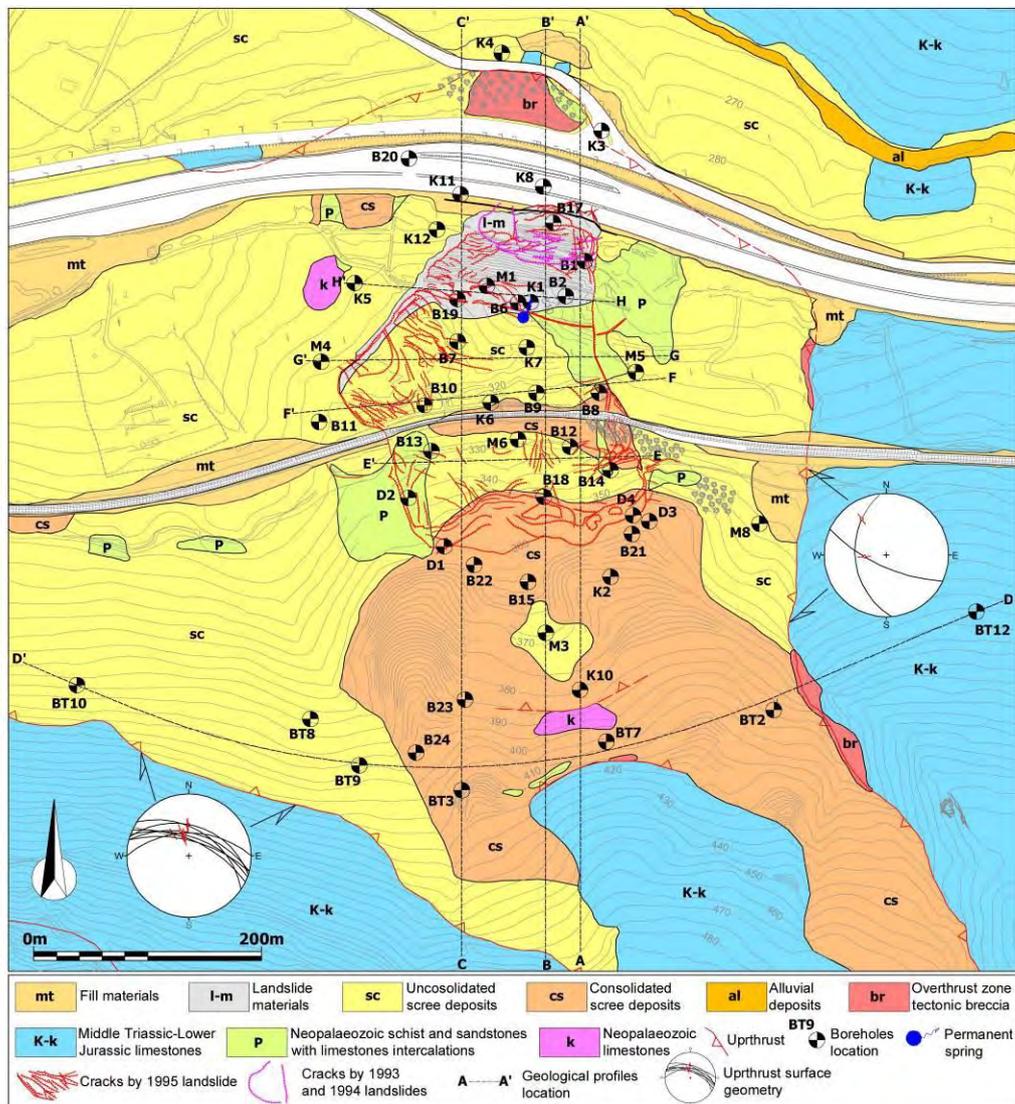
Figure 2 - Detailed geological map of Malakasa landslide.

The lithostratigraphy of the landslide area was determined based on the results from the geological investigation and geological mapping, made on a scale of 1:5000 and 1:1000, as well as on the data coming from the drillings and testing of the cores (Figures 2 and 3).

The Triassic limestones and the up-thrusted neopalaeozoic formations constitute the Alpine substratum of the wider landslide area, while the oldest and youngest phases of the colluvial deposits, covering the bedrock, constitute the most recent formations. The remainders of the neopalaeozoic nappe, which cover the Triassic limestones in the landslide area, consist of alternation of highly eroded schist-sandstones, shales, and mica schists, which have lost their initial structure and are present in the form of gravels, medium plastic clays, clayey sands, and clayey gravels. They are soft to very soft materials with olive-green, green and gray-green colours. They have been transformed into graphitic schists with intense abrasion and dark or dark-grey colours in deeper layers, and they are presented as clayey sands and sandy clays with medium plasticity, very soft and of medium cohesiveness, as well as silty sands and clayey sands and gravels with sandstone fragments. The former are arkoses of grey to dark colours which are crossed by light-coloured calcite veins (Figures 2 and 3).

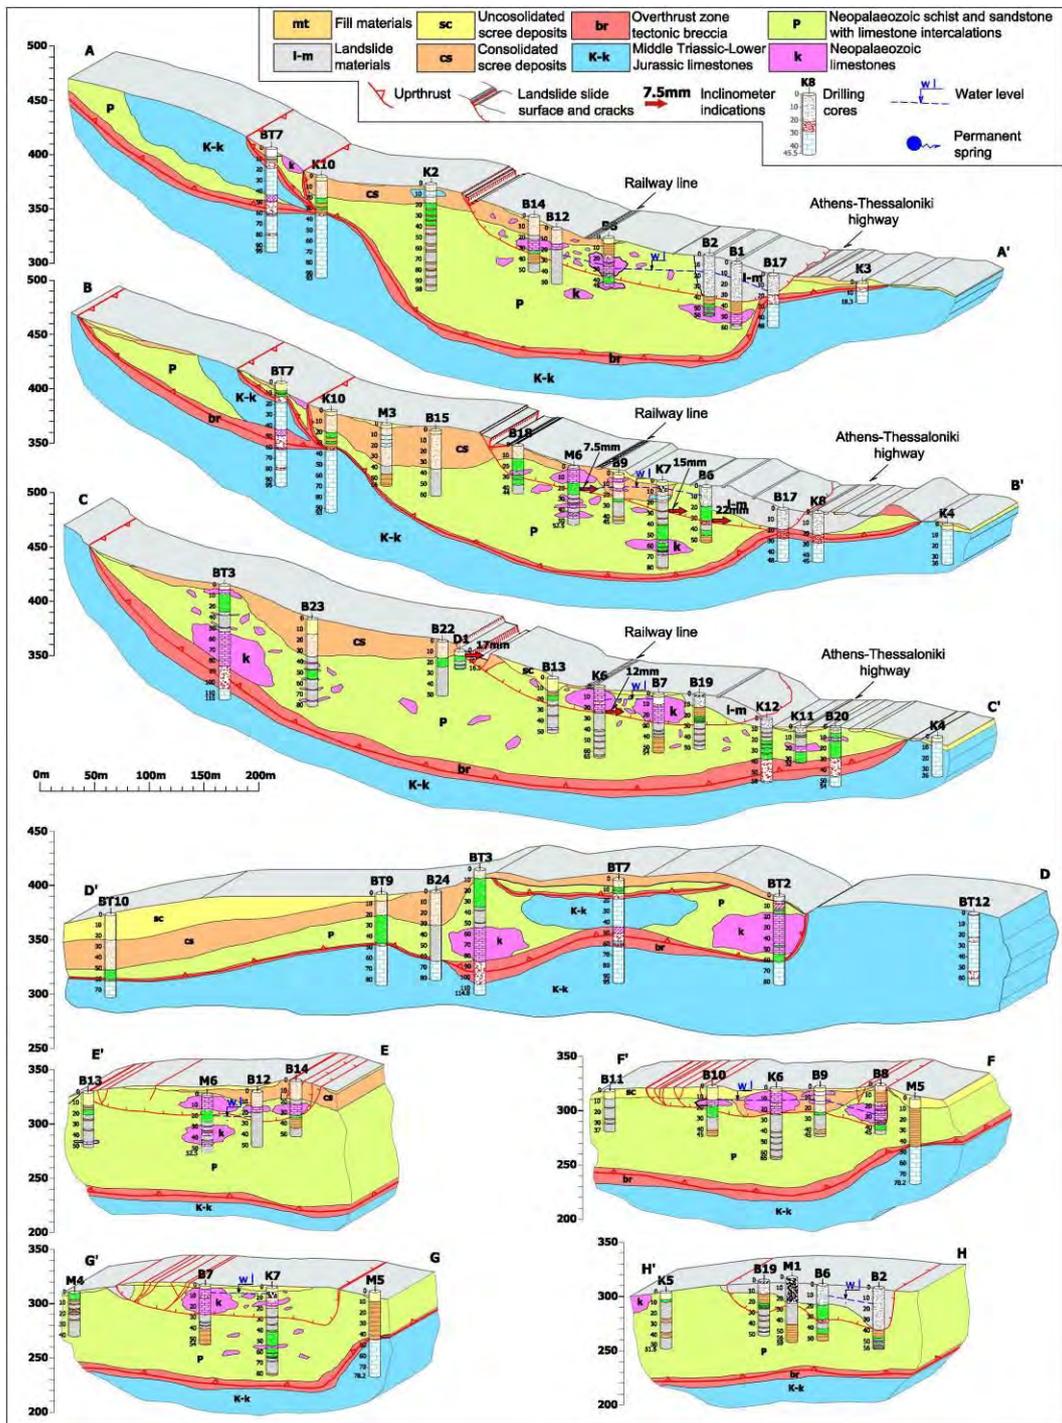
Figure 3 - Geological cross-section of Malakasa landslide.

The landslide presents classic tensile cracks at the head, with almost vertical walls and vertical displacement of few meters. These cracks turned into trench gaps, after the mass movement, being 15m to 30m wide and 15m deep. At its sides, the landslide is clearly defined by continual cracks which revealed the failure surface with characteristic glide lines to the direction of the movement. There is, also, intense ground elevation at the landslide toe and multiple failure surfaces, extremely smooth and with glide lines, in different levels (Figure 3).

(11.50mm). Finally, the inclinometer which was installed in borehole D1, in the west end of the landslide head, showed maximum movement of 17mm in the depth of 3.50m, in a time period of 104 days (Figures 3 and 4).

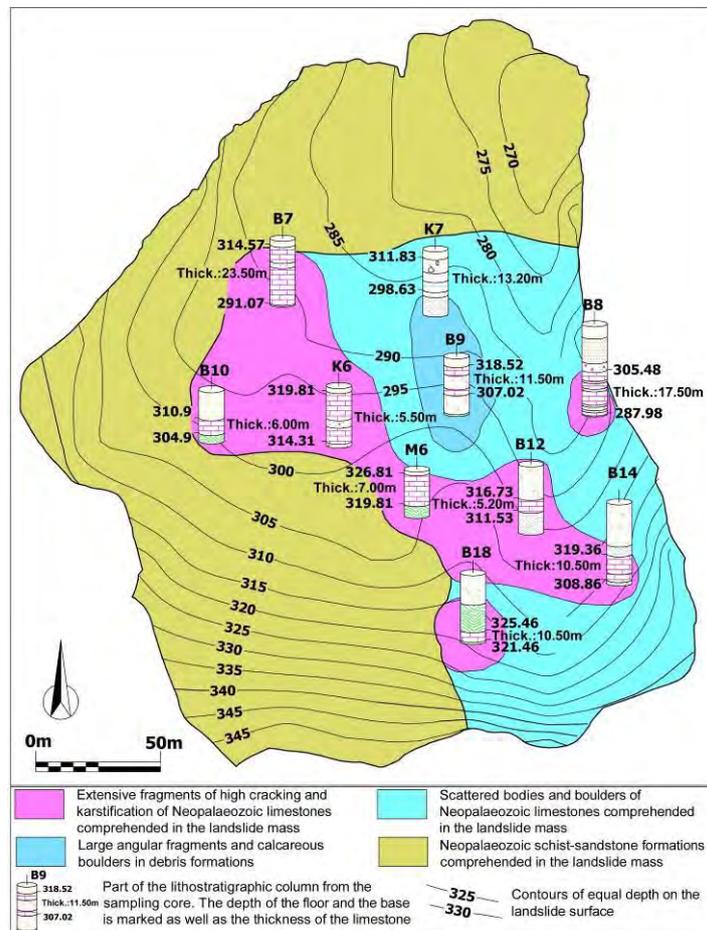
Figure 4 - Dispersion map of the limestone bodies in the mass of the landslide.

The limestone bodies are thinly bedded with intense folding and medium to high fragmentation and karstification. The discontinuities and karstic voids of the rock mass are filled by green clays and clayey sands. The largest proportion of RQD index values is between 0% and 20%. At least three large limestone bodies are contained in the schist-sandstone mass. The first one is about 40m thick and can be found in the western section of the up-thrusted mass, 170m upwards and NE of the landslide head. The second is about 35m thick and it is located 200m upwards and to the north of the landslide head. Finally, the third is located in the central section of the landslide, having NW-SE direction, extends up to a depth of 3m, and has a length of 195m and maximum width of 70m. Its thickness reaches 24m in its NW end, 5 to 7m in the most extended central section, and 10m in its SE end, while its volume is estimated at 216,000 m³. The two smaller limestone bodies, in the north-eastern and southern sides of the main section, are about 25 to 30m long and are having a thickness of 10 and 17m respectively, while their total volume is estimated at 33,000 m³ (Figure 4).

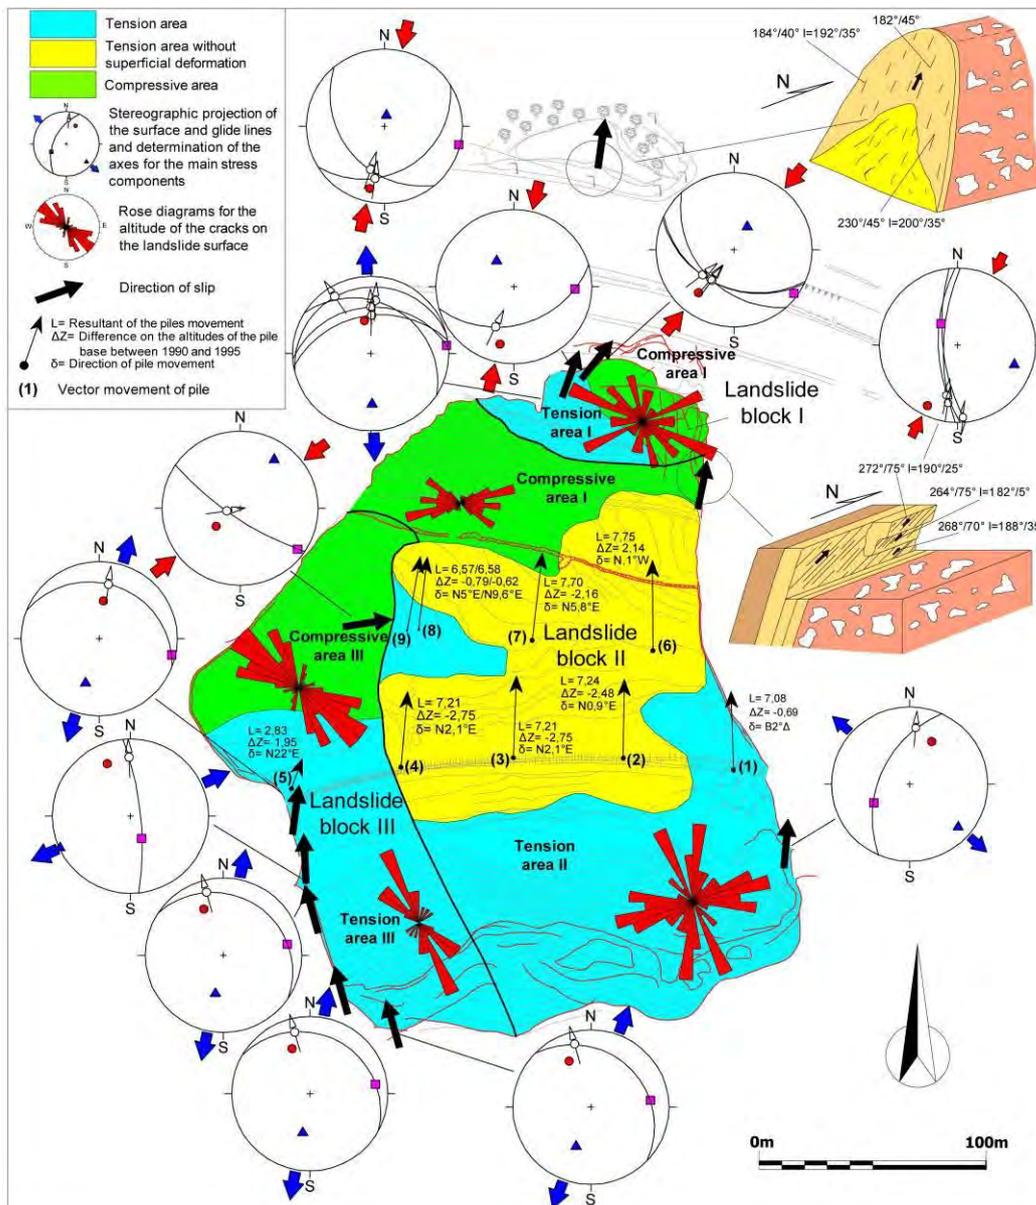
According to the geometric data of the movement, the tension and compression zones of the landslide, the orientation of the tensile and compressive axes, and the direction of the movement, in every location, are determined (Figure 5). An extended tension zone was determined at the SE side and the central section of the landslide mass, upwards and downwards the railway line. At its north section, failure surface dips to the NW and glide lines have NNE direction and NW-SE orientation of the tension axis (Tension area II). At the NE side of the landslide, movement took place on a surface dipping to the ESE, glide lines with NNE and NE direction, determining a zone of compressive events with orientation of the compressive axis to the NE-SW (Compressive area II). At least two older slip planes, with striations that have the same orientation as the recent ones, were determined at the sequential planes of the calc-crust, at the SE end of the compressive area II. At the SW section of the landslide, upwards the railway line, a tension zone was determined with tension axis orientation N-S and mass movement to the NNW at the most southern part, to the North at the middle part, and to the NNE when approaching the railway line (Tension area III). A compression zone by sequential compressive cracks was determined immediately downwards the morphological crest, which has planes with SW inclination and glide lines to the ENE (Compressive area III).

In conclusion, tension area (I) with compressive area (I), tension area (II) with compressive area (II), and tension area (II) with compressive area (III) define three different soil blocks of the unstable mass (Figure 5).

Figure 5 - Kinematic analysis of the landslide.

Two areas with distinct kinematic can be clearly defined by the movement vectors. The area which includes the western section of the landslide is defined by the poles 14 (5) and 5 (8) and the western boundary of the sliding mass (Figure 5). This section has been moved by 2.83m to the NE. The eastern section of the landslide shows its maximum movement at the central part, from 7.21m up to 7.75m, reducing at 6.57m up to 7.08m in its western and eastern margin. On the other hand, the eastern section of the landslide is divided, considering the direction of movement, into the western part, to the west of the poles 12 (3) and 6 (7) with a movement direction to the NNE, and the eastern part with a movement direction to the NNW (Figure 5).

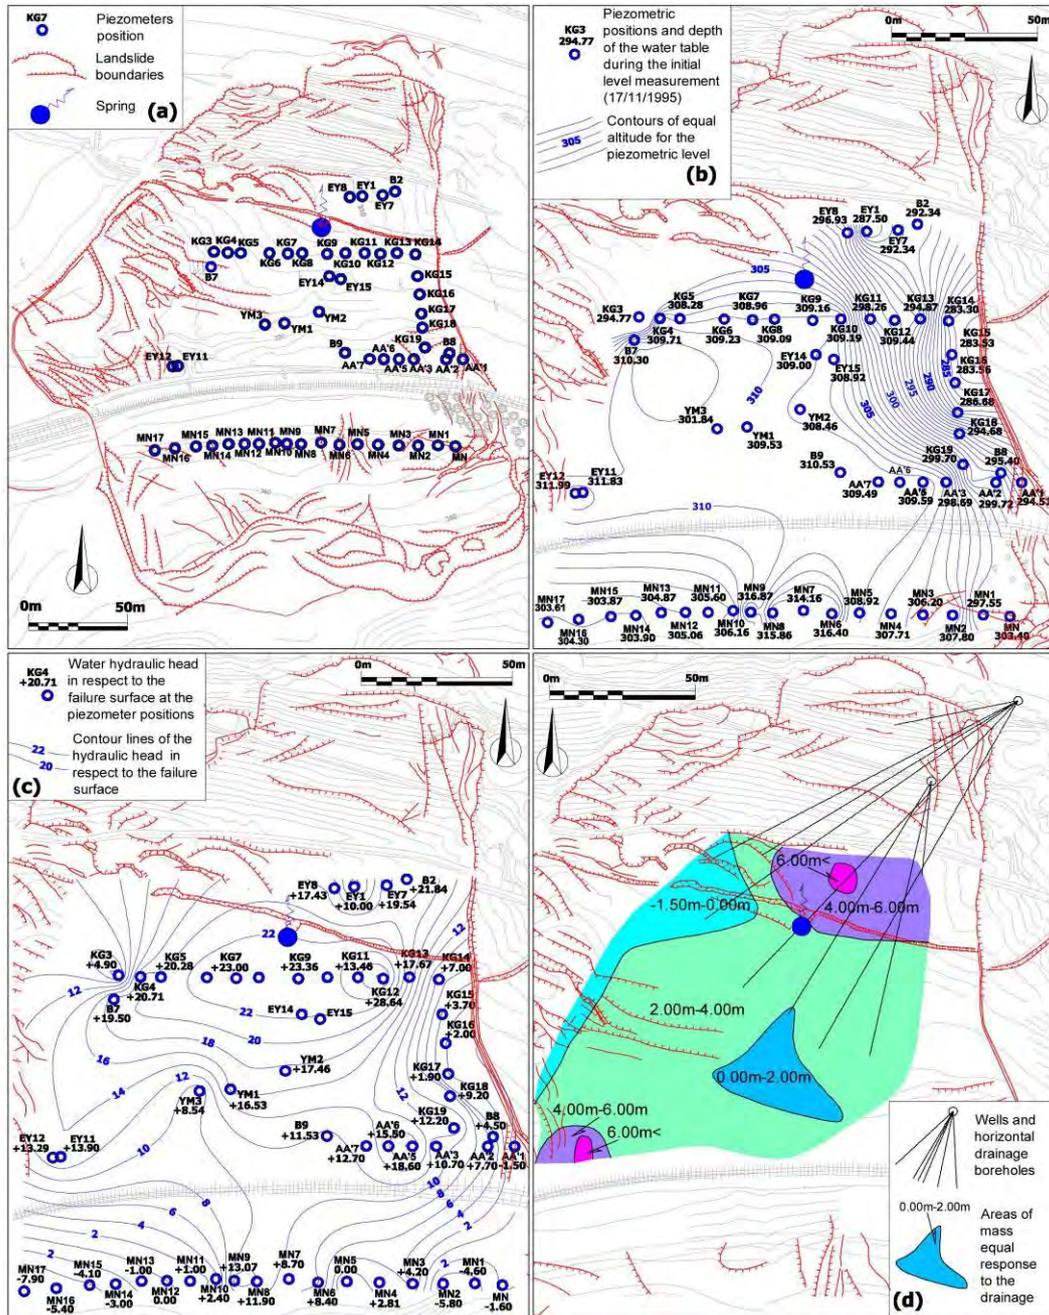
The spread of the Triassic and Neopalaeozoic limestone phases of the Parnitha Mt. favors the development of a rich karstic underground water potential. The spring at the landslide mass, in the altitude of +313 and with constant flow of $1.5\text{m}^3/\text{h}$ to $2\text{m}^3/\text{h}$, is an overflow spring and gushes out at the contact between the entrapped, highly cracked, karstic, Palaeozoic, calcareous blocks and the impermeable schist-sandstone bedrock. Also, the discharge of high quantities of water during the winter, at the wider spring area and the slope upwards the railway line, shows the existence of a significant, unsteady, hydraulic load in the landslide mass, whose volume depends on the rainfall (Figure 2). The underground karstic aquifer is developed in the central section of the landslide, between the elevation contour lines of +335, at the railway line area, and +310, at the drainage cemented trench. From the piezometer measurements in 42 vertical drillings, distributed in three parallel to the motorway axis branches and a conjunctive vertical branch, arises that the groundwater table varies between 2.00 and 35.11 meters from the surface (Figure 6a). In the central and most extended section of the aquiferous zone, the piezometric level ranges between +305 and +310 and reduces sharp to the NW in +282 and smoothly to the South in +304, displaying a small mean hydraulic gradient of 5° to the North (Figure 6b).

The groundwater in the central section of the landslide mass forms a significant hydraulic head above the failure surface with a volume of 500.000m^3 . The distribution of the hydraulic head is not uniform, so there are four distinct areas which are recognized. At the northern section of the aquiferous zone, the hydraulic head is over 20m, at the central section is between 10m and 20m, at the southern and the eastern sections is between 0m and 10m, while at the southern and eastern margins the piezometric surface is lower than the failure surface (Figure 6c).

Figure 6 - Maps of groundwater conditions in the Malakasa landslide. (a) Distribution of Casagrande type piezometers in the landslide mass. (b) Piezometric map of Malakasa landslide. (c) Potentially groundwater pressures on the slide rupture surface. (d) Response in the draining at the different locations in the slide mass by placing horizontal drains

The response to the drainage was different from place to place. The western side of the central section of the landslide showed degradation of the piezometric level between 0m and 9m, while at the rest of the western side the piezometric level increased up to 1.5m. Consequently, there is a clear discrimination into two areas, one of increased ground water capacity, high hydraulic head, increased discharge volumes and quick recharge, at the central section of the aquifer zone, and one area of decreased respective hydraulic parameters at the eastern and northern borders (Figure 6d).

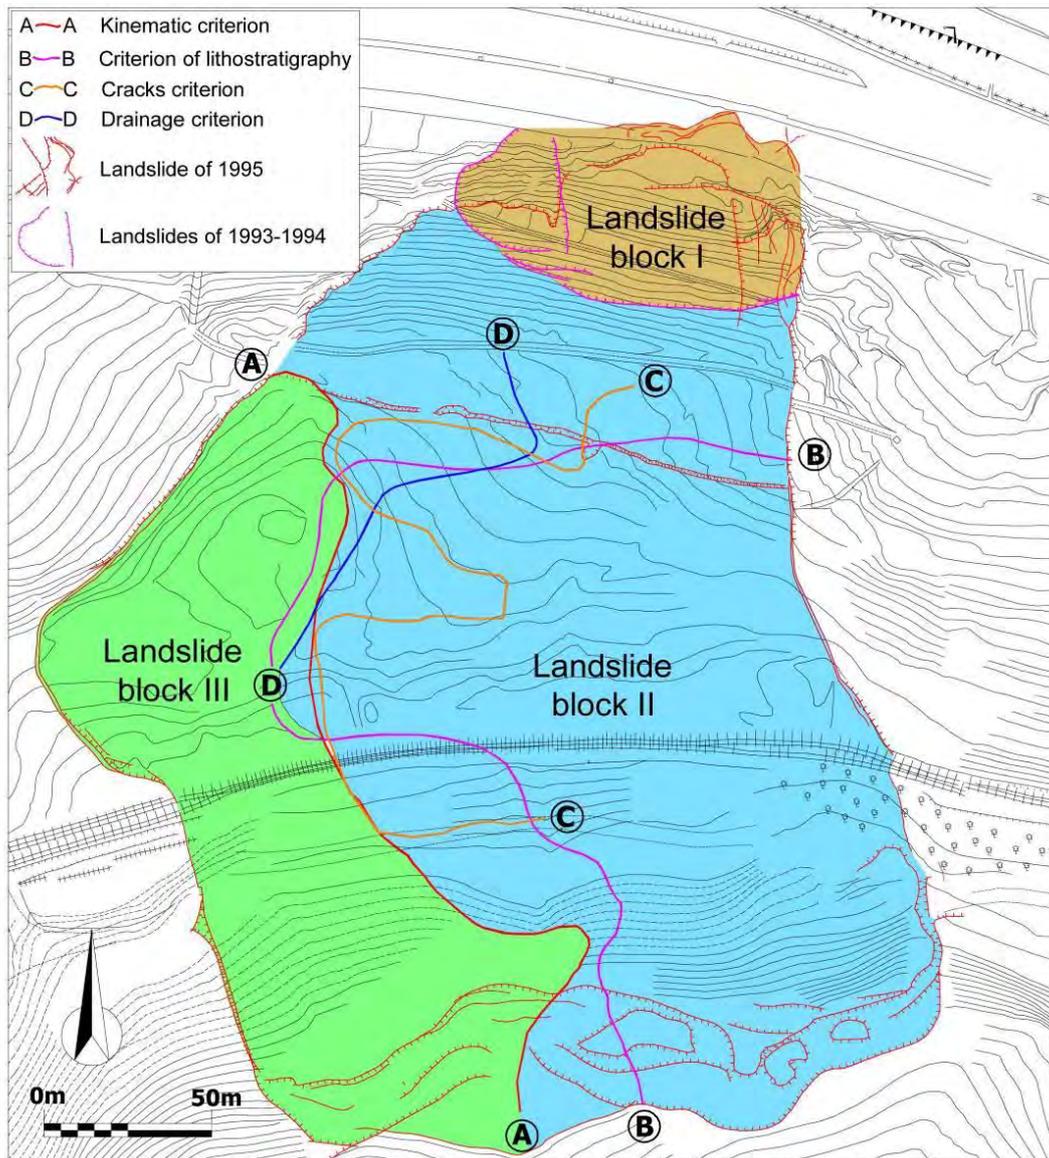
The landslide mass was separated into two distinct blocks: (i) to the eastern, and most extended block, with estimated volume of 993,000m³, where the significantly folded and fractured, permeable calcareous mass of estimated volume 250,000m³ develops on the tectonically stressed and impermeable schist-sandstone mass and (ii) to the longitudinal western block of limited extend, with estimated volume 225,000m³, where there are, exclusively, soil layers with increased permeability (Figure 7). The eastern block moved totally and independently, in respect to the western one, at NNE up to NE direction, with total horizontal movement of 7m and vertical movement of 2.50m. The tension and compressive cracks at the head and toe of the slope, respectively, accumulated at the periphery of the sliding mass and were totally absent from the central section due to its rigid nature. The western part of the sliding mass made up a distinct soil mass with independent spatial and temporal resultant movement to the North, total horizontal movement of 3m and vertical movement of 2m. The differential movement of 4m between the two fragments was covered through the numerous and dispersed cracks of the western section. The southern part of the eastern block seems to be an independent block which has boundaries that coincides with the failure of 1994. This soil block, with estimated volume of 63,000m³, moved in NW up to NNW direction with clockwise sliding component, pushed by the upward section of the landslide (Figure 7).

From the discharge of the horizontal drainage drillings, which perforate the sliding mass radically in order to unload it, the great potential of the calcareous aquifer was determined, with the discharge flows being over 100 times than the one of the western section (Figure 7). The sequential older failure surfaces, which were determined to the NE end of the landslide and in

Figure 7 - Delineation criteria of the soil blocks which form the landslide mass.

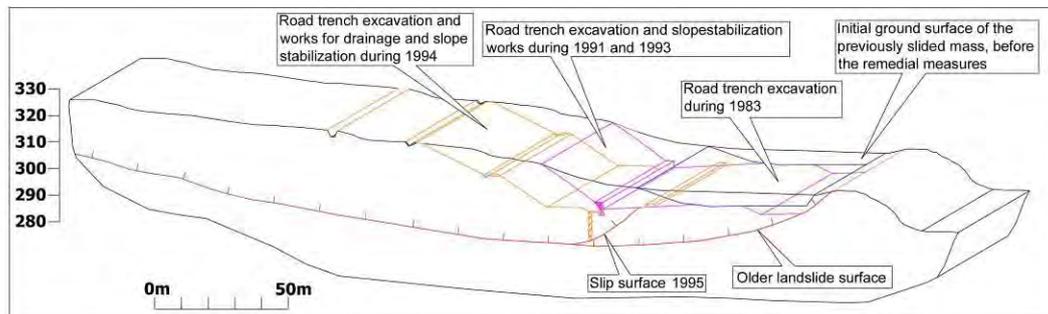
The gradual loss of support, caused by the sequential excavations in the slope toe made in a length of 110m, 155m in width and varied depth between 5m and 16m, in combination with the increased hydraulic head of the upward mass, was one of the most important factors for the landslide occurrence (Figure 8).

Figure 8 - Representation of the different excavation stages for the figuration of the National Highway at the landslide toe.
