GEOLOGICAL AND GEOTECHNICAL BEHAVIOUR OF EVINOS DAM FOLLOWING THE IMPOUNDMENT

Angelopoulos A.¹, Soulis V.J.², Malandraki V.³

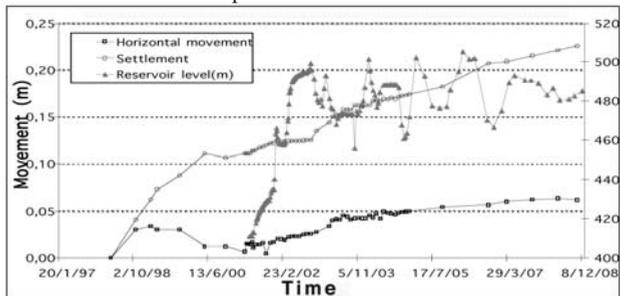
Fig. 5: Cumulative mean displacements and settlement in the dam's Crest.

- Piezometers placed downstream the grout curtain show considerably low piezometric level which demonstrates the efficiency of the grout curtain.
- Surface monumental stations placed on the dam crest (S68-72 downstream), indicate “extension” of the dam’s crest towards downstream, as well as a normal evolution of settlement.
