## GEOTECHNICAL INVESTIGATION OF THE ROCK SLOPE STABILITY PROBLEMS OCCURRED AT THE FOUNDATIONS OF THE COASTAL BYZANTINE WALL OF KAVALA CITY, GREECE

### Abstract

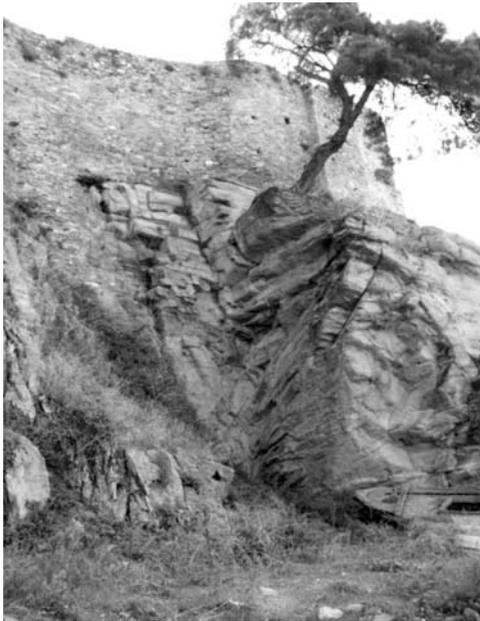
**Fig. 2:** Location P1. A fault intersects the slope forming a huge rock wedge and a wide fractured zone. The Wall fills the gap between the two sections of the fault.

Stability analyses conducted for the slopes with a dip direction 272°-302°, revealed that joints sets J1 and J2 form rock wedges rising along the slopes. These wedges tend to slide along the axis formed by the intersection of the before mentioned joints, with an angle of 73°. The slopes appearing a dip angle smaller than 73° are safe, as the rock wedges are self supported. On the contrary, the slopes with a larger dip angle are unstable. These wedge slides can threaten the Byzantine Wall only in cases where the foundation of the wall was constructed close to the slope edge. Precisely, in parts where the foundations were constructed in a distance smaller than half the height of the slope (Fig. 5E). Signs of oversized wedges that have already failed are visible in several parts of the slopes (Figs. 2, 4 and 6).

In order to avoid the wedge, plane and toppling failures spot bolting and sub-foundation constructions were proposed. To be more precise, the overhanging blocks could be supported by grouted rock bolts installed in selected locations. The underexcavated parts could be supported by filling the void with reinforced concrete constructions (buttresses, gravity walls etc.) camouflaged by stone coating. As presented in fig. 6, sub-foundation constructions were also applied in the past.

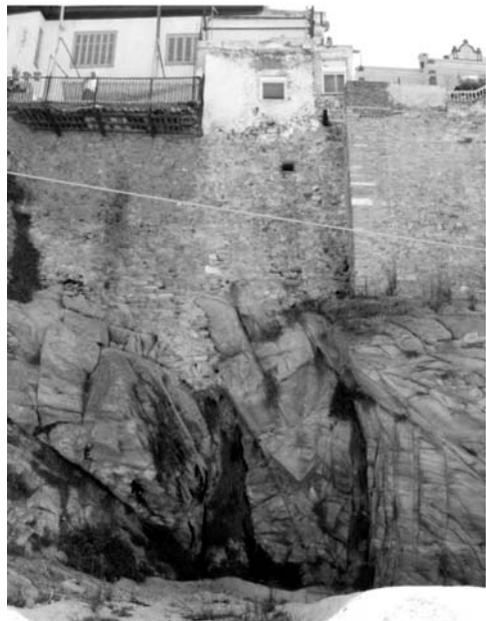
**Fig. 3:** Location P4. An intensively fractured zone caused by a fault. The wave erosion caused intensive underexcavation to the slope.

the wall was constructed in direct continuity with the slope. Even worse, in some places the wall was constructed forming a bridge across the two sections of the fault (Fig 3 & 5B,C,D). Figures 2 to 5 present typical examples of sections appearing slope stability problems capable of effecting the Byzantine monument.

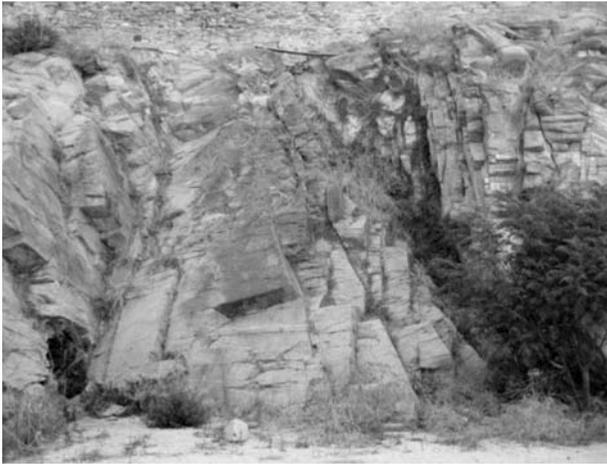
**Fig. 4:** Location P2. An oversized rock wedge that probably failed during the excavation of the small tunnel appearing at the base of the slope, on the left side of the picture. The extension of the failure could very easily damage the Byzantine wall.

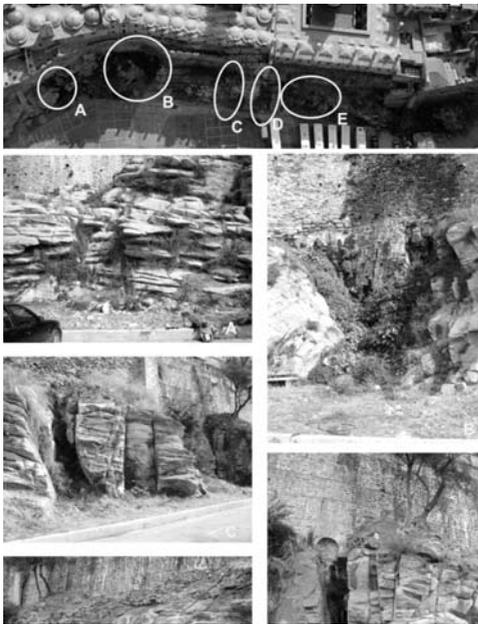
The corresponding analyses conducted for the slopes with a dip direction 202°-216° proved that those slopes are stable; no oversized rock wedges are formed (Fig. 5A). The only stability problems can be expected by the falls of small rock blocks sited along the slope face.

**Fig. 5:** Part P5. View of the slopes below Imaret monument intersected by the faults presented in the map of Fig. 1. The deterioration of the rock mass along the major tectonic lines cause serious rock slope stability problems threatening the monument. The letters pointing the various unstable locations correspond to the homonymous pictures (5A to 5E).

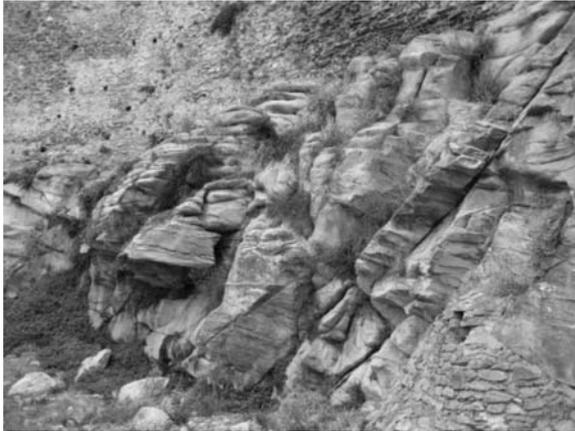
**Fig. 6:** Part P6. Several rock wedges are formed, to prevent them from sliding the underexcavated rock blocks were sub founded by the use of masonry walls – fills (lower right corner of the picture).

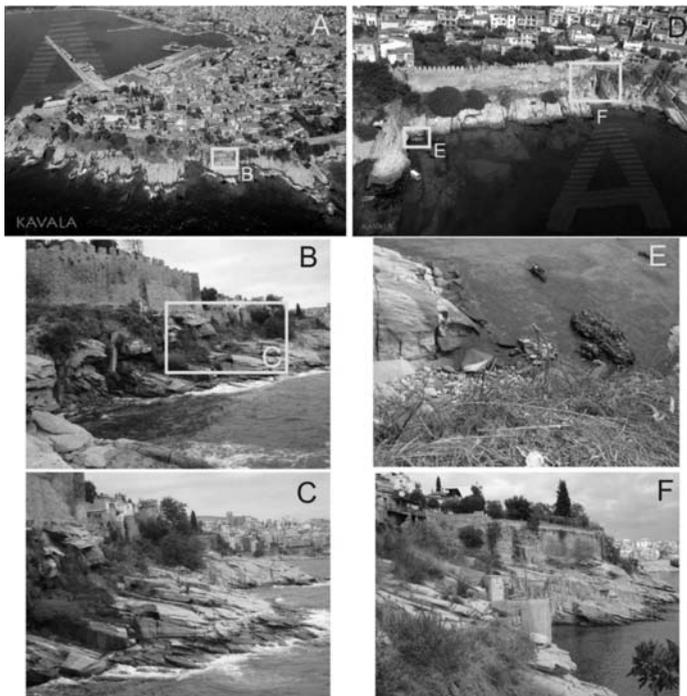
The South-eastern slopes present dip ranging between  $45^{\circ}$  and  $90^{\circ}$  and height extending 20 to 30m over the sea level. The lower parts of the slopes are found into the sea, effected by the marine erosion. The longest parts of the Byzantine wall are protected from the marine erosion and from the rock wedge failures as they are founded far from the edge of the slopes. However, along parts where the slopes are intersected by numerous faults, erosion processes have formed small gulfs and the sea has approached the historical construction, putting its foundation in danger (Fig. 7).

**Fig. 7:** Parts P9 and P10. View of the slopes along the SE part of the peninsula. Along the parts where the slopes are intersected by numerous faults the marine erosion processes have formed small gulfs and the sea has approached the historical construction, putting its foundation in danger. E: A collapsed section of the wall is presented.

Concluding, the slopes sited at the SE part of Panagia peninsula are not prone to rock sliding. On the contrary, toppling is likely to occur. Rock fragments of 2-3meters maximum height could topple, especially in parts where their foot is undercut (Figs. 7, 8). These phenomena could damage the historical monument at those areas where marine erosion has excavated rupture zones reaching to Byzantine wall's foundation.

The marine erosion of the slopes can be effaced by the installation of seawalls. These breakwater structures can be constructed by granite boulders, fitting to the surrounding bedrock and causing the minimum aesthetic distortion to the site. As presented in figure 7, the shallow sea, close to the coastline, allows the installation of the boulders by using barges. Unfortunately, these structures are going to block the small beaches formed along the gulfs. Small piers or narrow passages through the breakwater structures can provide solution to the problem.

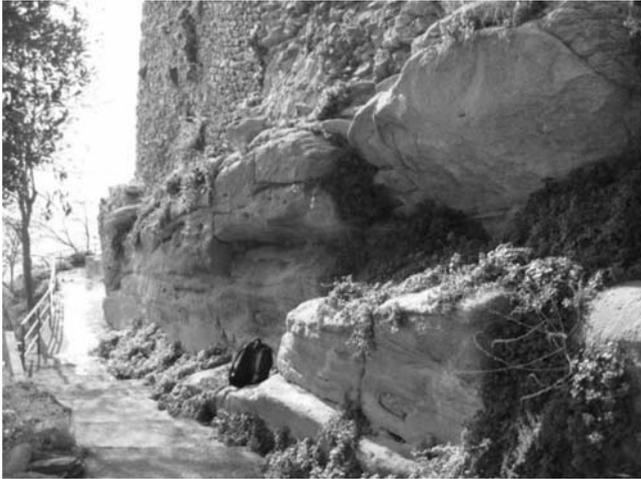
**Fig. 8:** Part P13. Underexcavated slope along a fault scarp. The wall was founded close to the edge. The toppling or the rupturing of the rock mass could cause extensive damages to the monument.
