ROCK SLOPE STABILITY PROBLEMS IN NATURAL SIGHTSEEING AREAS - AN EXAMPLE FROM ARVANITIA, NAFPLIO, GREECE

Loupasakis C.¹, Galanakis D.² and Rozos D.³

The natural sightseeing area of the Arvanitia walkway, in Nafplio city, is a typical example of site, with extensive human activities, manifesting serious rockfall stability problems. The applied stability analysis pointed out the geotechnical problems and allowed the suggestion of measures for the improvement of the geotechnical behaviour of the rock mass. The measures were planned with respect to the natural beauty and the historical character of the site. Further more, the stability problems located at the slopes of the Kastoria lake walkway are briefly presented. The differences between the two sites revealed the geotechnical problems arising when the landplaning engineers do not take under consideration the engineering geological conditions during the construction of infrastructures.

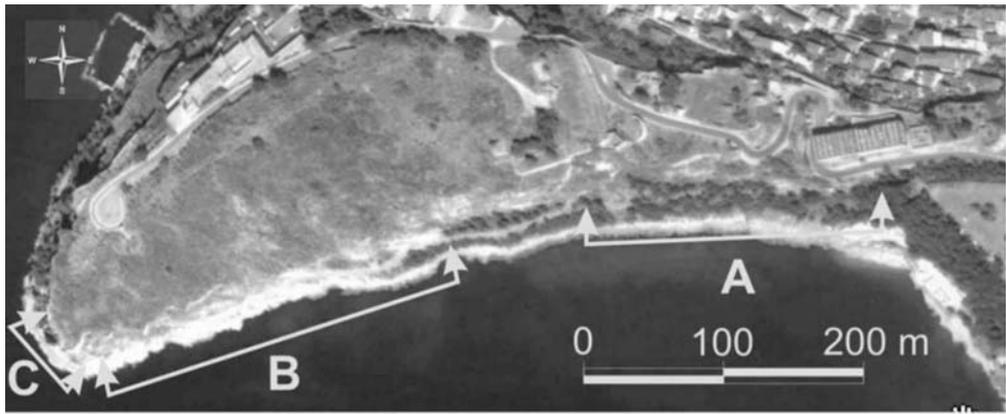
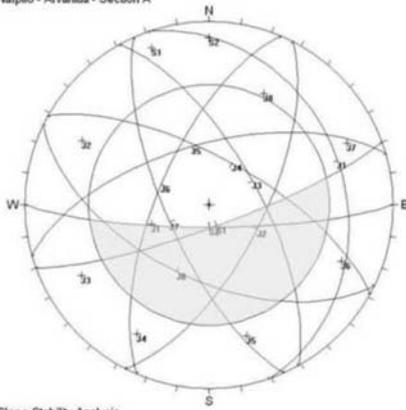
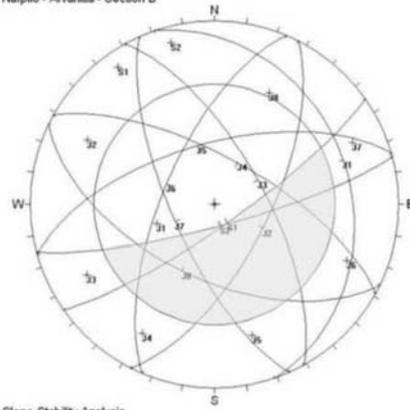
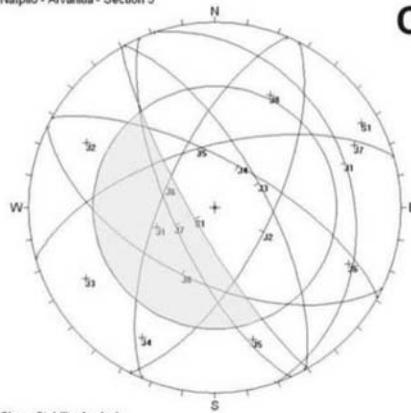
Fig 3. Satellite picture (Google Earth) pointing the parts of Arvanitia walkway (A, B and C) constructed along the base of the slopes. The Schmidt stereo diagrams presenting the numerous joint sets intersecting the A, B and C parts of the slopes. The numerous unstable wedges are clearly presented by checking the intersected major planes in the "zone of potential instability" (grey area) (Hocking, 1976; Hoek & Bray, 1981).

The Schmidt stereo-diagrams presented in figure 3 prove that the A, B and C parts of the slopes are intersected by multiple joint sets. Most of the joints appear very high persistence (>20 m), wide spacing (1-2 m), no separation (< 0.1 mm) and lack of weathering. Those parameters explain the high RQD values (reaching up to 80-90%) and justify the also high RMR ratings (75-80) that classify the limestones in the “good” rock mass category (Kolligri, 2008). Based on the before mentioned characteristics of the joints, the wedges formed along the slopes are common and almost always oversized.

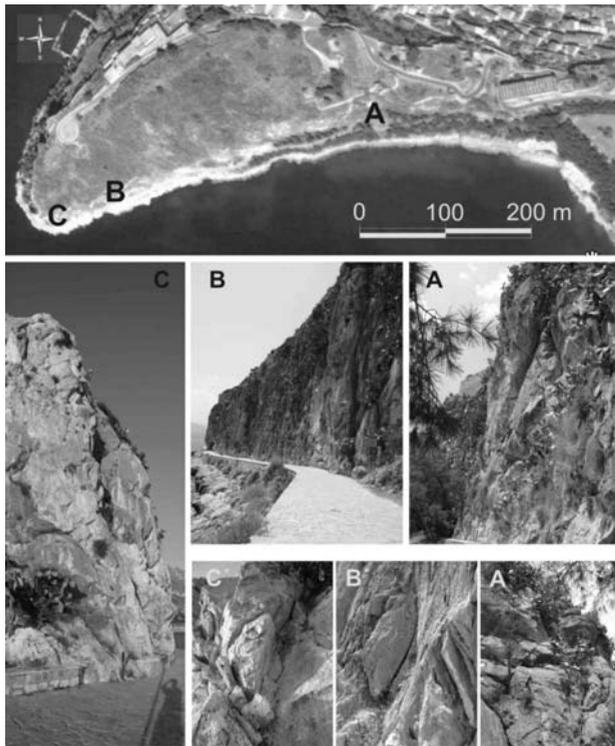
Fig 4. Photos presenting the condition of the rock mass in the before mentioned parts A, B and C of the walkway. Pictures A', B' and C' present focus on main wedges in the corresponding slopes.

and C are constructed attached to the base of the slopes without leaving any space for the installation of any protection measure. Those sections appear serious stability problems, due to the rock mass fracturing, and the disturbance caused by the excavation procedure.

Beside the tectonics, the rock mass condition was affected by unadvised excavation procedure. The lack of any pre-splitting technique during the cutting of the artificial slopes (figure 5c), led to the intensive cracking of their rock mass. The abundance of the overhanging blocks, the height of the slopes (reaching up to 40 m) and the installation of the road on the base of the slopes without keeping any safety distance, cause serious safety issues.

Unfortunately, the above mentioned stability problems require the application of remedial measures causing disturbance to the natural sightseeing character of the site. Indeed, the actions needed to be applied are: a) removal of all overhanging detached rock blocks, using controlled quarrying b) ap-

plication of spot bolting in order to stabilize all the big rock wedges and c) installation of a high strength rockfall protection uniaxial netting along the entire slope (Fig. 7B, C).

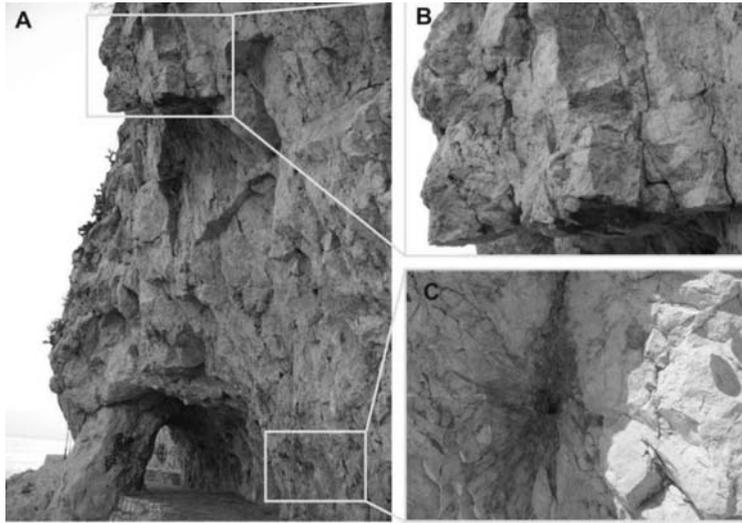
All these problems are even more intensive along section C. Several meters of the walkway are constructed not only attached at the base of the slope, but along overhanging parts. Even a small tunnel was constructed in order to cross a ledge of the rocky slope (fig. 5).

Fig 5.: A) A small tunnel constructed along section C. B) Wedges hanged over the entrance of the tunnel. C) the intense artificial fracturing around a drill used for the installation of explosives.

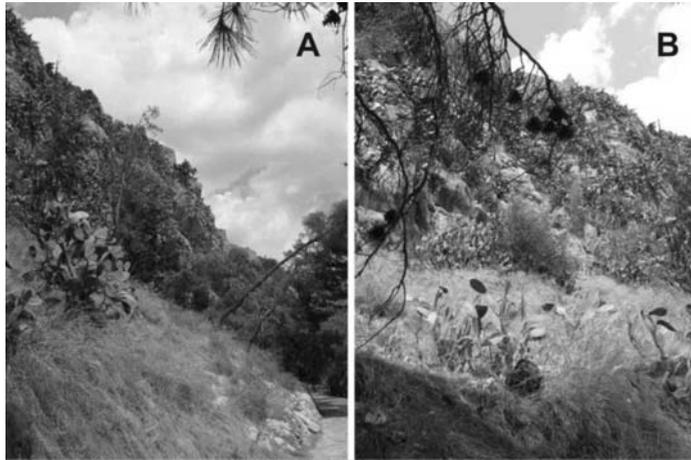
The slopes along the rest of the walkway (except parts A, B and C) manifest the same tectonic fragmentation but they are not disturbed by any excavation procedure. Further more the available space along the base of these slopes, as well as the tree cover, allow the installation of all necessary protection measures without causing any aesthetic destruction to the site (fig. 6).

Fig 6.: Photos taken from the slopes extending between section A and B. The available space allows the installation of camouflaged protection measures.

The selection of the proper protection measures for the slope parts being at a distance longer than ten meters from the walkway can be easily confronted. The available modern protection fences systems (Fig. 7D) could be very effective without causing any aesthetic distraction to the sightseeing site. These fences could be installed along the base of the slopes within the limits of the declivity extending between the slope base and the walkway, and can be camouflaged by planting trees or bushes. Along the western part of the walkway, with the larger available base declivity space, gabion boxes embankments (Fig. 7E) can be installed instead of fences. The installation of these embankments is cheap and they require no maintenance expenses, unless they are damaged.

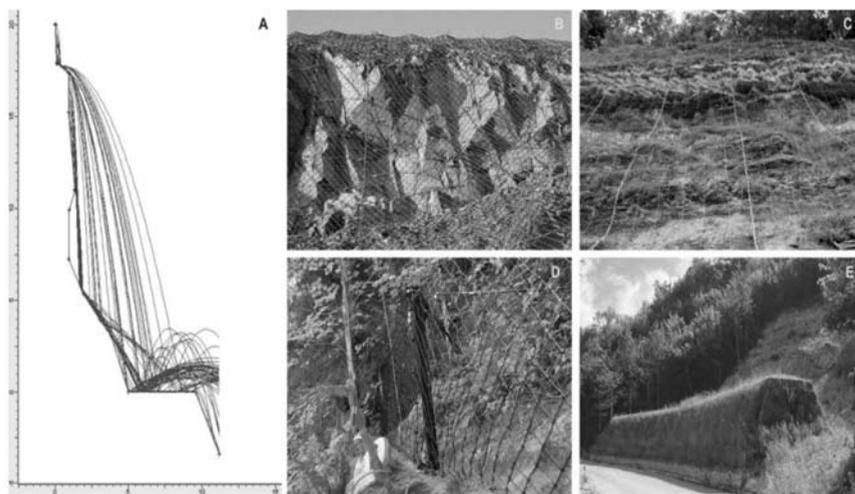
For the selection of the proper support measures of sections A, B and C, besides the stability analyses, rockfall propagation analyses were conducted (Fig. 7A), using the *RocFall* statistical analysis program. These analyses revealed that the spreading of the falling rocks covers the entire road width.

Fig 7.: A) Analysis for the estimation of the rock fall propagation in a typical cross section of the slope, B, C, D and E) typical support and protection measures. Wire nets (B and C), fences (D) and gabion boxes embankments (E).

Alternatively, as the net, causes a visible aesthetic demission, it could be substituted by the installation of a metallic frames shelter, covered on top with wavy sheet iron. Metallic frame constructions could be designed to take over the impact of a rock fall and at the same time their architectural design could make them fit the natural sightseeing setting.

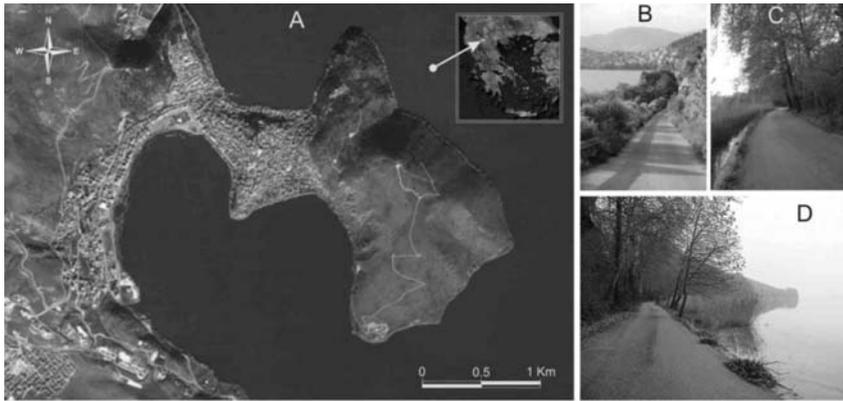
Fig 8.: A) Satellite pictures - taken from Google Earth - pointing the Kastoria peninsula surrounded by the, 8,5 km long, lake walkway, B, C and D) variant views of the walkway sections.

for the installation of proper protection measures, such as metallic fences, sort concrete walls or excavated trapping ditches (Fig. 8C & D). Limited sections with steep slopes (Fig. 8B) can be protected with wire nets, without causing serious aesthetic alteration to the site because of their reduced contribution to the total length of the road. Most of the before mentioned geotechnical problems could have been avoided if during the construction of the road the condition of the rockmass was taken under consideration. For example the road could have been constructed 1m higher in order to give space for a trapping ditch. Also, due to the shallow depth of the lake, limited section could have been constructed over the lake, avoiding the excavations.
