SAFETY ASSESSMENT AND REMEDIAL MEASURES DESIGN FOR AN EXTENSIVE ROCKFALL ALONG THE MAIN ROAD TO KIMI, EAST EUBOEA, GREECE

Loupasakis C.¹, Lalos G.¹ and Rozos D.¹

¹Laboratory of Engineering Geology and Hydrogeology, School of Mining and Metallurgical Engineering, National Technical University of Athens, 9 Iroon Polytechniou, Athens, Greece
cloupasakis@metal.ntua.gr, rozos@metal.ntua.gr

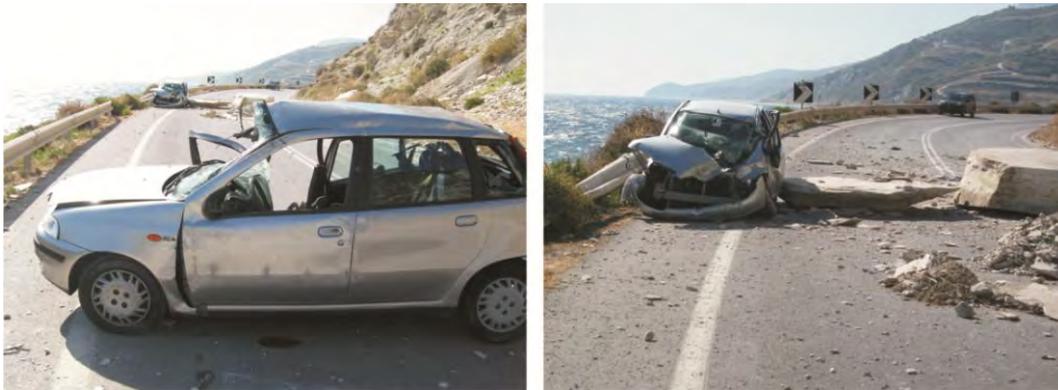
The currently examined failure along this road causes up to now serious socio-economic consequences as the remedial measures applied are temporary and incomplete. The unobstructed road connection with the harbour cannot be accomplished, as the slope still presents serious stability problems. Besides the abovementioned long lasting problems, the failure left behind a civilian with permanent disability, as the rocks crashed two cars passing through at the time (Figure 1).

Figure 1 – View of the road, right after the Rockfall took place. The oversize blocks as well as the crashed cars are presented.

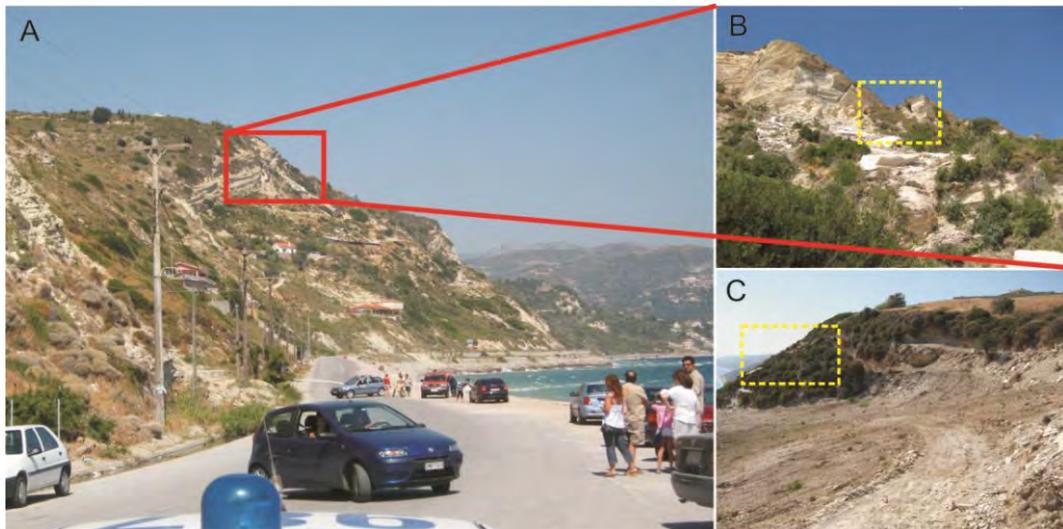
Figure 3 – View of the examined slope. The rock detachment area is indicated on picture A. Picture B provides a closer view of the detachment area. Picture C presents the earth moving works that took place before the failure at the crest of the slope.

At the same period, extensive emendatory earth moving works took place around the rock detachment area. The detachment area was located right next to an extensive excavation (Figure 3C) that was under construction at the period of the failure. So in order to prevent farther failures from the same location several rock blocks were moved from the site.

The examined slope consists of Neogene formations, clayey marls and calcitic marls to marly limestones. The clay marls occupy the lower parts of the slope and the marly limestones the upper. The morphology of the slope is highly affected by its geological structure. As presented at figure 3A, the lower parts, occupied by the relatively soft and erodible clayey marls, appear gentler inclination and the upper, occupied by the hard calcitic marls to marly limestones, much steeper, forming vertical slopes. Furthermore, the differences on the erodibility of the two formations lead to the underexcavation of the marly limestones, forming sections with overhanging blocks.

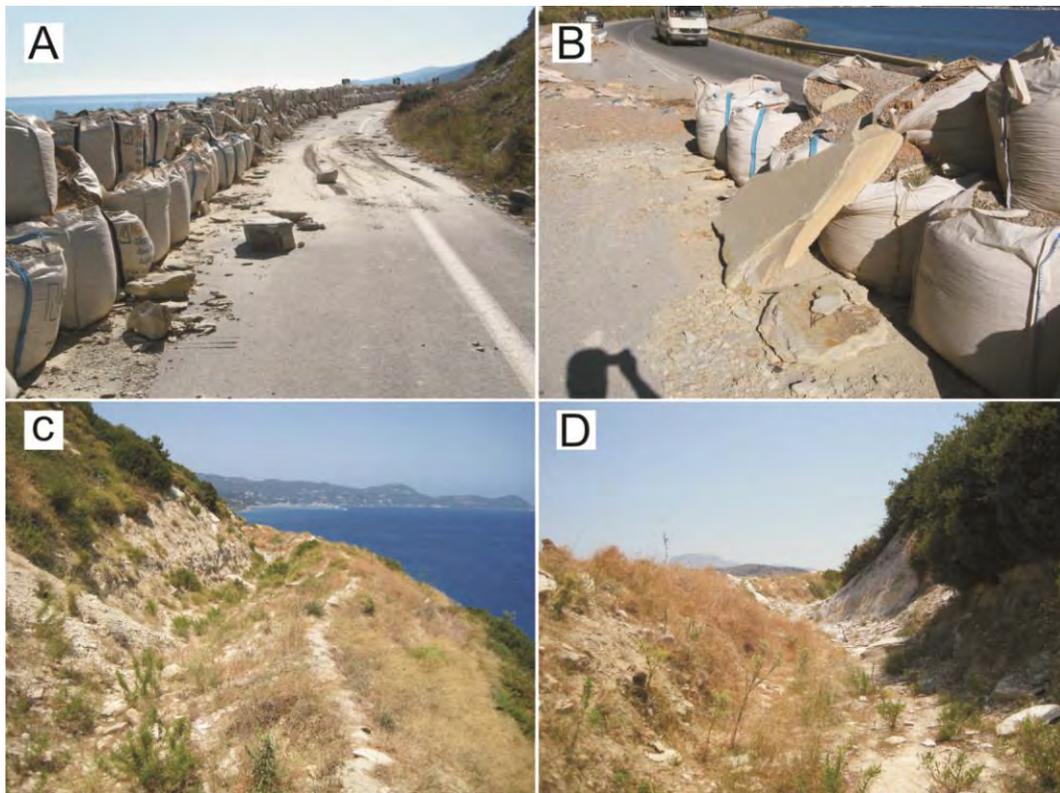
The following days, and before conducting a complete geotechnical study, a temporary embankment was installed in the middle of the road (Figures 2 & 4A,B). This 2m high embankment (E3 at Figure 2) was constructed by two series of big bags filled with gravels, aiming to provide a safety at the external lane of the road, preventing the complete blocking of the traffic. This temporary embankment still remains there as none ever decided to remove it. Figure 4A, B proves that although it was installed based on empirical estimations, it operated perfectly during the years, trapping several rock block and protecting the external lane of the road.

Besides the above mentioned embankment, extensive earth moving works took place on the slope aiming to modify its morphology, forming a complex of ditches and embankments, E1 & E2, as remediation measures (Figures 2 & 4C,D). This works took place after the installation of the E3 temporary embankment by contractors appointed by the municipality. Despite all these works the temporary embankment E3 was not removed at the end.

Figure 4 – A & B Photos present the embankment, E3, constructed in the middle of the road. The numerous trapped rock blocks prove the effectiveness of the embankment, initially constructed as a temporary protection measure. C & D photos present the embankments, E1 and E2.

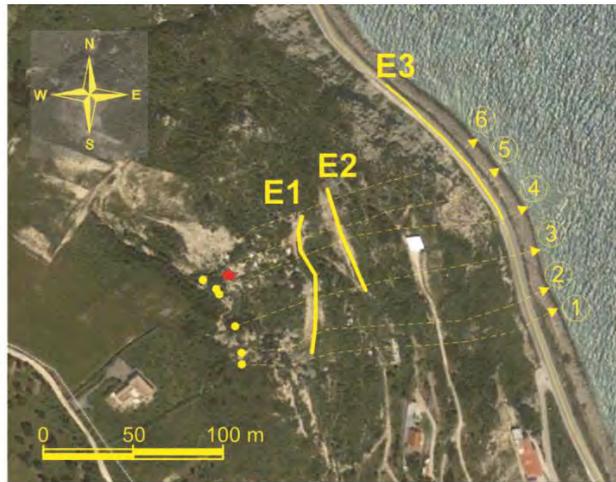
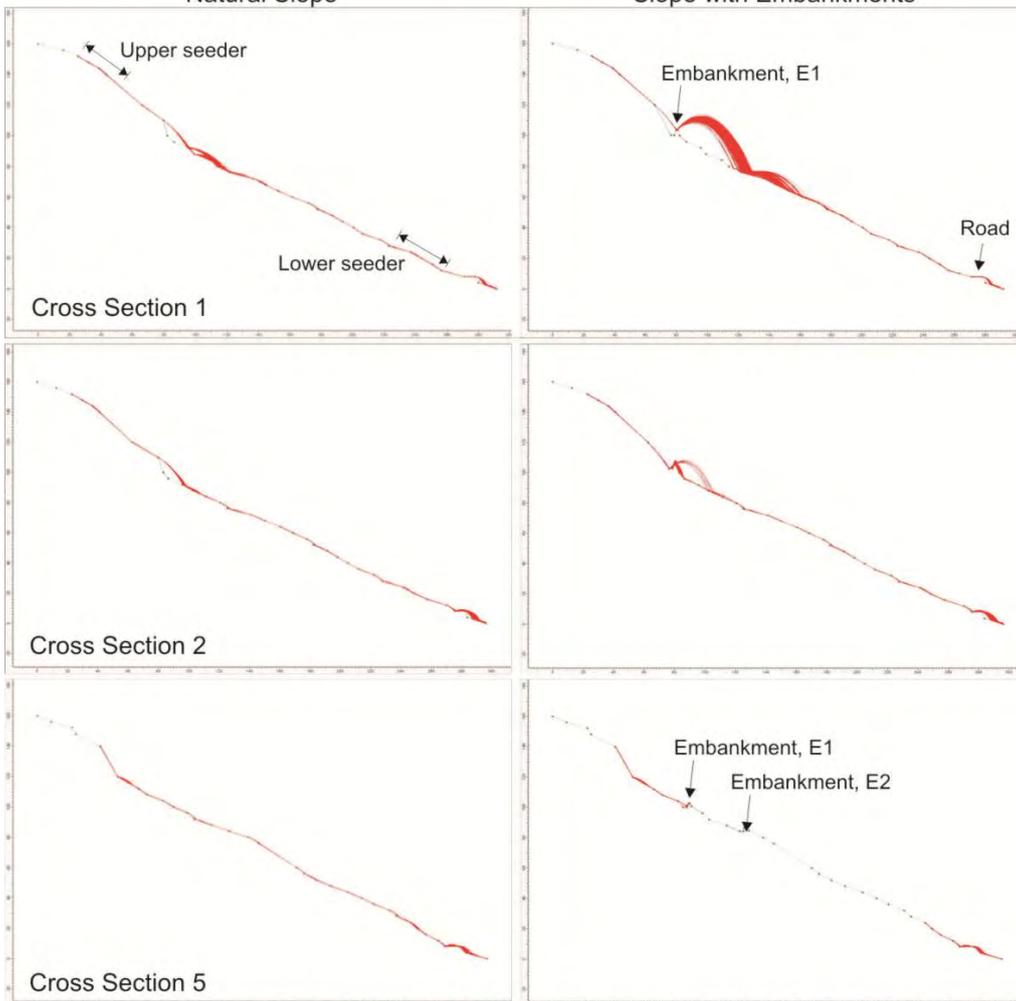
Figure 5 – The Satellite pictures, taken from Google Earth, points the six cross sections selected along the slope for the simulation of the rockfalls. Characteristic examples of simulation results are presented in selected cross sections.

The simulations proved that the embankments E1 and E2 improved the safety conditions of the slope but unfortunately they did not eliminate the risk. The outcomes of the simulations can be listed as follows:

Concluding, the embankments, E1 and E2, protect the road from the rock blocks detached from the northwestern part of the upper seeder (cross sections 3-6). On the contrary, they make the safety conditions at the rest of the seeder (cross sections 1&2) worse, accelerating the rolling blocks. Furthermore, the road stays completely unprotected from the lower seeder.

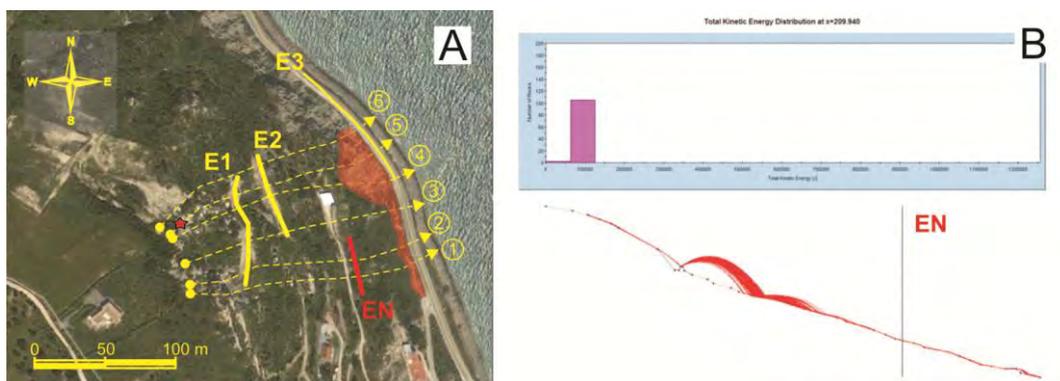
Figure 6 – A) Arrangement of the proposed extra remediation measures. B) The kinetic energy envelope at the location of the EN embankment.

In order to secure the road and safely remove the ``temporary`` embankment E3, a few additional remedial measures have to be constructed. The new remedial measures must block the boulders passing over E1 embankment, at the cross sections 1 and 2, and also secure the lower seeder.

The rockfall simulations indicated that the rock blocks bouncing over the embankment can be stopped by installing a new embankment, EN, at the location indicated in Figure 6. At this particular location the rock pieces move with a reduced kinetic energy and their bouncing height is decreased (Table 3). The current embankment can be constructed, as the previous embankments, by compacted soil materials or even better by reinforced soil materials. The reinforcement of the soil material can be accomplished by the use of geotextiles. The impact catchment face of the embankment can be protected by installing gabion blocks, gabion like wall face or impact catchment bags (Figure 7). Considering the bounce height (max 1.4m) and the radius (0.5m) of the boulders, an embankment 3m high is sufficient for the current position. Furthermore considering that reinforced embankments can stand an impact force up to several thousand Kj, this, low-price, solution can be sufficient even in the case of a bigger block rockfall. Most sophisticated and at the same time most expensive, pathetic remedial measures, suitable for the current location, are the rockfall fences.

The lower seeder can be secured by installing a uniaxial double-twist wire mesh covering the entire lower seeder. Double-twist mesh is the ideal solution due both to its flexibility in every direction and the fact that gaps in the mesh are avoided in the event of accidental breakage of some wires. The wire mesh must be suspended by using fixed anchorage at the top and removable anchorage at the bottom, to facilitate during the maintenance. The mesh must be kept free along the slope, letting the rock masses fall to the base of the slope but always keeping them between the rock slope and the barrier mesh. Before the installation of the mesh all individual hanging rock blocks must be removed. The installation of the wire mesh besides the obvious support, forces detached rock pieces to slide instead of rolling. So it does not allow them to obtain substantial kinetic energy.

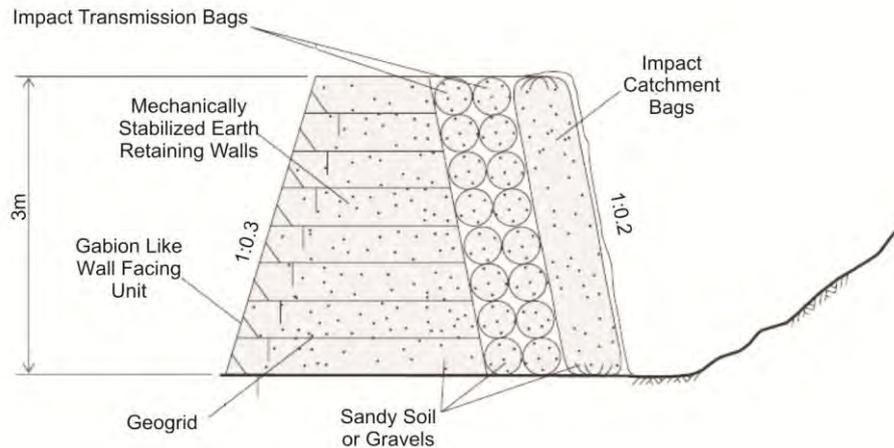
Figure 7 – A typical cross section of a reinforced soil embankment, containing all possible combinations of geomaterials (geogrids, gabion like wall face and impact catchment bags) (modified from Yoshida, 1999).
