## THE ENGINEERING GEOLOGICAL BEHAVIOUR OF DISTURBED AND WEATHERED GNEISS IN SLOPES. THE CASE OF THE “VERTICAL AXIS” OF EGNATIA MOTORWAY, KOMOTINI – NYMFEA, NORTHERN GREECE

Marinos V.<sup>1</sup> and Goricki A.<sup>2</sup>

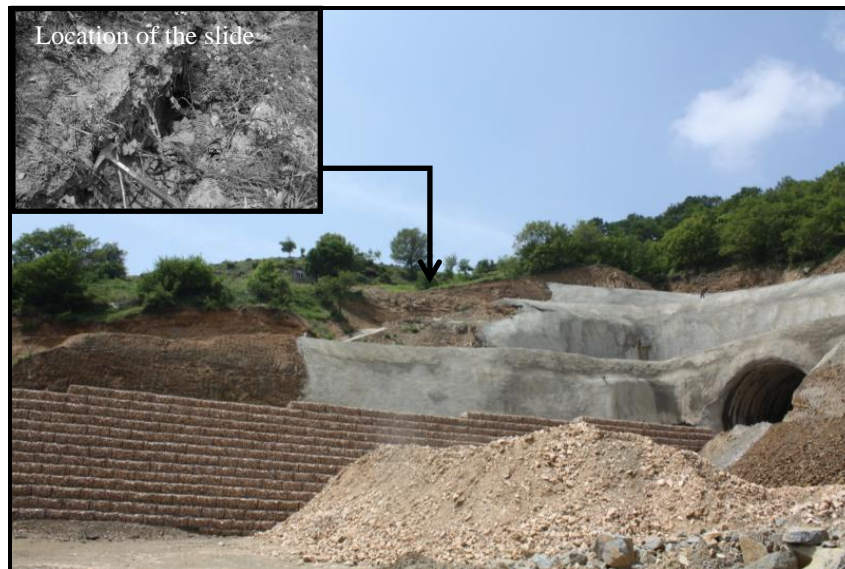
The first case study discusses a slide that occurred close to the entrance portal of Nymfea tunnel (Figure 1). The rock mass in the area is comprised of gneissic schists in the surface and schistosed gneiss in depth. The rock mass is highly to completely weathered at the surface (type V and VII) and becomes moderately weathered (type III) in depth. Six boreholes with inclinometers and piezometers were drilled to investigate the slide. The identification of weak zones, the thickness of the weathered cover in the specific area and the evaluation of inclinometer and piezometer measurements were of primary importance. Taking into consideration the above parameters, it was evaluated that the slide was driven within the weathered zone, occurred after the excavations of the tunnel portal. It started several meters above the cut and ended in the second bench of the excavated cut, developing several cracks in the already applied shotcrete. The weathered zone, other geological features and the tensile cracks are highlighted in the Figure 2. It is highlighted here that sliding could have been also assisted by the weathered schistosity that is favourable dipping with 30° towards the slope.

**Figure 1 - View of the entrance portal of Nymfea tunnel. The gabion wall is used here for the stabilization of the whole slope. The slide occurred above the gabion wall.**

The scope of the back analysis is to estimate the geotechnical properties of the completely weathered gneiss (type VII). The slide was driven within the weathered cover, starting several meters above the cut and ending in the second bench of the excavated cut, developing several cracks in the already applied shotcrete after the excavations of the tunnel portal. From the grain size distribution analysis of the completely weathered soil-like geomaterials it is found that the percentage of sand is around 50-70% and of silt and clay around 20-30%. Plasticity index is around 5-7. The shear strength properties that resulted from laboratory tests (cohesion  $c=31\text{kPa}$  and angle of friction  $\varphi=37^\circ$ ) are considered high and not representative for the material within the failure plane. An important parameter that influences the analysis results is the status of the pore water pressure at the time of the failure. The piezometric surface was assumed along the contact of the weathering cover and the more fresh bedrock. Moreover, due to intense raining before the slide and some infiltration within the weathering cover, a  $r_u$  coefficient of 0.25 was considered. It is noted that the weathered cover has some small cohesion since clayey-silty material are present in the mass. The concluded values from the analysis are  $c = 5\text{ kPa}$ ,  $\varphi = 28^\circ$ . It is highlighted that the analyses were done for circular and non-circular surfaces. The results from both the analyses were almost similar (0.998 for the non-circular and 1.029 for the circular surface with the Janbu-corrected method). The actual sliding surface seemed to be the non-circular one as it resulted from the tension cracks, the depth of the bedrock and the cracks in the shotcrete above the portal cut.

The solutions to stabilize the entrance portal cut of Nymfea tunnel can be categorised in two alternative solutions.

- Measures within the area of the failed rock mass by supporting with a pattern of pre-stressed anchors or removing the failed material.
- Measures at the bottom of the failed rock mass by retaining measures. Support the failed material at the lower to those focused to secure the road from further slides with the construction of passive measures.

Due to the large area and the great depth of the slide it was found, that retaining measures are the economic way to stabilise the slope. Reinforced concrete walls with pre-stressed anchors were combined with the Cut&Cover structure of the tunnel portal and constructed from the road level.

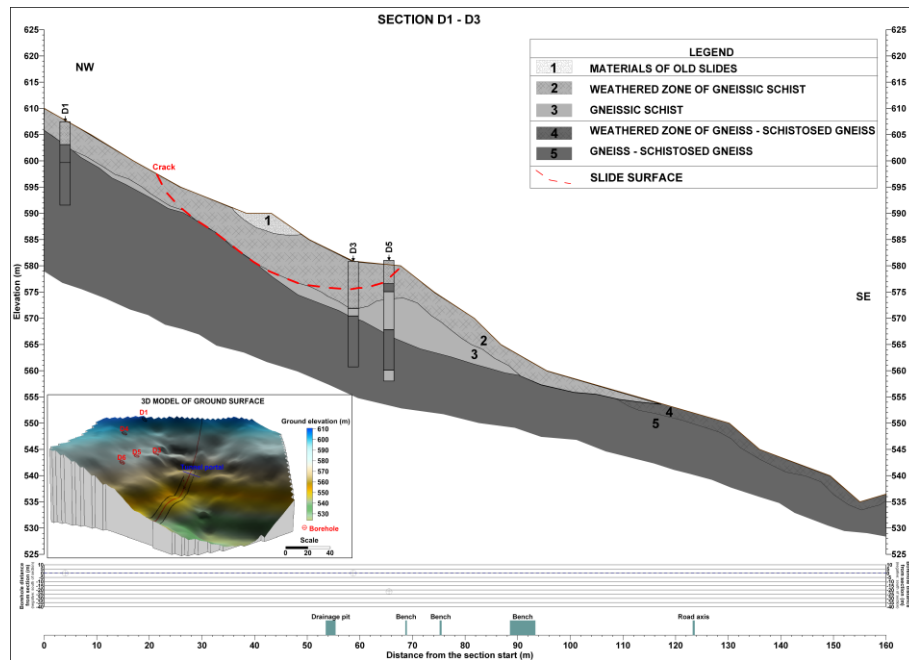
**Figure 2 - Geological section along the slide of the Nymfea entrance tunnel portal cut (Case Study 1).**

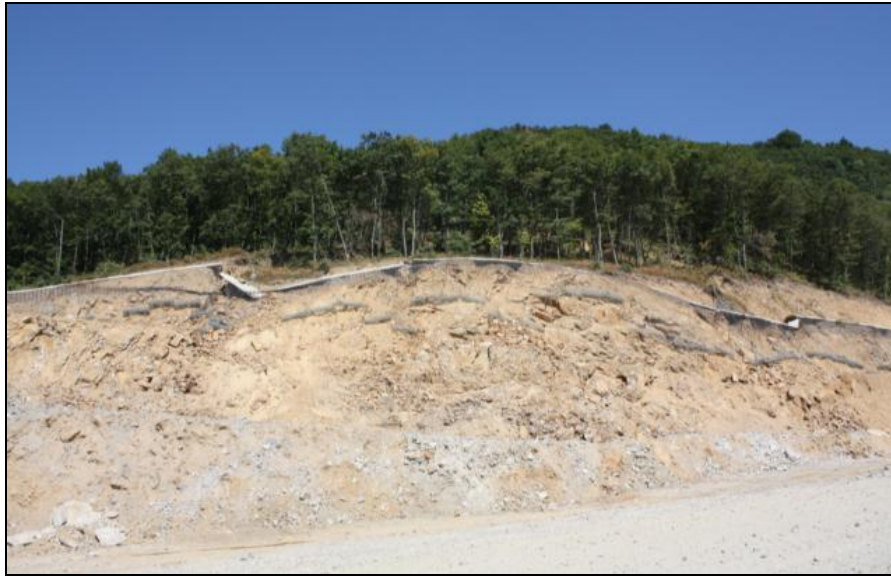
The slope stability problems along the road cut numbered O28 started on summer 2009. The road cut has a height of 30m with 4m wide benches every 10m and consists of schistose gneiss. After the excavation of the second bench, the first cracks on the slope surface were observed and then a greater slide of a significant part of the slope followed (Figure 3). This failure triggered a greater landslide that developed tension cracks in the natural ground, in a distance 70m behind the scarp of the road cut. The shotcrete along the benches failed and a significant part of the slope has been displaced. After that, the excavation works stopped and the slope was backfilled with a temporary buttress. These temporary actions stabilised the slope since no movement had been observed for two wet periods. In order to face these instabilities permanently, slight modification of the road axis with a horizontal offset of about 15m was decided and a new geotechnical design was implemented.

1. Two shear zones have been recognised in cut O28, one sub-vertical and one sub-horizontal. The first was evident after the slide of the slope and the second was recognised in one of additionally drilled investigation boreholes (Γ19A). The mechanical characteristics of these zones are very poor, since they are consisted of foliated particles of clayey-sandy nature with small rock fragments. The shear zones, other geological features and the tensile cracks are highlighted in the Figure 4. These features can be combined geometrically and it can be presumed that the failure occurred along this surface. It is multi-planar but can be conceptualized in significant degree as circular. It is evident that the excavations of the cut, the design of the slope angles and the presence of shear zones created adverse conditions for the stability of the road cut. Although there are no detailed information about the groundwater conditions at the time of the failure, the fact that sliding occurred during the dry season (summer period), led to the conclusion that the shear zones were the crucial elements triggering the slope failure.

Figure 3 - The slide of the road cut O28. Drain trenches and benches have cracked.

The slide has a length of 150m and a width of 80m. To avoid intensive, costly and time consuming retaining structures the road axis was slightly modified by moving it approx. 15m horizontally away from the side. Due to this the extension and height of the cut slope decreased significantly and it was only necessary to stabilise a small part of the failed rock mass. This was done by cement grouting of the jointed gneiss. Additionally drainage holes were drilled in the rock mass to drain the surface water saturating into the ground and to avoid the development of any water pressure.

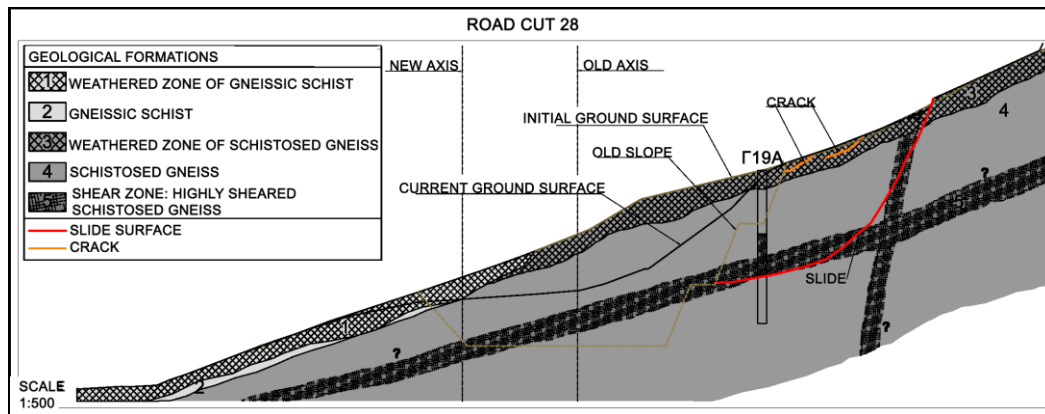
Figure 4 - Geological section along the slide of the road cut O28 (Case Study 2).

In this case study, the sliding occurred along two shear zones, consisting of foliated gneiss that resembles almost to sandy-clayey soil material after its tectonic disturbance. The first shear zone forms the scarp of the slide, and the second - the main sliding surface – is almost parallel to the slope surface. Although the geotechnical parameters of the surrounded gneissic rock mass (type III,  $\gamma = 25\text{ kN/m}^3$ ,  $\sigma_{ci}=35\text{MPa}$ ,  $\text{GSI}= 25\text{-}35$ ,  $c= 100\text{ kPa}$  and  $\varphi= 30^\circ$ ) were incorporated in the analyses, the critical parameters are the ones of the shear zones. The piezometric surface has been found in a depth of 13m due to the fracturing of the rock mass. The concluded values from the analysis are  $c = 50\text{ kPa}$ ,  $\varphi = 23^\circ$ . Similarly to case study 1, the analyses were done for circular and non-circular surfaces. Although the sliding surface fits better (geometry of shear zones, location of surface cracks on the cut and the natural slope, depth of movement) to a non-circular surface, the results were similar (0.999 for the non-circular and 1.015 for the circular surface).
