INVESTIGATION AND MITIGATION OF A FAILURE AT THE TAXIARCHES CANAL OF MORNOS AQUEDUCT

Mourtzas N.D.¹, Gkiolas A.², Vakiris D.² and Soulis V.³

Abstract

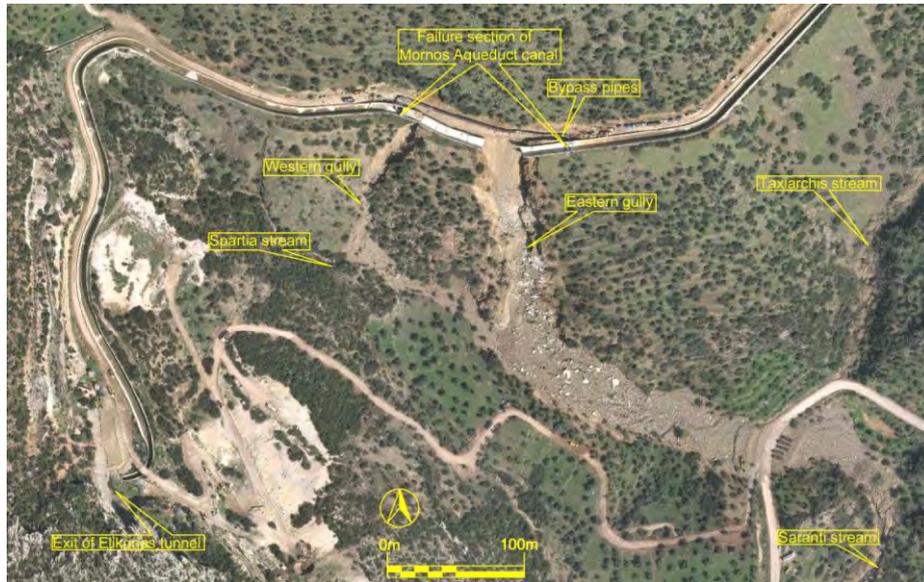
In the afternoon of 29/03/2011 a significant soil fracture and failure at the Taxiarches canal of Mornos Aqueduct took place, extending to a section of approximately 7 canal segments, with an 11.50 m to 12 m length each (total length 80 m).

downhill and four segments upstream (2, 3, 4 and 5) and another one downstream (8) tilted and were damaged (Figures 1 and 2). During the final phase of the failure, water discharge dropped from 100 m³/sec to 10 m³/sec, within a two to three minutes time period, resulting in an estimated outflow volume in the order of 300 to 400 thousand cubic meters. This sudden outflow resulted in erosion of 45.000 m³ soil material, consisting of fine and coarse grained material of the overthrust zone.

Figure 1 - Aerial view of the slide area.

At the area of the slid segments, the subsoil, the surveillance road and part of the cut slope have also slid downhill forming a gully (eastern) with steep high sides, with a length of 150 m, a maximum width of 45 m and depth ranging between 10 m to 18 m. Upstream the main failure area, four canal segments have undergone significant displacements, mainly horizontal towards lower elevations. At the area of the most distant segment a secondary gully (western gully) with steep sides was formed, with a length of 250 m, a maximum width of 18 m and depth ranging from 2 m to 3 m (Figures 1 and 2).

The sudden discharge of a great water volume, after the canal failure, created two gullies spaced 75 m apart. The eastern major gully, of a length of 150 m, has a direction of NNW-SSE, maximum width of 45 m and it is 18 m deep (Figures 1 and 3). Its slopes are steep with gradients reaching 80% in the western slope, where friable and vulnerable to erosion calcareous-clayey materials are predominant and 100% in the eastern, where sandstones and conglomerates are developed.

Immediate remedial measures were taken, including temporary filling of part of the failed and eroded soil mass and construction of temporary twin bypass pipes, of 2 m diameter each. Backfilling for the pipes foundation was implemented by means of a steep temporary embankment, using material from a nearby quarry, without proper compaction.

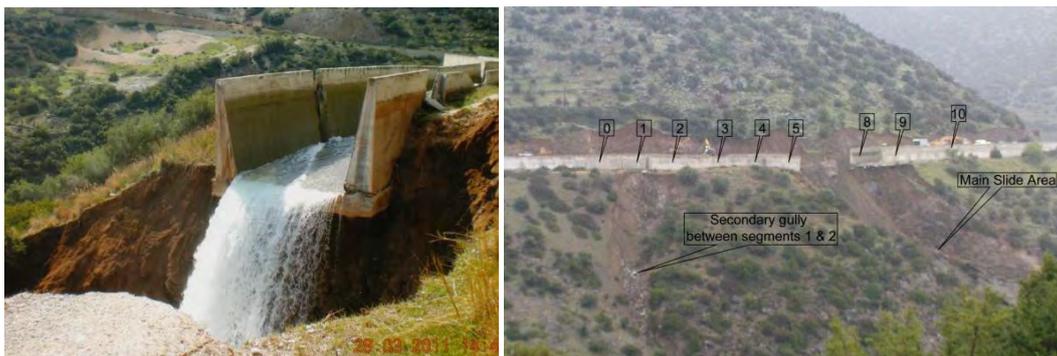
The reinforced concrete canal cross-section is U-shaped with a width of 5 m and 4.50 m height. The canal is constructed in cut and its hillside wall was backfilled up to a 4m height, where a surveillance road is allocated. Due to the failure, two of the canal segments (No 6 and 7) slid

Figure 2 - Canal segment failure (left), Main slide shortly after occurrence (right).

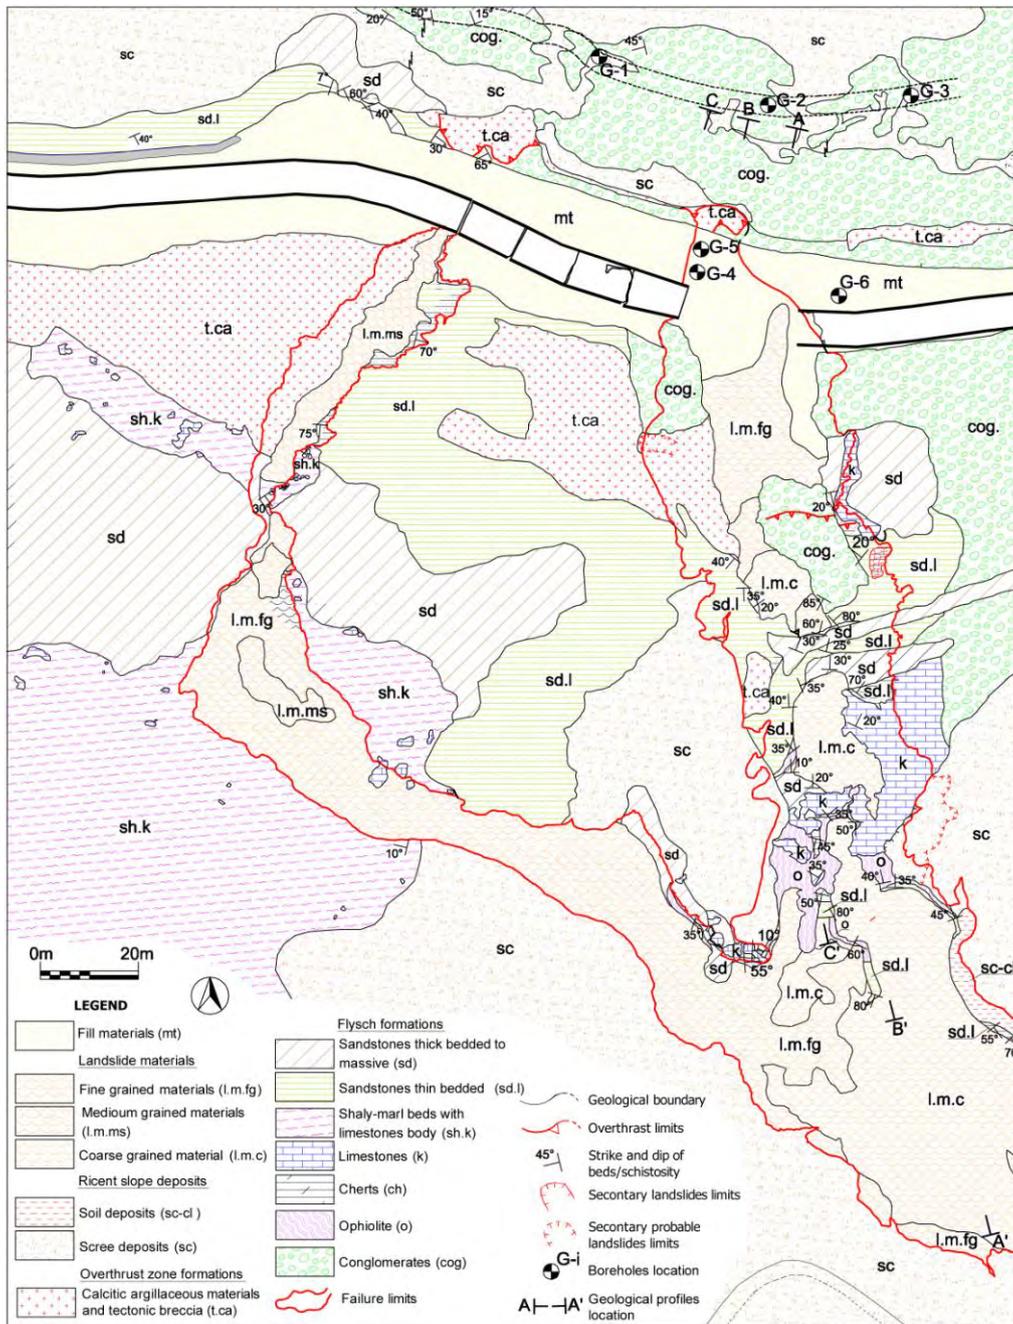
According to the geological mapping of the failure area (Figures 3 and 4), schists with intercalations of thinly and thickly bedded sandstones are located at the base of the stratigraphic sequence. At their southern boundary show a general dip towards the south (ranging from SE to SW) at angles 50° to 80°. At their northern appearances are dipping towards NNE and NNW at

angles 35° to 40°. The extended limestone body, massive to thickly bedded, with a general dip to NE at angle 20°, follows. The next formation uphill are alternations of thinly to thickly bedded sandstones with a limited schist intercalation, dipping 25° to 35° NE, with thickness of ca.35 m. They are followed by cohesive and massive conglomerates. Tectonic breccia covers the tectonic surfaces. The ash-green coloured schists with limestone intercalations are located at the foot of the western gully, dipping 10° WNW. Thickly and thinly bedded, intensively tectonized sandstones follow, dipping 70° to 75° SW (Figures 3 and 4).

Figure 3 - Geological map of the landslide area.

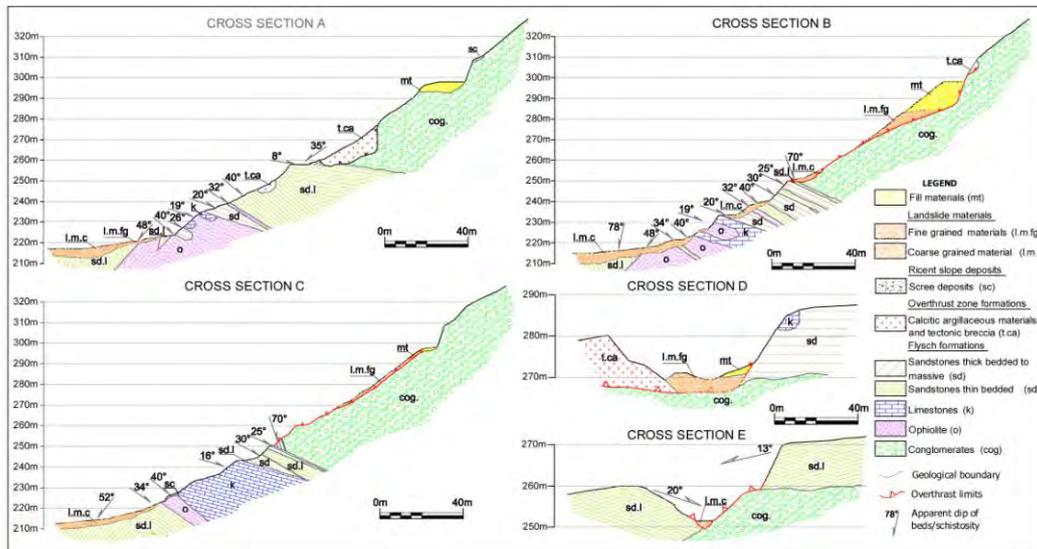
Figure 4 - Geological cross-sections of the landslide area.

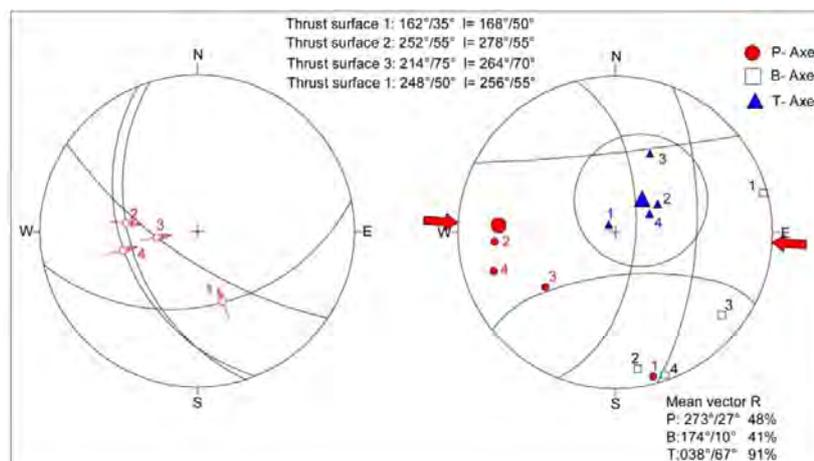
The kinematic analysis of the overthrust, based on the orientation data (dip direction/dip) of the overthrust plane and the orientation of striations, revealed that this large-scale compressive event took place under a compressive stress regime of WNW-ESE direction (Figure 5).

Figure 5 - Kinematic analysis of overthrust.

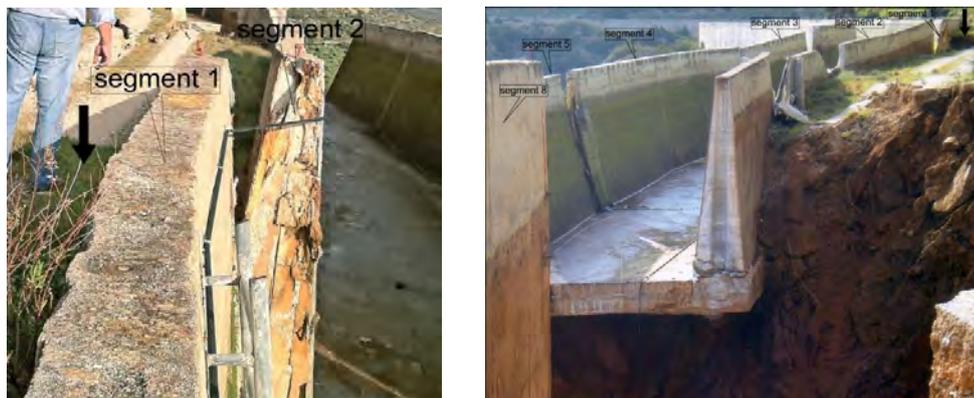
- The soil fracture and the following canal failure is not considered limited in the area of the two slid canal segments (No 6 and 7), but extended throughout the area of all the tilted canal segments (No 2 to 8). Furthermore it is delimited by the overthrust geometry. The western limit of the failure is located in the contact area of segments No 1 and 2, where a soil subsidence on the uphill side of the left canal wall is evident (Figure 6), causing tilting of segment No 2, thus enabling the canal water outflow at the right (downhill) canal wall, resulting in soil erosion and formation of the western (smaller) gully. The northern limit of the failure is related to the geometry of the overthrust.

Figure 6 - Soil subsidence on the uphill side of the left canal wall between segments 1 and 2 and along the surveillance road.

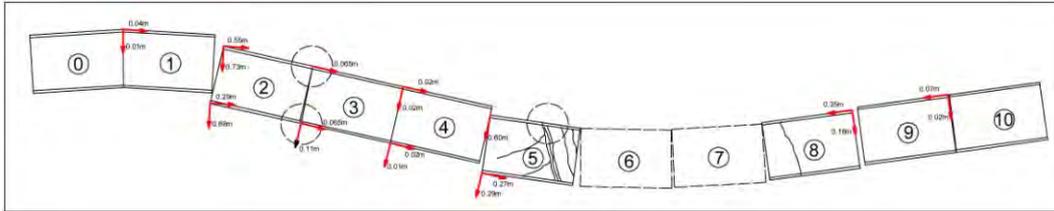
- Based on a detailed recording of the canal segments displacements (Figure 7) and their associated structural damages, it is concluded that the main displacement was perpendicular to the canal (N to S), but also along the canal with direction from segment No 2 towards segment No 5 and 6, along with rotation. The above displacement is considered to occur instantly, resulting in increase of the curvature of the canal with downhill (N to S) direction. The above

kinematics is also confirmed by the fact that all joints between hillside (northern) wall canal segments demonstrate compression failures, while all downhill (southern) wall canal segments are detached (extension).

Figure 7 - Displacement of canal segments.

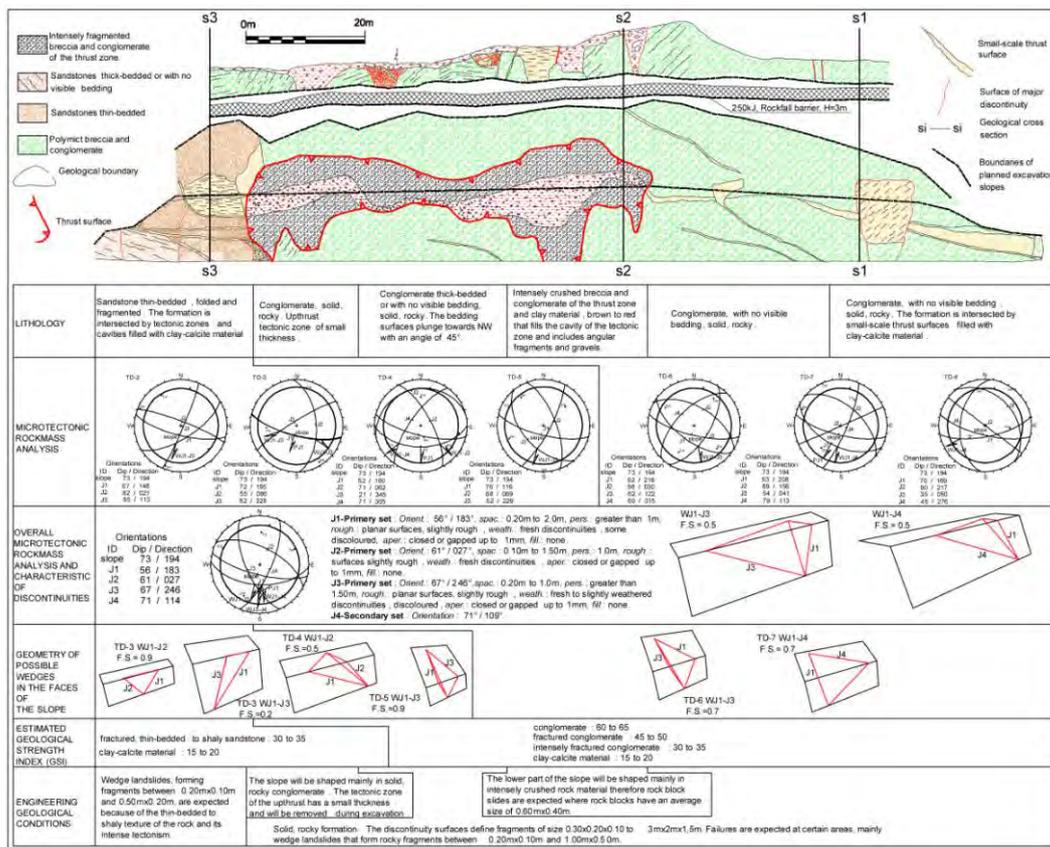
The rock mass is crossed by three major and one minor discontinuity sets dipping towards the SSE, NE, SW, and SE at angles ranging from 60° to 70°. According to ISRM (1981), their spacing is characterized as close to very wide (0.10 m up to 2.0 m), their persistence low (greater than 1m up to 1.50m), their surfaces are smooth to slightly rough, planar (VII–VIII), fresh with evidence of oxidation at positions, very tight to open (aperture up to 1mm), without filling material (Figure 8).

Based on the geological mapping of the slope faces, the quantitative description of discontinuities of the rock mass, their stereographic projection in individual rock mass parts and sliding potential failure modes, the geological structure and the engineering geological conditions along the new cut slopes, designed parallel and 5 to 6 m uphill of the existing cut, were estimated (Figures 8 and 9).

Figure 8 – Engineering geological mapping of existing slope face.

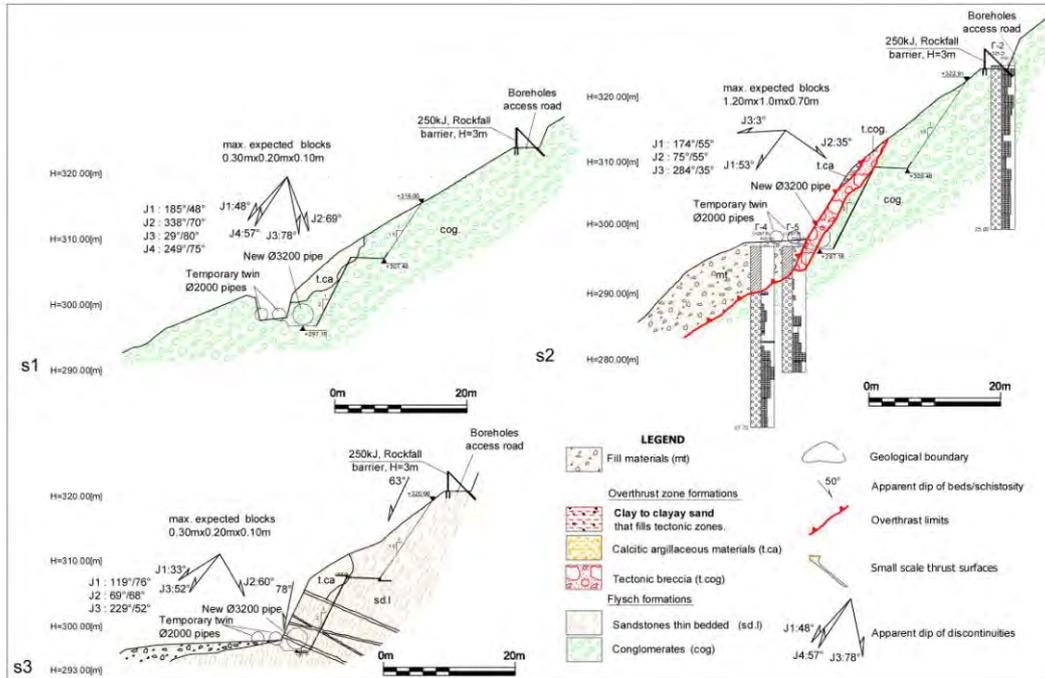
The new slope at its western end was expected to be excavated in sandstones, mainly thinly bedded and fragmented, crossed by three major discontinuity sets. Wedge failures of rock blocks of estimated sizes ranging from 0.20 m x 0.10 m to 0.50 m x 0.20 m were expected, due to the thinly bedded to foliaceous structure and intense fragmentation of the rock mass. Subsequently, the slope was anticipated to be excavated in massive to thickly bedded conglomerates, crossed by

three major and one minor discontinuity sets. Wedge failures of rock blocks of estimated size ranging from 0.20 m x 0.10 m to 1.0 m x 0.50 m, were expected. Rock quality was considered downgraded, mainly in the overthrust area and also in places where the rock mass was crossed by small-scale thrusts and major joints. The development of small-scale cavities filled with clayey and calcareous-clayey material was considered possible (Figures 8 and 9).

Figure 9 – Engineering geological cross-sections along the new slope.

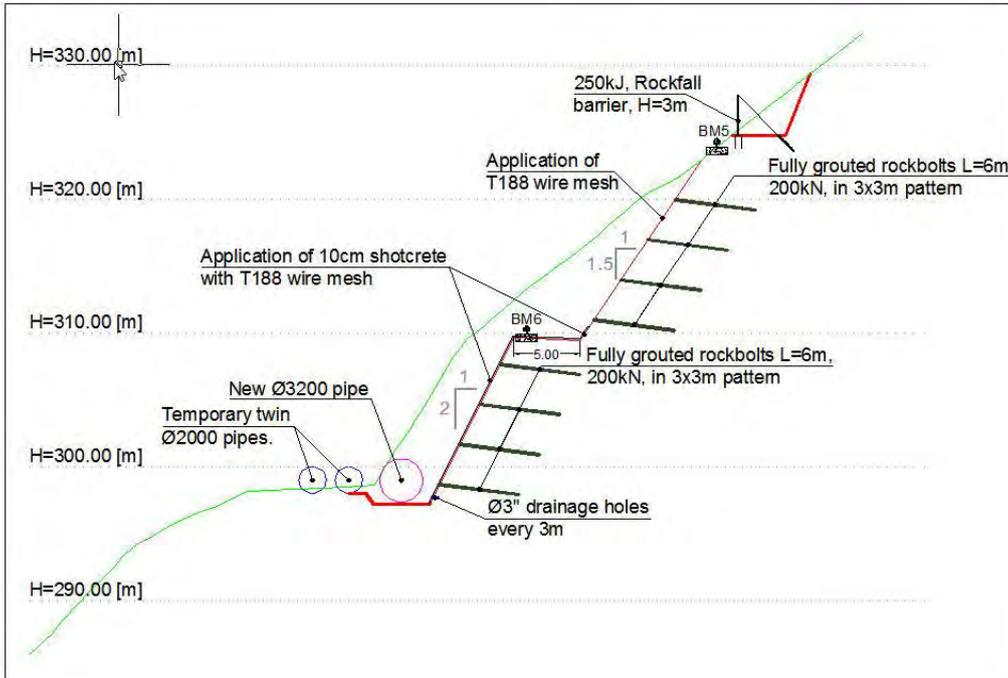
Figure 10 – Excavation geometry - support and protection measures.

The average cut height was 25 m. The cut was excavated mostly within fresh and massive rock, as expected. A 5 m wide berm was constructed at intermediate height of the cut, for stability and protection reasons. The cut inclination was selected 2:1 (h:b) below the berm and 3:2 (h:b) above it. Stability measures included installation of 6 m long rockbolts of 200 kN capacity in 3 m x 3 m pattern, and application of wire mesh on the upper part of the slope and wire mesh combined with 10 cm shotcrete on the lower part of the slope. To ensure protection against rockfalls commencing on the natural slope above the cut, the construction of a 3 m high rockfall barrier, of 250 kJ capacity at the cut crown, in front of a rock trap, was constructed. Finally to avoid water pressures behind the shotcrete, installation of a row of drainage holes of 3” diameter was also implemented (Figure 10).

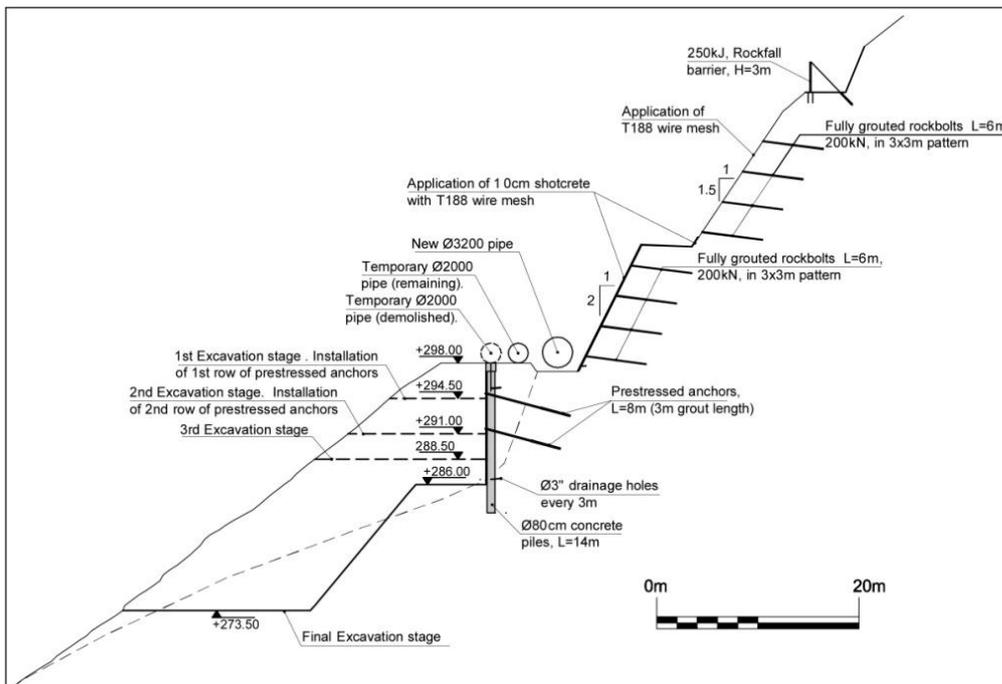
Figure 11 - Support measures and excavation stages for removal of temporary fill.

The safe restoration of the canal water supply, being urgent and critical, has been achieved, though the completion of the remediation should include also rehabilitation of the slide area. The proposed solution for the rehabilitation comprises the removal of the southern temporary pipe of 2 m diameter, in order to provide space at the crest of the temporary fill, for the construction of a pile wall, of 80 cm diameter concrete piles. The pile wall will secure the stability of the remaining northern temporary pipe of 2 m diameter and will be used as temporary support for the suggested excavation in order to remove the loose temporary fill. Excavation of the loose fill will be executed in stages and the pile wall will be supported by two rows of pre-stressed anchors (Figure 11).

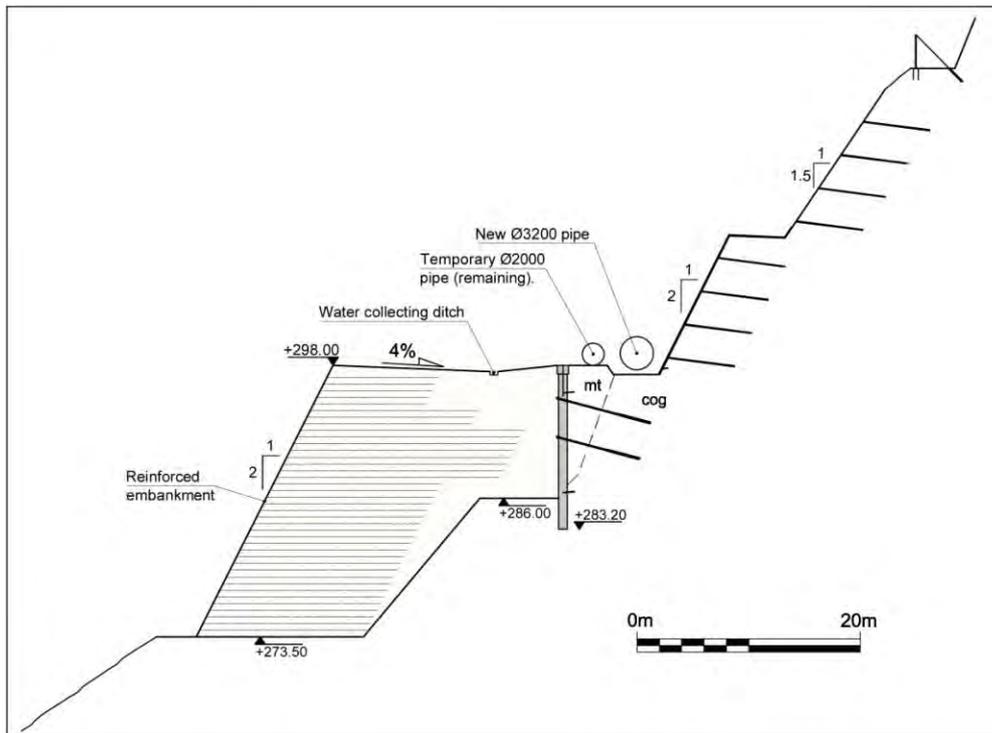
Figure 12 - Rehabilitation by reinforced embankment construction.

Following the above construction methodology, full removal of the uncompacted temporary fill or any other loose superficial material is feasible. Rehabilitation will be achieved by the construction of a reinforced embankment under fully controlled conditions, founded on sound rock (Figure 12).
