## INVESTIGATION AND MITIGATION OF A FAILURE AT THE TAXIARCHES CANAL OF MORNOS AQUEDUCT

*The sudden soil fracture and failure at the Taxiarches canal of Mornos Aqueduct of the Athens Water Supply and Sewerage Company (EYDAP SA), took place approximately 540m after the exit of Elikonas tunnel and resulted in failure and displacement of the canal segments along an 80m long section. Due to the failure the water supply was interrupted and two extensive gullies, spaced 75m apart, were created by the water outflow. The water discharge resulted in subsoil erosion and transportation of vast masses of geomaterial and two of the canal segments downhill. The debris flow destroyed part of Prodromos-Saranti Road, swapping along olive cultivations and causing extensive damage to Saranti settlement. The failure of the canal occurred in an area of steep morphology, at the front of an overthrust, within tectonic breccia and calcareous-clayey material of chaotic structure and reduced mechanical properties, vulnerable to erosion. The boundaries of the main fracture were defined by the thrust geometry.*

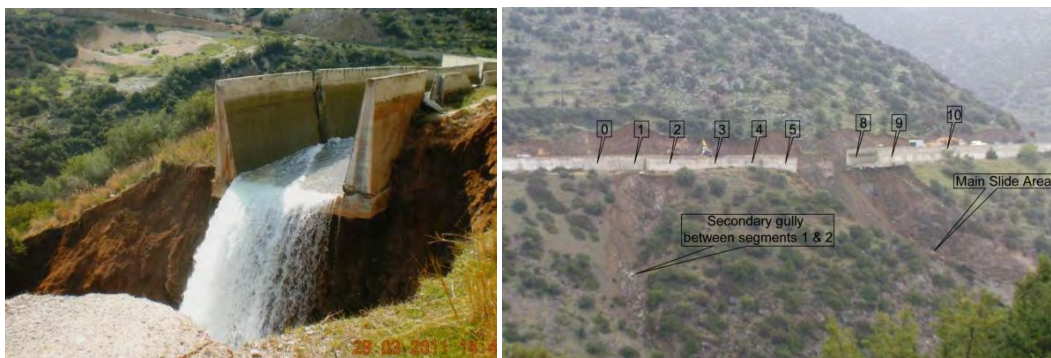
downhill and four segments upstream (2, 3, 4 and 5) and another one downstream (8) tilted and were damaged (Figures 1 and 2). During the final phase of the failure, water discharge dropped from 100 m<sup>3</sup>/sec to 10 m<sup>3</sup>/sec, within a two to three minutes time period, resulting in an estimated outflow volume in the order of 300 to 400 thousand cubic meters. This sudden outflow resulted in erosion of 45.000 m<sup>3</sup> soil material, consisting of fine and coarse grained material of the overthrust zone.

At the area of the slid segments, the subsoil, the surveillance road and part of the cut slope have also slid downhill forming a gully (eastern) with steep high sides, with a length of 150 m, a maximum width of 45 m and depth ranging between 10 m to 18 m. Upstream the main failure area, four canal segments have undergone significant displacements, mainly horizontal towards lower elevations. At the area of the most distant segment a secondary gully (western gully) with steep sides was formed, with a length of 250 m, a maximum width of 18 m and depth ranging from 2 m to 3 m (Figures 1 and 2).

**Figure 2 - Canal segment failure (left), Main slide shortly after occurrence (right).**

Immediate remedial measures were taken, including temporary filling of part of the failed and eroded soil mass and construction of temporary twin bypass pipes, of 2 m diameter each. Backfilling for the pipes foundation was implemented by means of a steep temporary embankment, using material from a nearby quarry, without proper compaction.

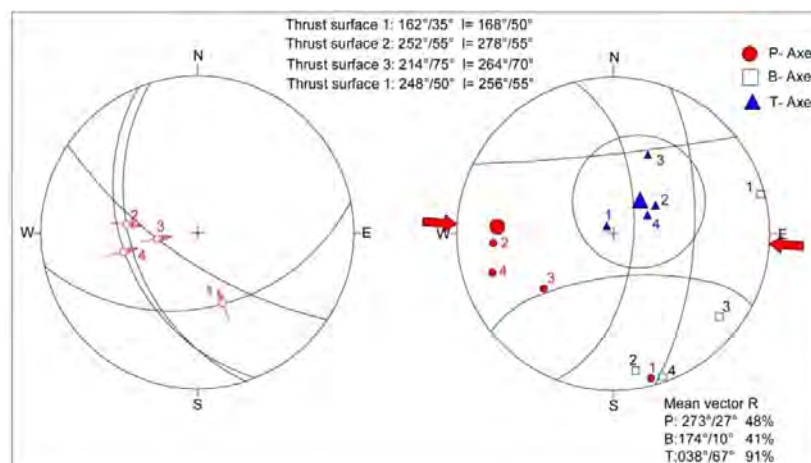
The kinematic analysis of the overthrust, based on the orientation data (dip direction/dip) of the overthrust plane and the orientation of striations, revealed that this large-scale compressive event took place under a compressive stress regime of WNW-ESE direction (Figure 5).

Figure 5 - Kinematic analysis of overthrust.

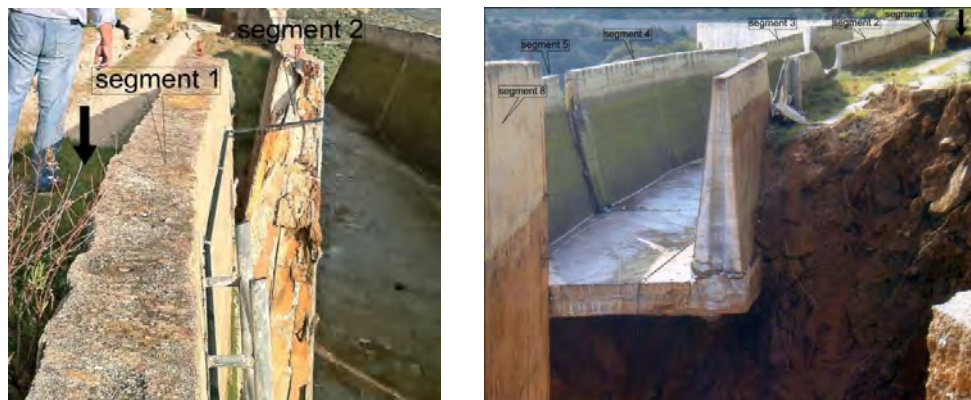
- The soil fracture and the following canal failure is not considered limited in the area of the two slid canal segments (No 6 and 7), but extended throughout the area of all the tilted canal segments (No 2 to 8). Furthermore it is delimited by the overthrust geometry. The western limit of the failure is located in the contact area of segments No 1 and 2, where a soil subsidence on the uphill side of the left canal wall is evident (Figure 6), causing tilting of segment No 2, thus enabling the canal water outflow at the right (downhill) canal wall, resulting in soil erosion and formation of the western (smaller) gully. The northern limit of the failure is related to the geometry of the overthrust.

**Figure 6 - Soil subsidence on the uphill side of the left canal wall between segments 1 and 2 and along the surveillance road.**

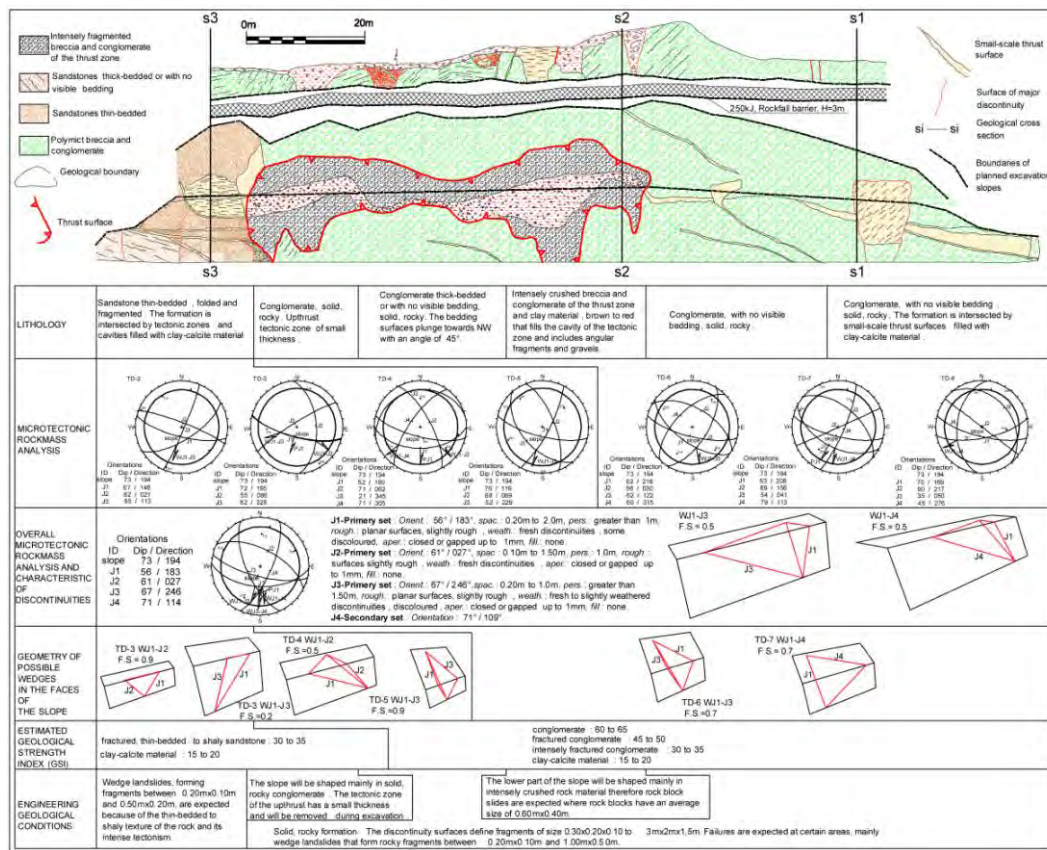
The rock mass is crossed by three major and one minor discontinuity sets dipping towards the SSE, NE, SW, and SE at angles ranging from 60° to 70°. According to ISRM (1981), their spacing is characterized as close to very wide (0.10 m up to 2.0 m), their persistence low (greater than 1m up to 1.50m), their surfaces are smooth to slightly rough, planar (VII–VIII), fresh with evidence of oxidation at positions, very tight to open (aperture up to 1mm), without filling material (Figure 8).

Based on the geological mapping of the slope faces, the quantitative description of discontinuities of the rock mass, their stereographic projection in individual rock mass parts and sliding potential failure modes, the geological structure and the engineering geological conditions along the new cut slopes, designed parallel and 5 to 6 m uphill of the existing cut, were estimated (Figures 8 and 9).

**Figure 8 – Engineering geological mapping of existing slope face.**

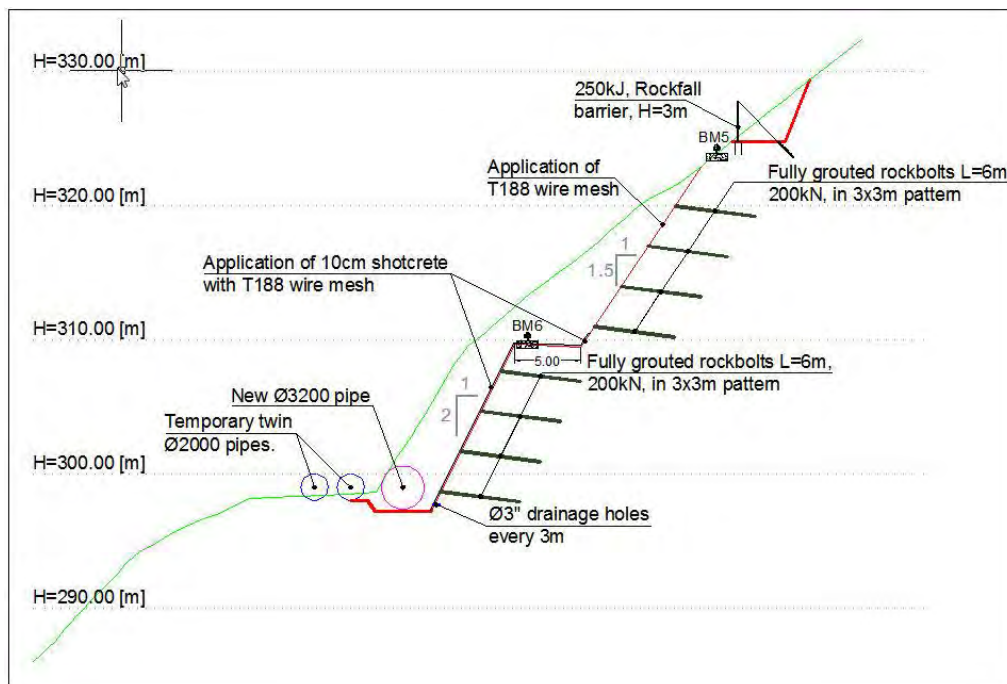
**Figure 10 – Excavation geometry - support and protection measures.**

The average cut height was 25 m. The cut was excavated mostly within fresh and massive rock, as expected. A 5 m wide berm was constructed at intermediate height of the cut, for stability and protection reasons. The cut inclination was selected 2:1 (h:b) below the berm and 3:2 (h:b) above it. Stability measures included installation of 6 m long rockbolts of 200 kN capacity in 3 m x 3 m pattern, and application of wire mesh on the upper part of the slope and wire mesh combined with 10 cm shotcrete on the lower part of the slope. To ensure protection against rockfalls commencing on the natural slope above the cut, the construction of a 3m high rockfall barrier, of 250 kJ capacity at the cut crown, in front of a rock trap, was constructed. Finally to avoid water pressures behind the shotcrete, installation of a row of drainage holes of 3" diameter was also implemented (Figure 10).

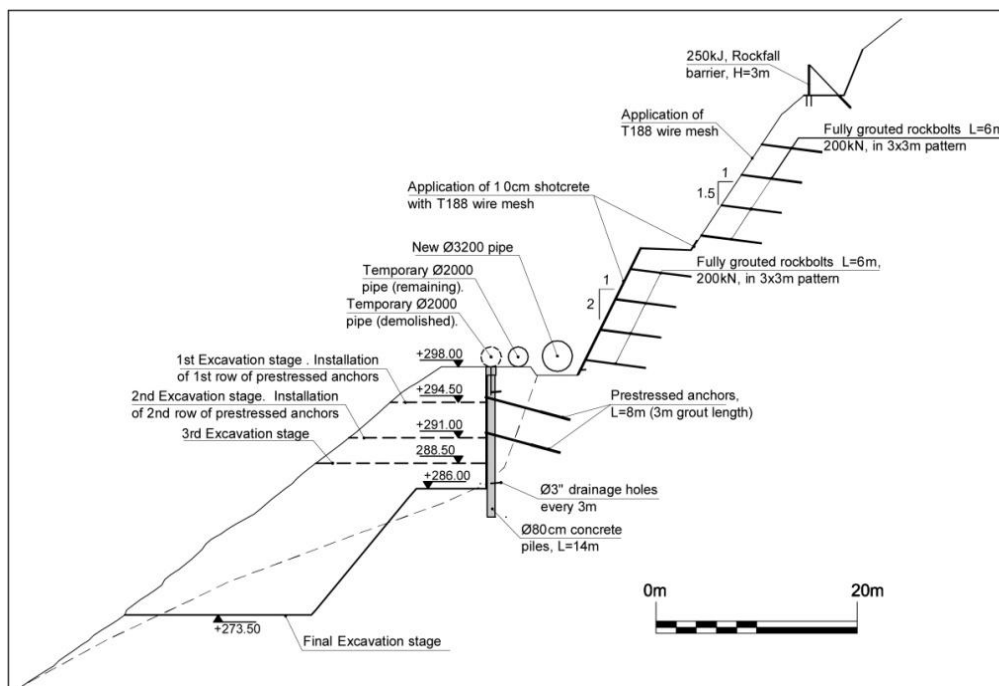
**Figure 11 - Support measures and excavation stages for removal of temporary fill.**

The safe restoration of the canal water supply, being urgent and critical, has been achieved, though the completion of the remediation should include also rehabilitation of the slide area. The proposed solution for the rehabilitation comprises the removal of the southern temporary pipe of 2 m diameter, in order to provide space at the crest of the temporary fill, for the construction of a pile wall, of 80 cm diameter concrete piles. The pile wall will secure the stability of the remaining northern temporary pipe of 2 m diameter and will be used as temporary support for the suggested excavation in order to remove the loose temporary fill. Excavation of the loose fill will be executed in stages and the pile wall will be supported by two rows of pre-stressed anchors (Figure 11).

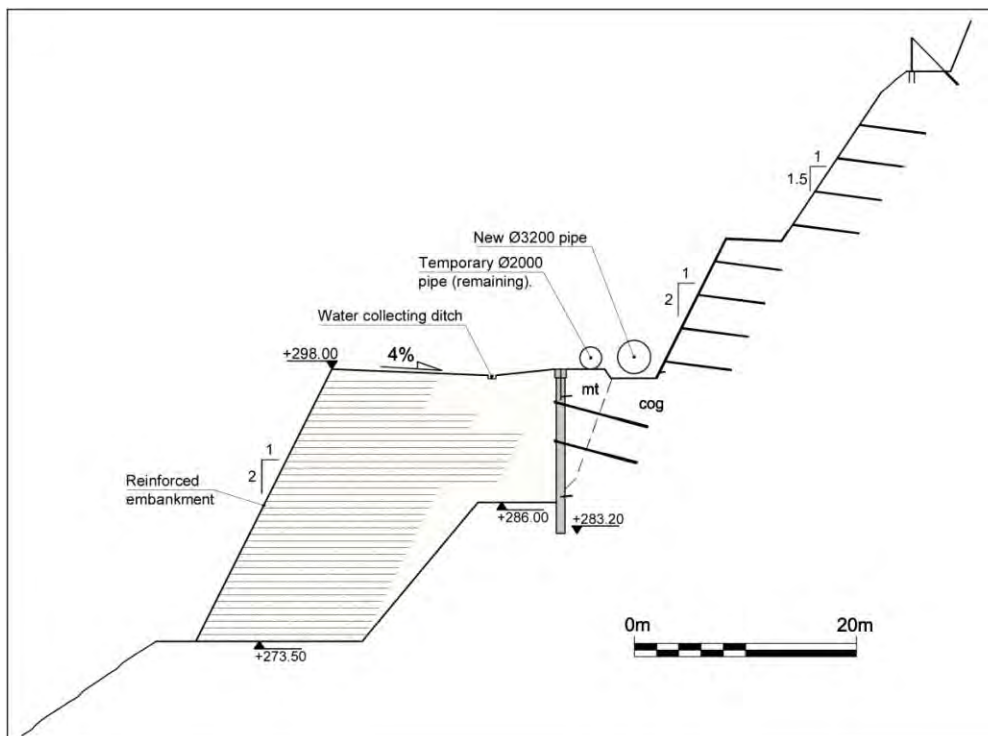
**Figure 12 - Rehabilitation by reinforced embankment construction.**

Following the above construction methodology, full removal of the uncompacted temporary fill or any other loose superficial material is feasible. Rehabilitation will be achieved by the construction of a reinforced embankment under fully controlled conditions, founded on sound rock (Figure 12).
