ENGINEERING GEOLOGICAL CONDITIONS OF KLOKOVA MOUNTAIN, GREECE

Saroglou H.¹ and Kazilis N.²

Abstract

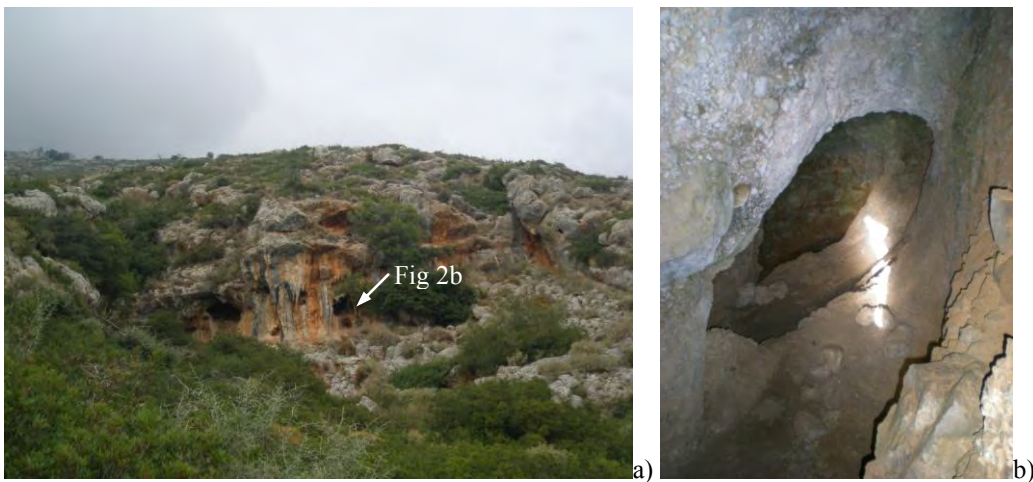
Figure 2 - Karstic voids related to faults in cemented scree a) general view, b) detail of void.

- Gullies developed along faults with dimensions up to 5 m (Figure 2 a and b). The location of such a karstic void is shown in Figure 1, coinciding with a fault line.

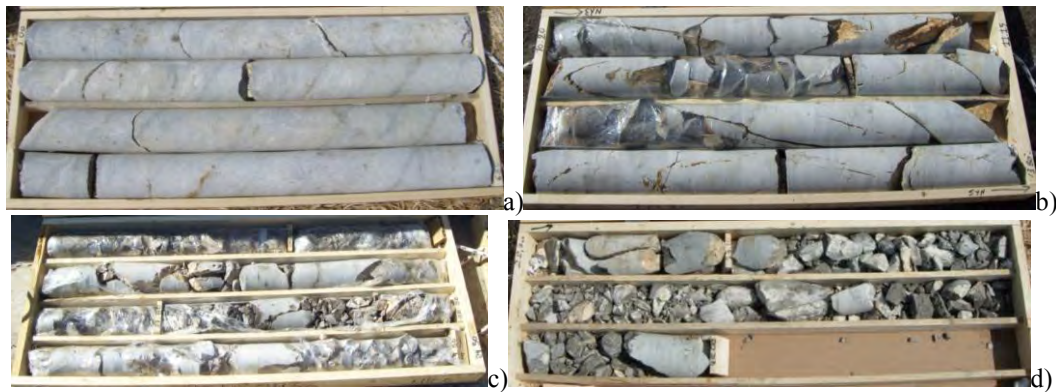
Figure 6 – a) to d) Rockmass types e) range of GSI for each rockmass category of limestones

- Blocky rockmass type, which locally presents parts of practically intact rock (in which the distance of discontinuities is greater than 2 m), with good to fair joint surface conditions (Figure 6a and b). This rockmass type is rated in the range $RMR=70-85$ and $GSI=65-80$.
- Very blocky rockmass type, which generally entails parts of better quality rockmass (blocky) with fair to good joint surface conditions (Figure 6c). This rockmass type is rated in the range $RMR=50-65$ and $GSI=40-60$. It can be seen, that the very blocky rockmass type includes sections with lower degree of fracturing resulting in a blocky rockmass.
- Disintegrated rockmass type due to the tectonic disturbance in fault zones. The width of these zones is generally small, up to 2-5 m (Figure 6d). This rockmass type is rated in the range $RMR=35-45$ and $GSI=25-35$.

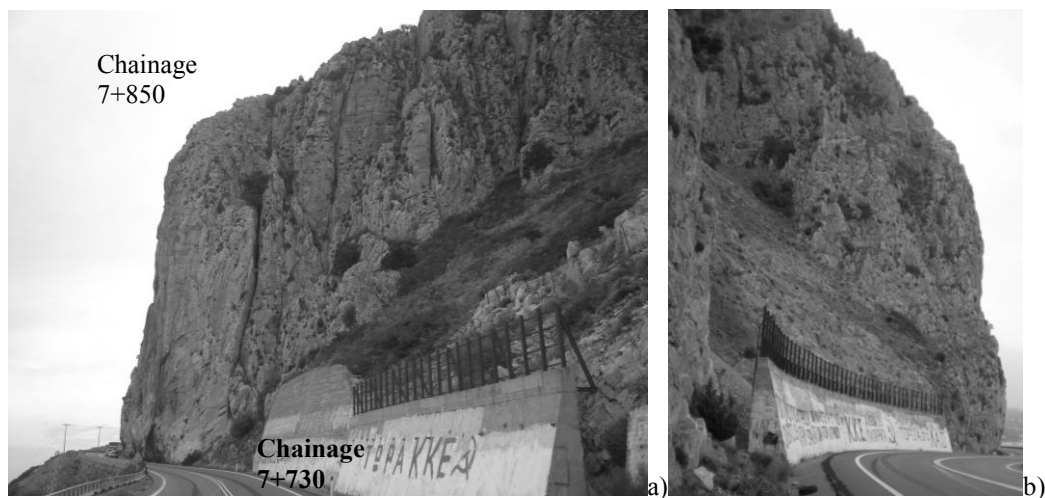
Figure 7 - Very steep slope morphology (overhanging slopes) posing a very high rock fall risk.

- Sections where fault surfaces form very steep (almost vertical) or overhanging rock slopes adjacent to the roadway as shown in Figure 7a. Single rock blocks can be found at the crest or on distinct locations on these slopes.
- Sections where the rock cliffs at higher elevations create potential conditions for detachments of large rock quantities, which although part of the rockfall trajectory may be on slope talus the falling blocks may eventually reach the roadway with substantial impact energies.
- Sections where the rockmass is highly fractured and the slopes are adjacent to the roadway, usually found at moderate slope heights. The risk becomes higher if the slope height is higher (Figure 7b). Such cases are encountered in tectonised zones in which the degree of fracturing of the limestone is high.

The detachment of rocks may occur due to seismic loading or by the action of water percolating through the limestone rockmass. The phenomenon may be triggered also due to the loss of support

of blocks where open discontinuities and karstic voids exist. Low or medium risk areas are those in sections with relatively small heights of slopes. Considering the proximity of the high rock slopes (height up to 100 m) to the roadway and the magnitude of impact of a potential rockfall episode, it could be considered that the existing retaining structures offer little protection. The existing mitigation measures include two retaining walls with low energy barriers on their crest, located in the middle section of Klokova area (Figure 7a and b) as well as wire rope nets installed on rock slopes with relatively small height and in restricted length.

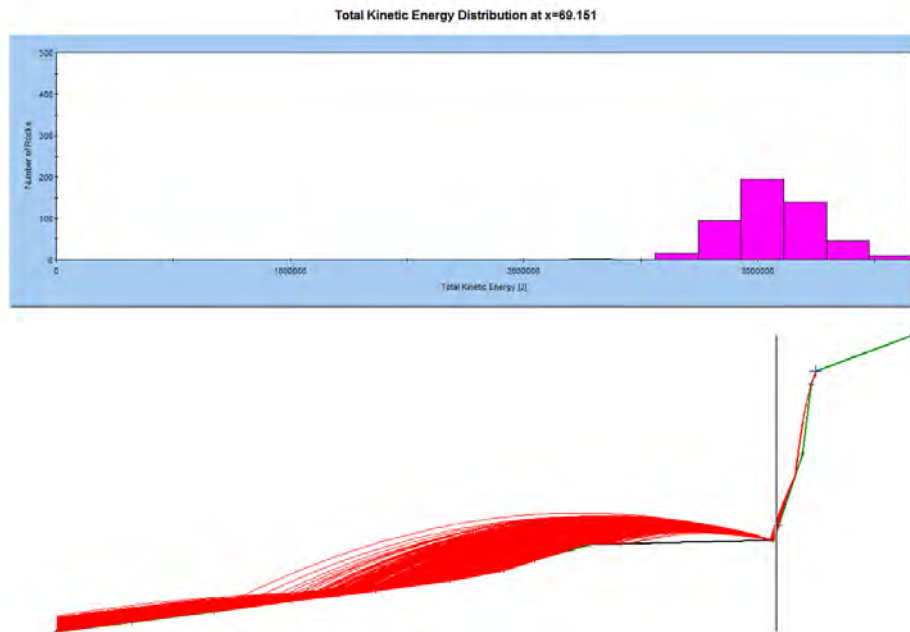
Figure 8 - Rockfall analysis at chainage 7+850.

The maximum kinetic energy on the roadway in Chainage 7+730 was 1100 kJ while in Chainage 7+850 it reached 3500 kJ. The presence of scree on the slope and its lower inclination in section 7+730 resulted in lower total kinetic energy and bounce height.

An example of the analysis in Chainage 7+850 is shown in Figure 8, depicting the trajectories of rocks and the total kinetic energy distribution at the road level. Based on the results of the analyses, it can be concluded that the nature of the geological formation on the slope as well as the slope geometry, is decisive on the magnitude of the total kinetic energy at impact on the road. It can also

be concluded that rockfall barriers should be installed on the slope face in order to restrain the falling rock before the falling rock reaches the road. The installation of barriers in locations with adequate catchment area can be effective, while in locations with no or very limited catchment area, the construction of rockfall galleries may be necessary.
