GEOLOGICAL AND GEOTECHNICAL BEHAVIOUR OF EVINOS DAM FOLLOWING THE IMPOUNDMENT

Angelopoulos A.¹, Soulis V.J.², Malandraki V.³

Abstract

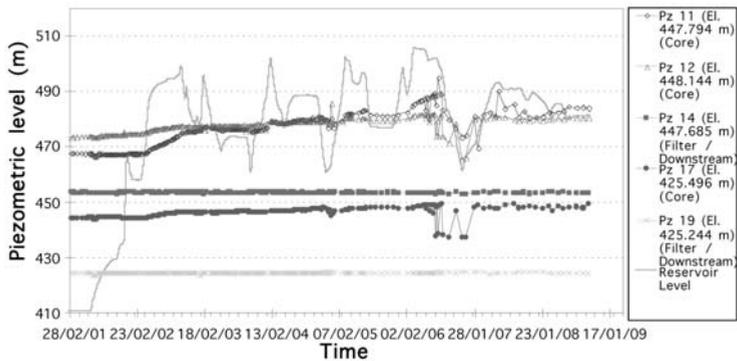
A large number of vibrating wire piezometers were installed in the shoulders and the core of the dam. The pore water pressure development differs through the dam due to the partial saturation and the low permeability values of the core. Piezometers Pz11-19 are placed in Section VI of the Evinos dam. In fig. 2 piezometers Pz11, Pz12 and Pz17 initially show no response in the changes of the reservoir level. In March 2006 the reservoir has overflowed. This period lasted for 3 months initiating the response of piezometers to the changes of the reservoir level. Piezometer Pz11 is more sensible to changes of reservoir level. This behaviour indicates that a flow net has been gradually started to establish in the core even for higher values of the reservoir level. Piezometers Pz14 and Pz 19 which are installed in the filter zone (free drainage material), showed a constant piezometric level through time. In fig. 3 the changes in the piezometric level of piezometers Pz31-33-34 are

Fig. 2: Evolution of piezometric level in piezometers located in Section VI of the dam.

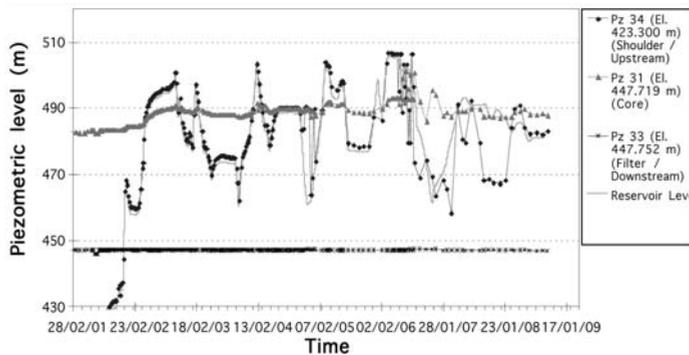
Fig. 3: Evolution of piezometric level in piezometers located in Section IX of the dam.

shown. These piezometers are placed upstream, downstream and at the core of the dam's body in section IX. Piezometer Pz34 which is installed upstream generally follows the fluctuation of the reservoir level. However, there was a period of drop of the reservoir level in the end of 2007 that Piezometer Pz34 didn't follow. Piezometer Pz 33 is placed in the filter zone downstream the dam's body. It shows no changes in its piezometric level as it is a free drained material. The study of the pore pressure development generally confirms the successful response of dam's core.

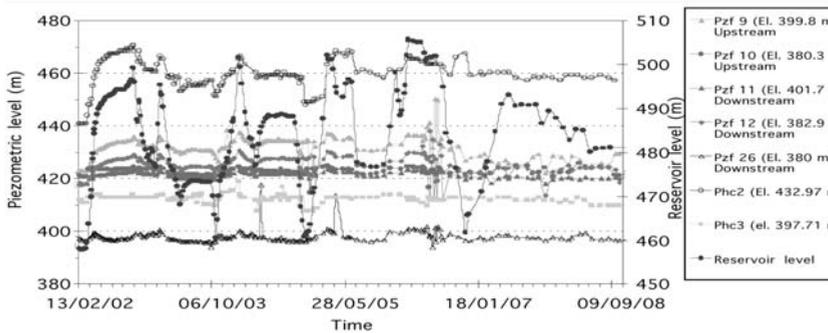
Piezometers are also placed in the foundation of the dam to inspect both the piezometric level in the foundation and the effectiveness of the grout curtain. In fig. 4 changes of the piezometric level measured in piezometers placed along Section VI can be depicted. Piezometers Pzf 11, Pzf 12, Pzf 26 show constant piezometric level through time. Piezometers installed upstream Pzf9, Pzf 10 show roughly constant piezometric level (about +420), which is influenced by the level of rainfall. Hydraulic piezometers are also installed through the grout curtain tunnel. Phc 2 follows the changes observed in the reservoir level. Phc 3 is less sensible to changes of the reservoir level. The response of piezometers placed in the foundation of Evinos Dam show little infiltration from the reservoir.

Fig. 4: Evolution of piezometric level in piezometers located in the foundation of the dam.

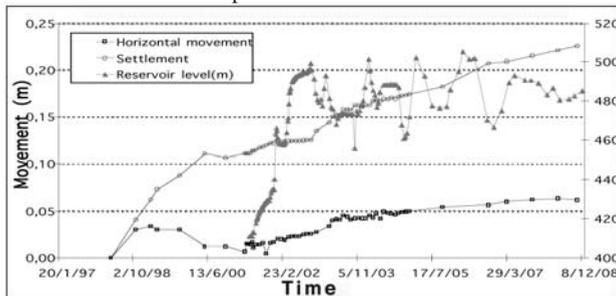
Fig. 5: Cumulative mean displacements and settlement in the dam's Crest.

Additionally the evaluation of the stability of Evinos Dam is carried out through the systematic measurement of horizontal and vertical movement of the dam's crest. In the dam's crest a number of surface monumental stations have been positioned upstream and downstream the dam's longitudinal axis (S24 -S33 upstream, S64-S73 upstream, Dounias, 2006). In fig. 5, the evolution of horizontal and vertical movements in respect with time are depicted for the same group of stations. The horizontal movement of the dam's crest is gradually increasing through time, although its magnitude is negligible. The settlement of the dam is increased following the impoundment of the reservoir. A slight increase of settlement rate is recorded even in the 4th period of operation in the dam's crest (February 2005-November 2008, Angelopoulos et.al., 2007,2008). During this period of operation the maximum settlement recorded is of the order of 5.2cm. The total settlement of the dam's crest is of the order of 22.6 cm and is regarded as safe. In fig. 6 the cumulative horizontal displacements D_x and settlement D_v for the group of stations S68-S72 in the dam's crest is presented. In the same figure the cumulative displacements D_x and settlement D_v for the group of stations B03-B07 in the area of the landslide of the left abutment '93 is also presented. The small vector denotes the displacements values and settlement in the date of impoundment (11/2001), the large vector denotes the displacement and settlement in the end of 2008 (12/2008).

Fig. 6: Cumulative displacements D_x and settlement D_v for the group of stations S68-S72 in the dam's Crest, for the group of stations B03-B07 in the area of 1993 Landslide.

- Piezometers placed downstream the grout curtain show considerably low piezometric level which demonstrates the efficiency of the grout curtain.
- Surface monumental stations placed on the dam crest (S68-72 downstream), indicate “extension” of the dam’s crest towards downstream, as well as a normal evolution of settlement.

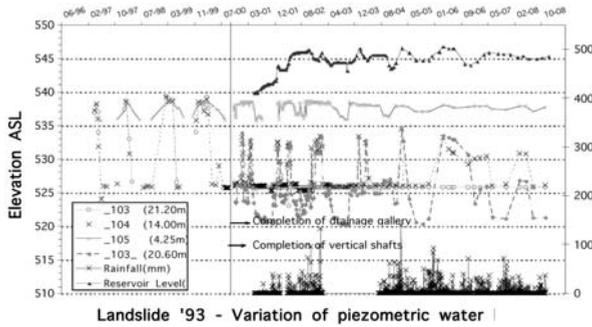
The piezometric levels are continuously monitored after the completion of stabilization works. Piezometers are placed in different depths within the landslide's body. The deepest one is placed inside the substratum. In figs. 8, 9 the fluctuation of peizometric level in respect with time can be depicted. In the same figures the fluctuation of rainfall and the fluctuation of the reservoir's water level are recorded during the monitoring period. The stabilization works succeeded in reducing the piezometric level of deep piezometers that exhibit an immediate response in respect to the rainfall but they also exhibit an immediate pore pressure decrease. The piezometers located in depth up to 15.00m (i.e Π105 depth 4.25m, Π108 depth 12.30m, Π111 depth 12.20m, Π115 depth 11.40m) ex-

Fig. 8: Piezometric measurements of group Π103-Π105

cept the piezometer Π104 (depth 14.00m) show reduced fluctuation of piezometric level after the completion of drainage tunnels. Piezometers placed in deeper levels (i.e Π106 depth 30.00m, Π109 depth 32.80m) do not exhibit any fluctuation of their piezometric level and they are considered as dry. In spring 2006 the dam has overflowed for a total period of three months. Piezometers Π103A and Π104 maintained their high piezometric level besides the substantial drop in the reservoir's level.

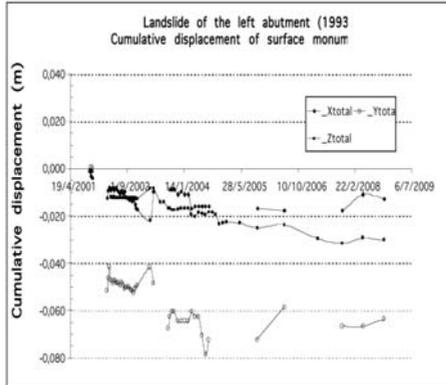
Fig. 10: Measurement of displacements in station K1 nearby piezometers Π112-115.

The stabilization works succeeded in reducing the overall movements to values between the limits of the instrumental measuring fault. Station K1 is located near by the group of piezometers Π112-115, while station K2 is located nearby the group of piezometers Π109-111.

- The horizontal displacements and settlement measured in surface monumental stations (K1, K2, K3) suggest that the landslide of the left abutment '93 is not active.

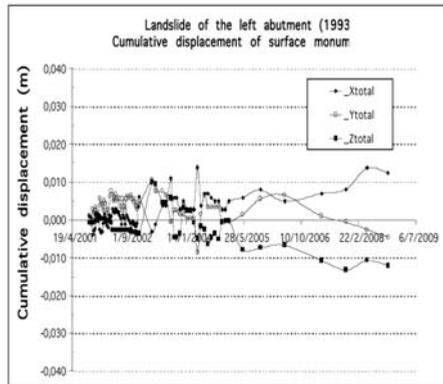
Fig. 11: Measurement of displacements in station K2 nearby piezometers Π109-111.

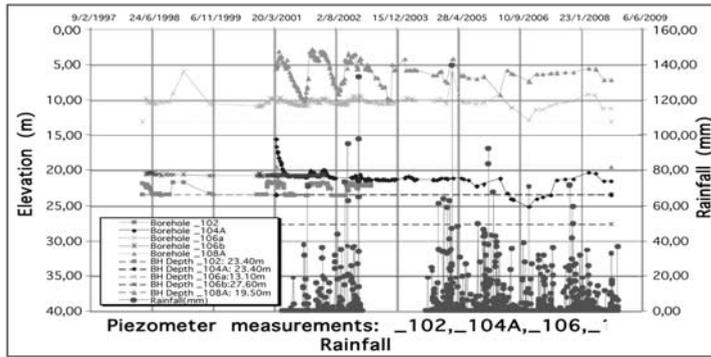
Fig. 13: Piezometric Measurements of Group Γ102, Γ104A, Γ108A and Γ106a & b.

Piezometers are installed in the area of Agios Demetrios-Arahova Country Road Landslide to record the fluctuation of piezometric level upstream and downstream the drainage tunnel. In fig. 13, the history of fluctuation of the piezometric levels of piezometers Γ102, Γ104A, Γ108A and Γ106a & b is presented. In the same fig. 13 the rainfall level curve is also depicted. The piezometers that are located in depth levels greater than 15m are affected by the drainage tunnel and show decreased piezometric levels in respect with piezometers placed in depth levels smaller than 15m. The measurements of piezometers placed deeply in the area of landslide are affected by the reservoir’s water level rise.

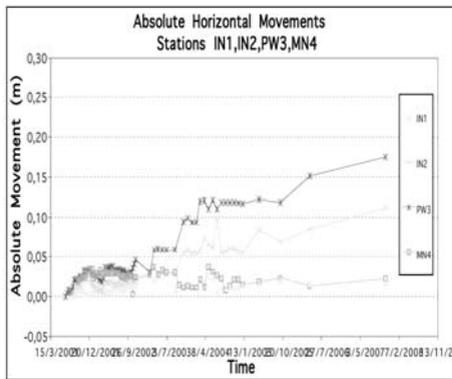
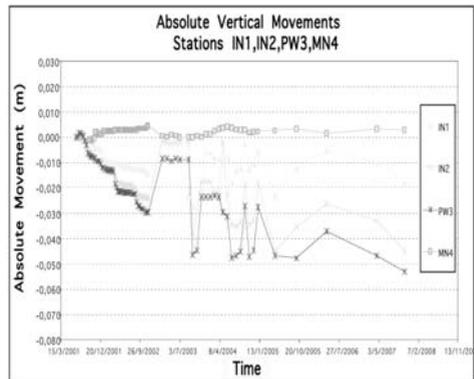
Fig. 14: Measurement of horizontal displacements in the area of Road Landslide.

Fig. 15: Measurement of settlement in the area of Road Landslide.

In figs 14, 15 the horizontal displacement measurements together with the settlement measurements are shown for the area of the landslide. The horizontal displacements measured downstream the drainage tunnels appear to be reduced in MN4, IN1 stations compared to the horizontal displacements measured in stations located upstream the drainage tunnels (PW3, IN2 upper part of landslide). The settlement (1,9 cm) of the lower parts of landslide MN4, IN1 are smaller compared to the settlement recorded (5.3cm) in stations PW3, IN2.

- The horizontal displacements and settlement measured downstream the drainage tunnels in the area of Agios Demetrios-Arahoa Country Road Landslide appear to be reduced in comparison to the horizontal displacements and settlement measured in stations located upstream the drainage tunnels.

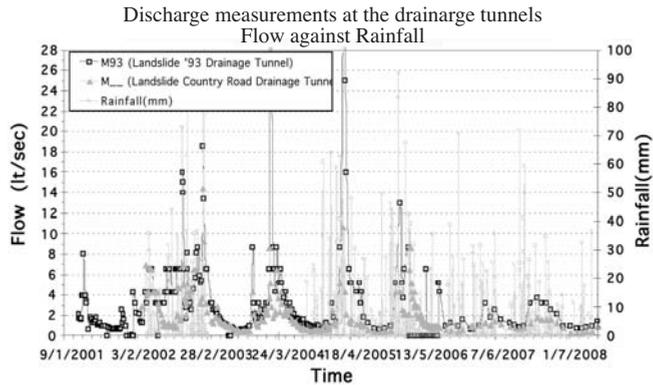
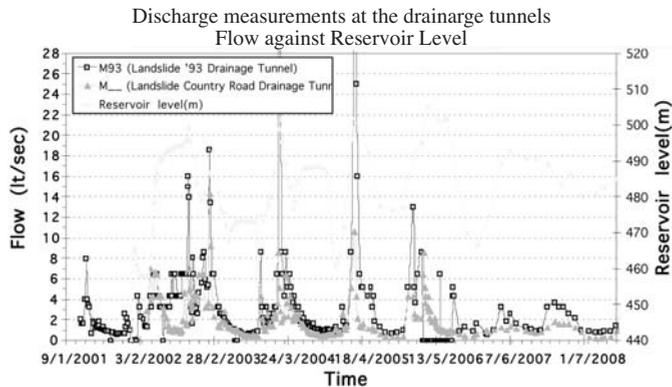
Fig. 16: Discharge measurements at the drainage tunnels in the areas of 1993 Landslide, and Country Road Landslide in relation to the rainfall.

Fig. 17: Discharge measurements at the drainage tunnels in the areas of 1993 Landslide, and Country Road Landslide in relation to the reservoir level.

In figs. 16, 17 the discharge measurements at the drainage tunnels of: a) Landslide of the left abutment '93 and b) Agios Demetrios-Arahova Country Road Landslide are depicted respectively. It is observed that the discharge at the outlets of these two drainage tunnels depends on the level of rainfall and exhibits immediate response. The discharge of the drainage tunnel within the landslide of the left abutment '93 depends on the reservoir level. It is shown that the discharge of the drainage tunnel within the landslide of the left abutment '93 is increased remarkably when the reservoir water level is above +485m.
