Bulletin of the Geological Society of Greece

Vol. 43, 2010

GEOLOGICAL AND GEOTECHNICAL BEHAVIOUR OF EVINOS DAM FOLLOWING THE IMPOUNDMENT

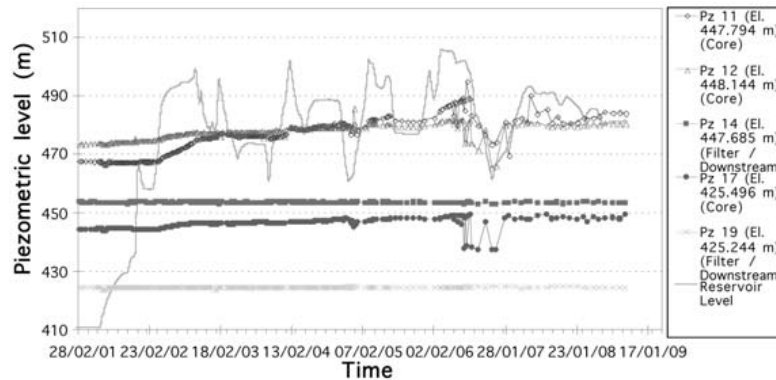
A large number of vibrating wire piezometers were installed in the shoulders and the core of the dam. The pore water pressure development differs through the dam due to the partial saturation and the low permeability values of the core. Piezometers Pz11-19 are placed in Section VI of the Evinos dam. In fig. 2 piezometers Pz11, Pz12 and Pz17 initially show no response in the changes of the reservoir level. In March 2006 the reservoir has overflowed. This period lasted for 3 months initiating the response of piezometers to the changes of the reservoir level. Piezometer Pz11 is more sensible to changes of reservoir level. This behaviour indicates that a flow net has been gradually started to establish in the core even for higher values of the reservoir level. Piezometers Pz14 and Pz 19 which are installed in the filter zone (free drainage material), showed a constant piezometric level through time. In fig. 3 the changes in the piezometric level of piezometers Pz31-33-34 are

Fig. 2: Evolution of piezometric level in piezometers located in Section VI of the dam.

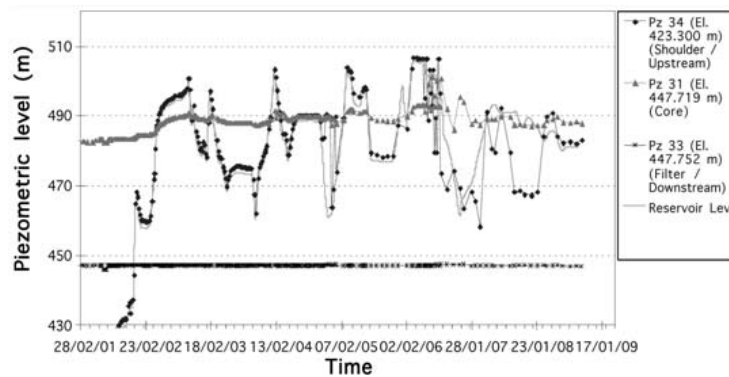
Fig. 3: Evolution of piezometric level in piezometers located in Section IX of the dam.

shown. These piezometers are placed upstream, downstream and at the core of the dam's body in section IX. Piezometer Pz34 which is installed upstream generally follows the fluctuation of the reservoir level. However, there was a period of drop of the reservoir level in the end of 2007 that Piezometer Pz34 didn't follow. Piezometer Pz 33 is placed in the filter zone downstream the dam's body. It shows no changes in its piezometric level as it is a free drained material. The study of the pore pressure development generally confirms the successful response of dam's core.

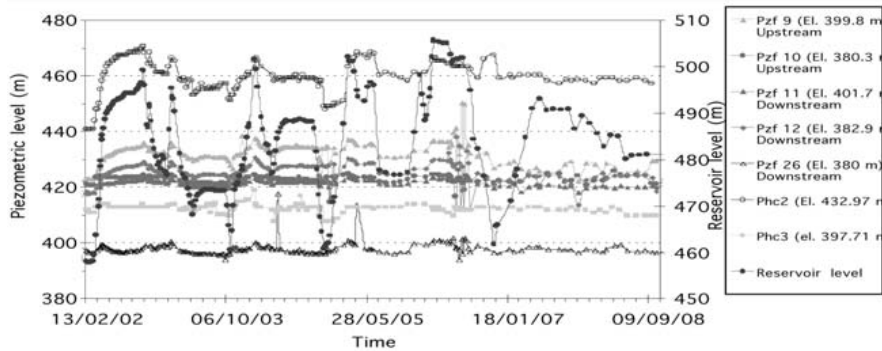
Piezometers are also placed in the foundation of the dam to inspect both the piezometric level in the foundation and the effectiveness of the grout curtain. In fig. 4 changes of the piezometric level measured in piezometers placed along Section VI can be depicted. Piezometers Pzf 11, Pzf 12, Pzf 26 show constant piezometric level through time. Piezometers installed upstream Pzf9, Pzf 10 show roughly constant piezometric level (about +420), which is influenced by the level of rainfall. Hydraulic piezometers are also installed through the grout curtain tunnel. Phc 2 follows the changes observed in the reservoir level. Phc 3 is less sensible to changes of the reservoir level. The response of piezometers placed in the foundation of Evinos Dam show little infiltration from the reservoir.

Fig. 4: Evolution of piezometric level in piezometers located in the foundation of the dam.

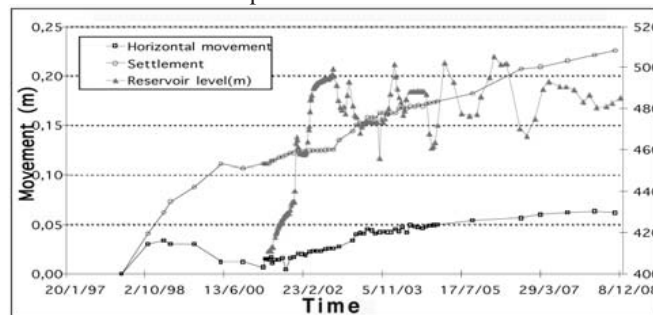
Fig. 5: Cumulative mean displacements and settlement in the dam's Crest.

Additionally the evaluation of the stability of Evinos Dam is carried out through the systematic measurement of horizontal and vertical movement of the dam's crest. In the dam's crest a number of surface monumental stations have been positioned upstream and downstream the dam's longitudinal axis (S24 -S33 upstream, S64-S73 upstream, Dounias, 2006). In fig. 5, the evolution of horizontal and vertical movements in respect with time are depicted for the same group of stations. The horizontal movement of the dam's crest is gradually increasing through time, although its magnitude is negligible. The settlement of the dam is increased following the impoundment of the reservoir. A slight increase of settlement rate is recorded even in the 4th period of operation in the dam's crest (February 2005-November 2008, Angelopoulos et.al., 2007,2008). During this period of operation the maximum settlement recorded is of the order of 5.2cm. The total settlement of the dam's crest is of the order of 22.6 cm and is regarded as safe. In fig. 6 the cumulative horizontal displacements D_x and settlement D_v for the group of stations S68-S72 in the dam's crest is presented. In the same figure the cumulative displacements D_x and settlement D_v for the group of stations B03-B07 in the area of the landslide of the left abutment '93 is also presented. The small vector denotes the displacements values and settlement in the date of impoundment (11/2001), the large vector denotes the displacement and settlement in the end of 2008 (12/2008).

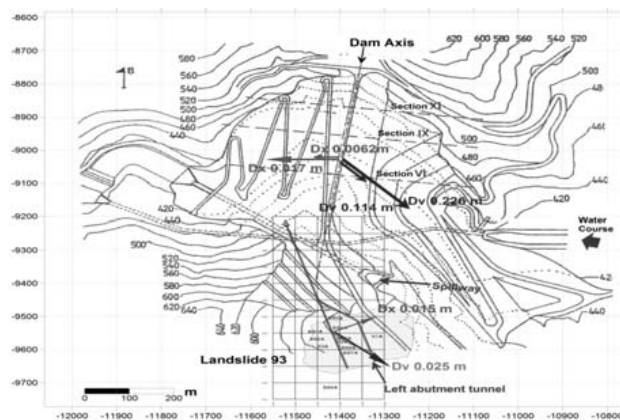
Fig. 6: Cumulative displacements Dx and settlement Dv for the group of stations S68-S72 in the dam's Crest, for the group of stations BΘ3-BΘ7 in the area of 1993 Landslide.

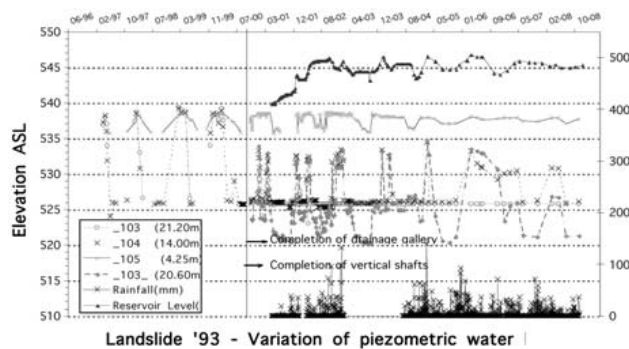
The piezometric levels are continuously monitored after the completion of stabilization works. Piezometers are placed in different depths within the landslide's body. The deepest one is placed inside the substratum. In figs. 8, 9 the fluctuation of peizometric level in respect with time can be depicted. In the same figures the fluctuation of rainfall and the fluctuation of the reservoir's water level are recorded during the monitoring period. The stabilization works succeeded in reducing the piezometric level of deep piezometers that exhibit an immediate response in respect to the rainfall but they also exhibit an immediate pore pressure decrease. The piezometers located in depth up to 15.00m (i.e Π105 depth 4.25m, Π108 depth 12.30m, Π111 depth 12.20m, Π115 depth 11.40m) ex-

Fig. 8: Piezometric measurements of group Π103-Π105

cept the piezometer Π104 (depth 14.00m) show reduced fluctuation of piezometric level after the completion of drainage tunnels. Piezometers placed in deeper levels (i.e Π106 depth 30.00m, Π109 depth 32.80m) do not exhibit any fluctuation of their piezometric level and they are considered as dry. In spring 2006 the dam has overflowed for a total period of three months. Piezometers Π103A and Π104 maintained their high piezometric level besides the substantial drop in the reservoir's level.

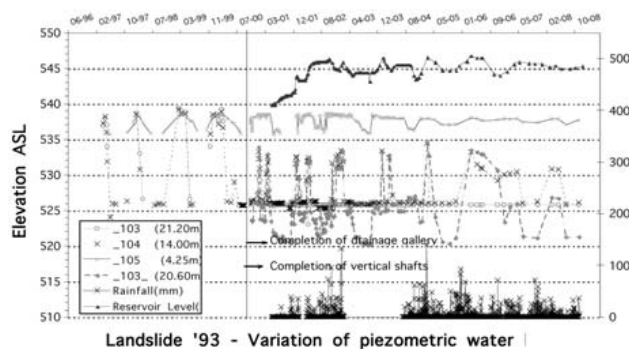
Fig. 9: Piezometric measurements of group Π112-Π115.

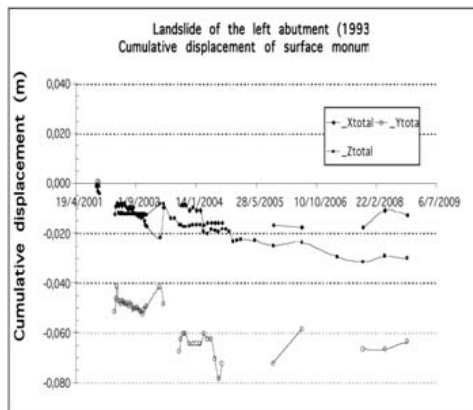
Fig. 10: Measurement of displacements in station K1 nearby piezometers Π112-115.

The stabilization works succeeded in reducing the overall movements to values between the limits of the instrumental measuring fault. Station K1 is located near by the group of piezometers Π112-115, while station K2 is located nearby the group of piezometers Π109-111.

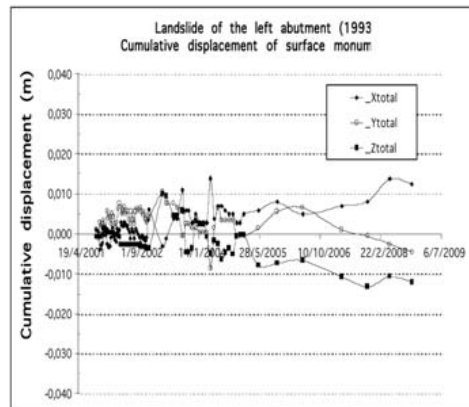
Fig. 11: Measurement of displacements in station K2 nearby piezometers Π109-111.

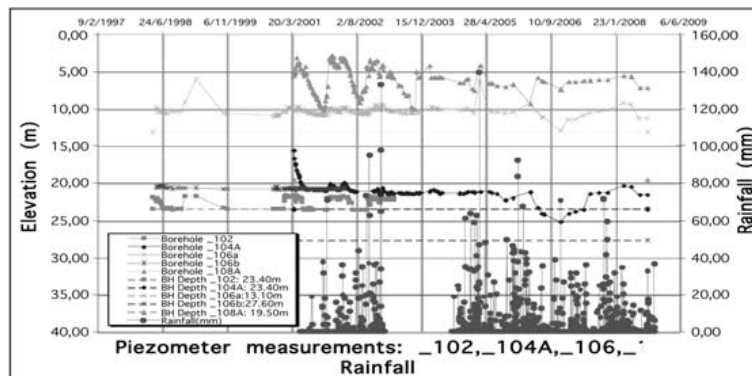
Fig. 13: Piezometric Measurements of Group Γ102, Γ104A, Γ108A and Γ106a & b.

Piezometers are installed in the area of Agios Demetrios-Arahova Country Road Landslide to record the fluctuation of piezometric level upstream and downstream the drainage tunnel. In fig. 13, the history of fluctuation of the piezometric levels of piezometers Γ102, Γ104A, Γ108A and Γ106a & b is presented. In the same fig. 13 the rainfall level curve is also depicted. The piezometers that are located in depth levels greater than 15m are affected by the drainage tunnel and show decreased piezometric levels in respect with piezometers placed in depth levels smaller than 15m. The measurements of piezometers placed deeply in the area of landslide are affected by the reservoir's water level rise.

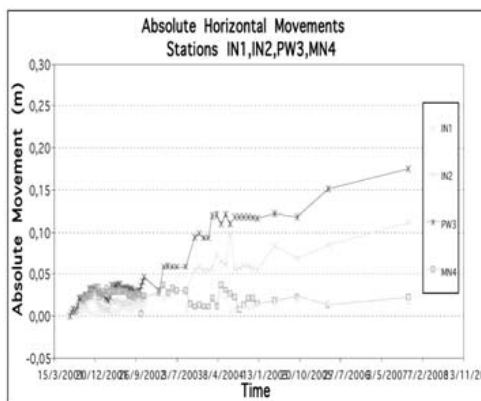
Fig. 14: Measurement of horizontal displacements in the area of Road Landslide.

In figs 14, 15 the horizontal displacement measurements together with the settlement measurements are shown for the area of the landslide. The horizontal displacements measured downstream the drainage tunnels appear to be reduced in MN4, IN1 stations compared to the horizontal displacements measured in stations located upstream the drainage tunnels (PW3, IN2 upper part of landslide). The settlement (1.9 cm) of the lower parts of landslide MN4, IN1 are smaller compared to the settlement recorded (5.3cm) in stations PW3, IN2.

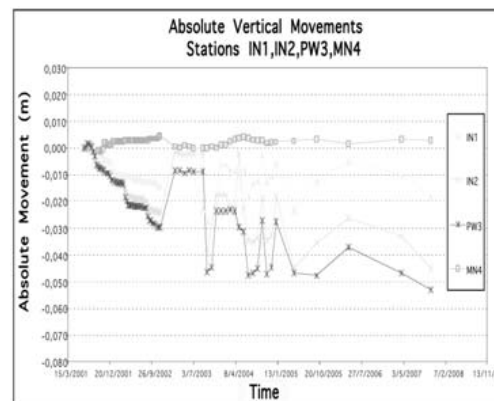
Fig. 15: Measurement of settlement in the area of Road Landslide.

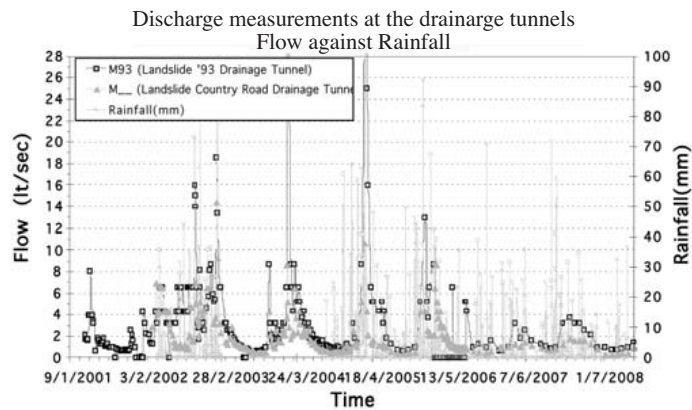
Fig. 16: Discharge measurements at the drainage tunnels in the areas of 1993 Landslide, and Country Road Landslide in relation to the rainfall.

In figs. 16, 17 the discharge measurements at the drainage tunnels of: a) Landslide of the left abutment '93 and b) Agios Demetrios-Arahova Country Road Landslide are depicted respectively. It is observed that the discharge at the outlets of these two drainage tunnels depends on the level of rainfall and exhibits immediate response. The discharge of the drainage tunnel within the landslide of the left abutment '93 depends on the reservoir level. It is shown that the discharge of the drainage tunnel within the landslide of the left abutment '93 is increased remarkably when the reservoir water level is above +485m.

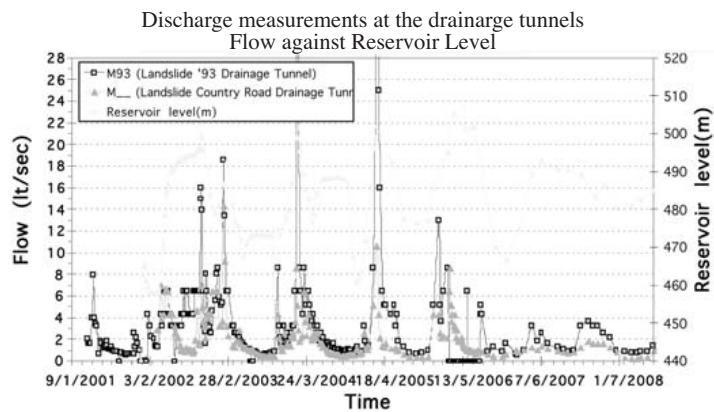
Fig. 17: Discharge measurements at the drainage tunnels in the areas of 1993 Landslide, and Country Road Landslide in relation to the reservoir level.
