## GEOTECHNICAL INVESTIGATION OF THE ROCK SLOPE STABILITY PROBLEMS OCCURRED AT THE FOUNDATIONS OF THE COASTAL BYZANTINE WALL OF KAVALA CITY, GREECE

### Abstract

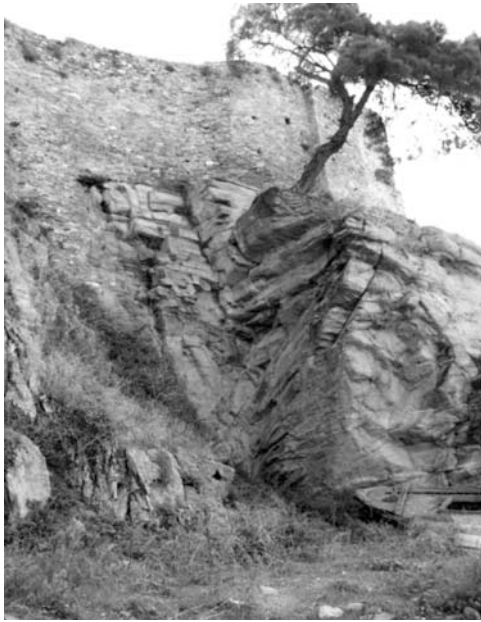
The western – south western slopes present dip ranging between 45° and 90° and height extending 10 to 20m over the pier level. The Byzantine wall along several sections was founded close to the edge of the slopes and as a result slope failures can effect directly the integrity of the monument (Figs 2 & 4). The stability problems are more intensive along the faults. The rock mass is fractured and

**Fig. 2:** Location P1. A fault intersects the slope forming a huge rock wedge and a wide fractured zone. The Wall fills the gap between the two sections of the fault.

In order to avoid the wedge, plane and toppling failures spot bolting and sub-foundation constructions were proposed. To be more precise, the overhanging blocks could be supported by grouted rock bolts installed in selected locations. The underexcavated parts could be supported by filling the void with reinforced concrete constructions (buttresses, gravity walls etc.) camouflaged by stone coating. As presented in fig. 6, sub-foundation constructions were also applied in the past.

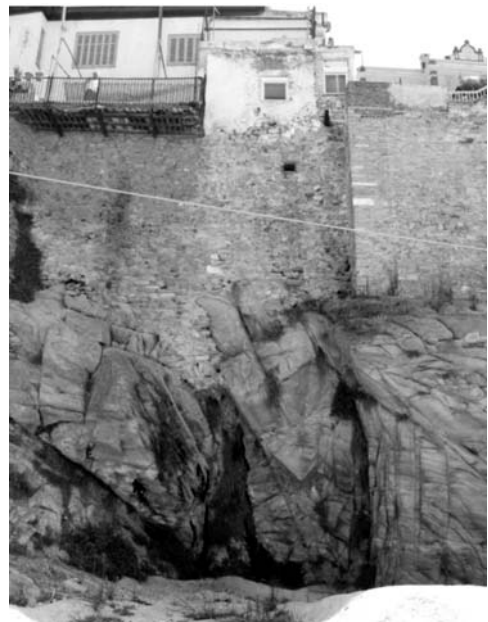
**Fig. 3:** Location P4. An intensively fractured zone caused by a fault. The wave erosion caused intensive underexcavation to the slope.

the wall was constructed in direct continuity with the slope. Even worse, in some places the wall was constructed forming a bridge across the two sections of the fault (Fig 3 & 5B,C,D). Figures 2 to 5 present typical examples of sections appearing slope stability problems capable of effecting the Byzantine monument.

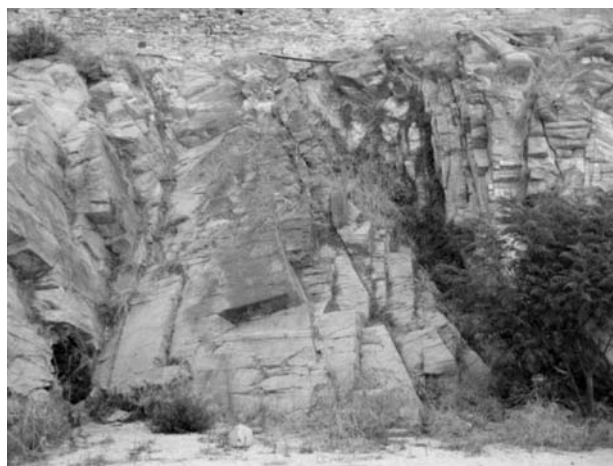
Stability analyses conducted for the slopes with a dip direction 272°-302°, revealed that joints sets J1 and J2 form rock wedges rising along the slopes. These wedges tend to slide along the axis formed by the intersection of the before mentioned joints, with an angle of 73°. The slopes appearing a dip angle smaller than 73° are safe, as the rock wedges are self supported. On the contrary, the slopes with a larger dip angle are unstable. These wedge slides can threat the Byzantine Wall only in cases where the foundation of the wall was constructed close to the slope edge. Precisely, in parts where the foundations were constructed in a distance smaller than half the height of the slope (Fig. 5E). Signs of oversized wedges that have already failed are visible in several parts of the slopes (Figs. 2, 4 and 6).

**Fig. 4:** Location P2. An oversized rock wedge that probably failed during the excavation of the small tunnel appearing at the base of the slope, on the left side of the picture. The extension of the failure could very easily damage the Byzantine wall.

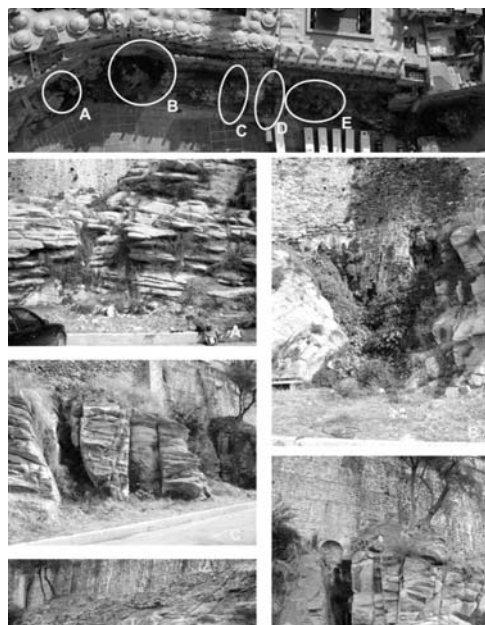
The corresponding analyses conducted for the slopes with a dip direction 202°-216° proved that those slopes are stable; no oversized rock wedges are formed (Fig. 5A). The only stability problems can be expected by the falls of small rock blocks sited along the slope face.

**Fig. 5:** Part P5. View of the slopes below Imaret monument intersected by the faults presented in the map of Fig. 1. The deterioration of the rock mass along the major tectonic lines cause serious rock slope stability problems threatening the monument. The letters pointing the various unstable locations correspond to the homonymous pictures (5A to 5E).

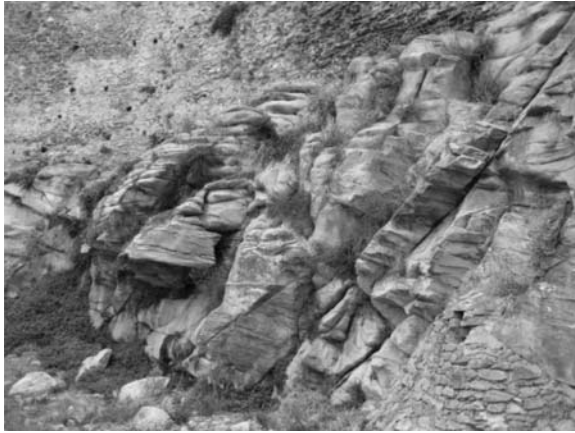
**Fig. 6:** Part P6. Several rock wedges are formed, to prevent them from sliding the underexcavated rock blocks were sub founded by the use of masonry walls – fills (lower right corner of the picture).

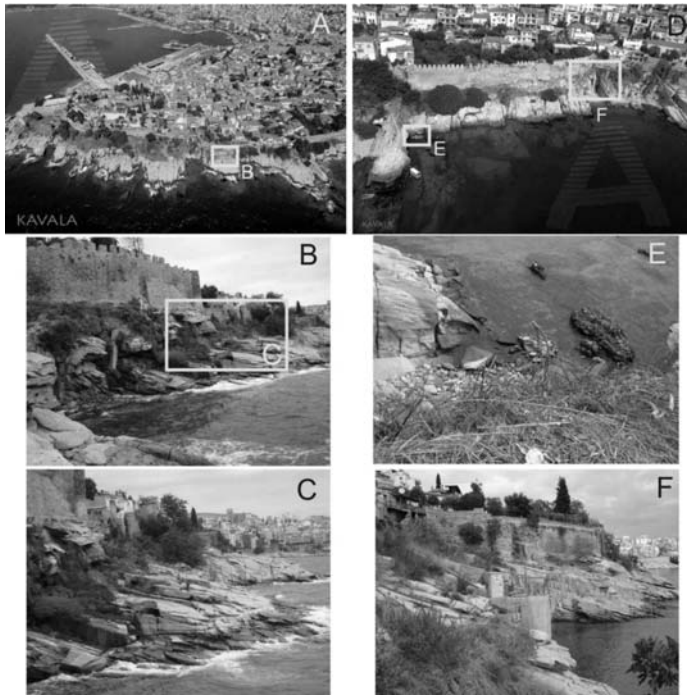
The South-eastern slopes present dip ranging between  $45^\circ$  and  $90^\circ$  and height extending 20 to 30m over the sea level. The lower parts of the slopes are found into the sea, effected by the marine erosion. The longest parts of the Byzantine wall are protected from the marine erosion and from the rock wedge failures as they are founded far from the edge of the slopes. However, along parts where the slopes are intersected by numerous faults, erosion processes have formed small gulfs and the sea has approached the historical construction, putting its foundation in danger (Fig. 7).

**Fig. 7:** Parts P9 and P10. View of the slopes along the SE part of the peninsula. Along the parts where the slopes are intersected by numerous faults the marine erosion processes have formed small gulfs and the sea has approached the historical construction, putting its foundation in danger. E: A collapsed section of the wall is presented.

The marine erosion of the slopes can be effaced by the installation of seawalls. These breakwater structures can be constructed by granite boulders, fitting to the surrounding bedrock and causing the minimum aesthetic distortion to the site. As presented in figure 7, the shallow sea, close to the coastline, allows the installation of the boulders by using barges. Unfortunately, these structures are going to block the small beaches formed along the gulfs. Small piers or narrow passages through the breakwater structures can provide solution to the problem.

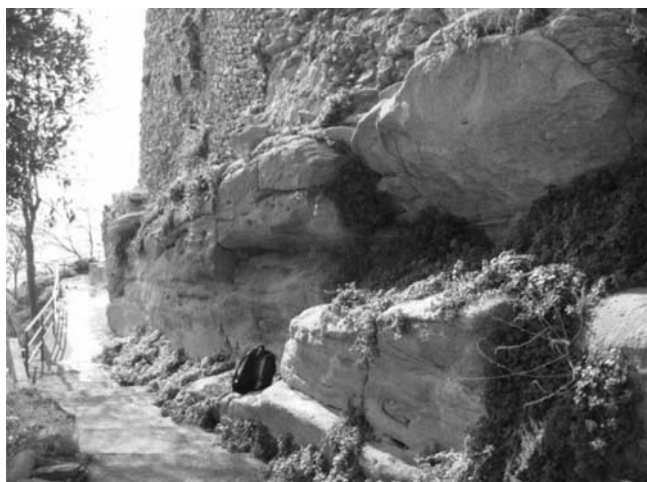
**Fig. 8:** Part P13. Underexcavated slope along a fault scarp. The wall was founded close to the edge. The toppling or the rupturing of the rock mass could cause extensive damages to the monument.

Concluding, the slopes sited at the SE part of Panagia peninsula are not prone to rock sliding. On the contrary, toppling is likely to occur. Rock fragments of 2-3meters maximum height could topple, especially in parts where their foot is undercut (Figs. 7, 8). These phenomena could damage the historical monument at those areas where marine erosion has excavated rupture zones reaching to Byzantine wall's foundation.
