SLOPE STABILIZATION ON CHALKOUTSI – DILESI ROAD, AT PIGADAKIA LOCATION, ATTICA PREFECTURE

A series of ongoing landslides occurred at the steep coastal slopes at Pigadakia location, on the road connecting Chalkoutsi and Dilesi towns, at NE Attica. These landslides caused severe disruption on local traffic.

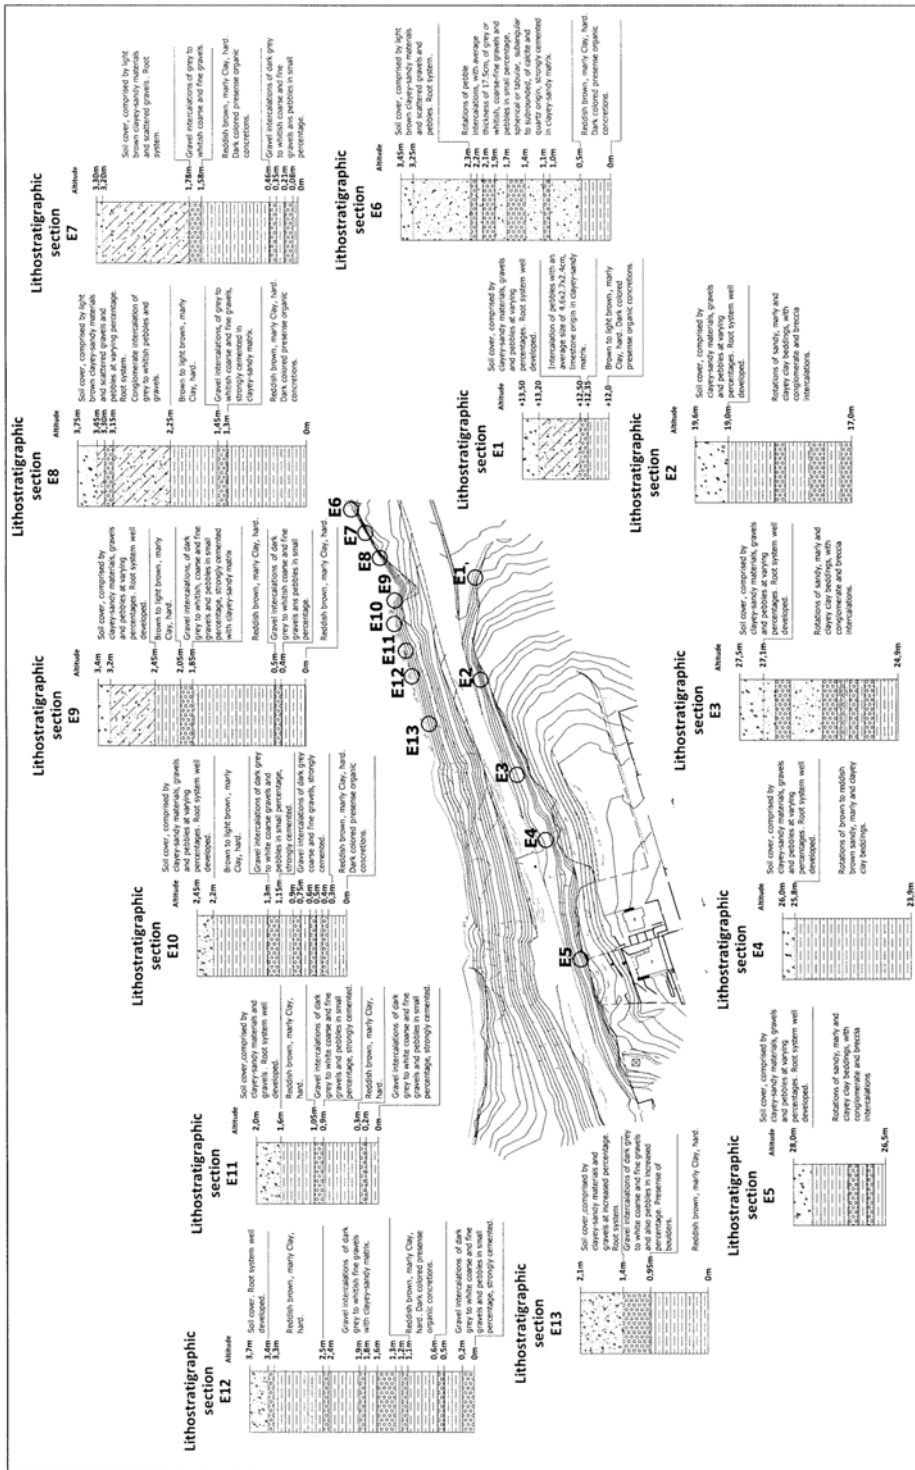
structures formed by the surface water runoff. The Neogene substratum appearing along the natural and man-made slopes is presented in detail at the lithostratigraphic logs of figure 2.

Fig.2: Lithostratigraphic sections of the natural slopes.

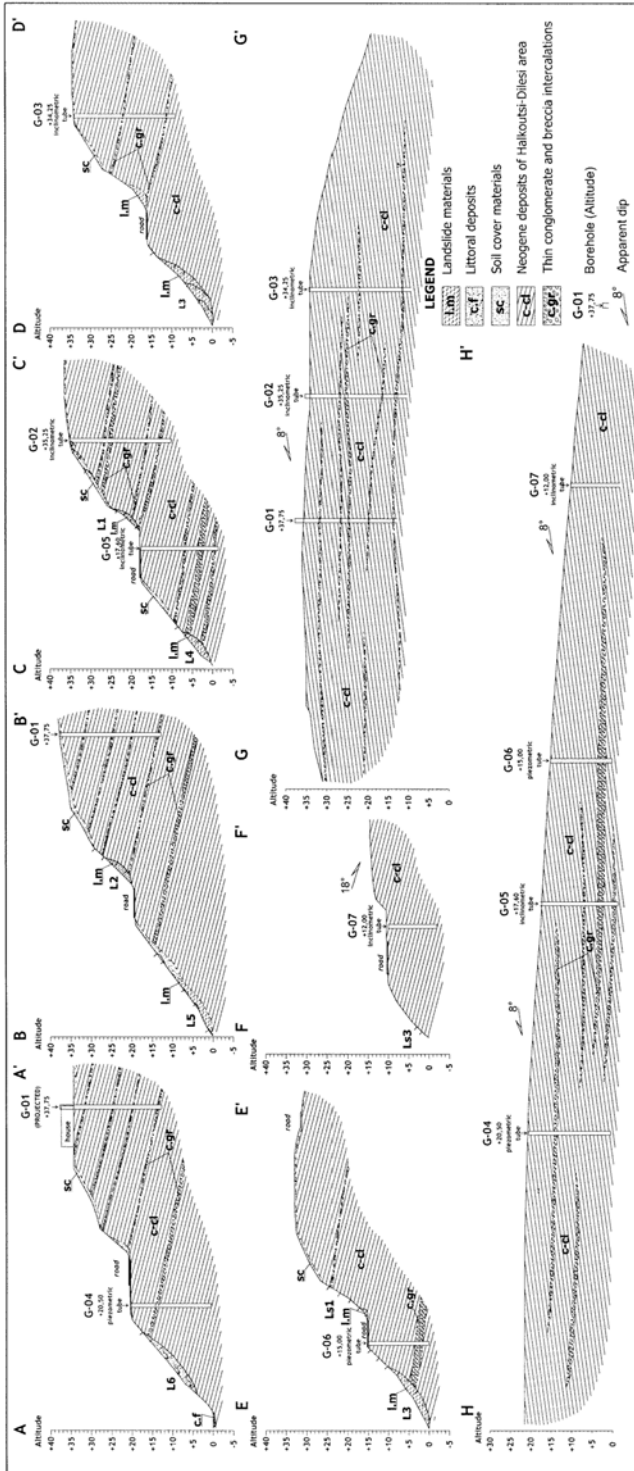
Fig. 3: Geological cross sections.

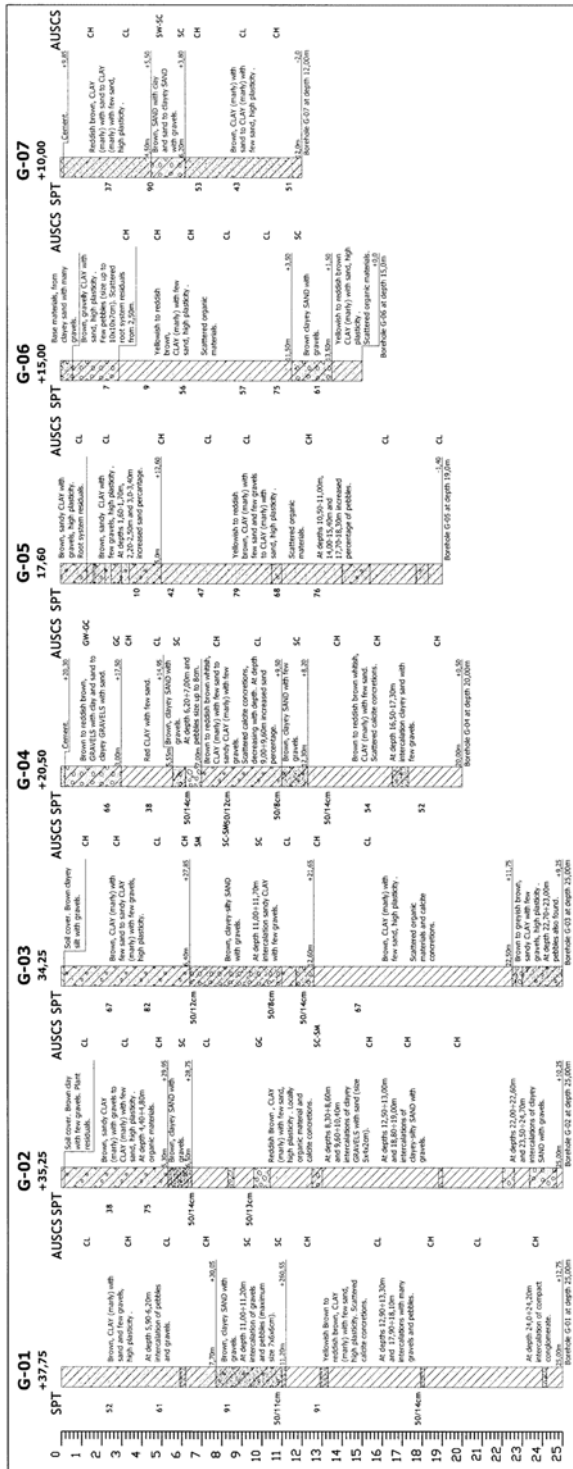
Fig. 4: Boreholes logs

The observed slides in lower and upper slopes of the road are caused by the gradual diminishing of the shear resistance of hard clayey formations due to the progressive loss of the cohesion component of the shear strength, caused by the combined action of increased moisture content and displacements. The increase of the moisture content is caused by the infiltration of surface waters to the interior of their mass and is facilitated by the presence of the preexisting discontinuities into the body of the clay. The steep excavation slopes ($45^{\circ} - 55^{\circ}$) applied and the gradual loss of the shear strength from peak values to the fully softened values (Skempton, A.W., 1948, 1964, 1967, 1977; Terzaghi, K., Peck, R.B., Gholamreza, M., 1996) led to an increased tendency for slope displacements. In order to ensure the long term stability of the slopes an excavation with milder slopes ($\sim 25^{\circ} - 30^{\circ}$) was necessary. Regarding the lower slopes, their instability is influenced by the additional continuous erosion of the slope toe by the sea waves causing a continuous loss of their support.

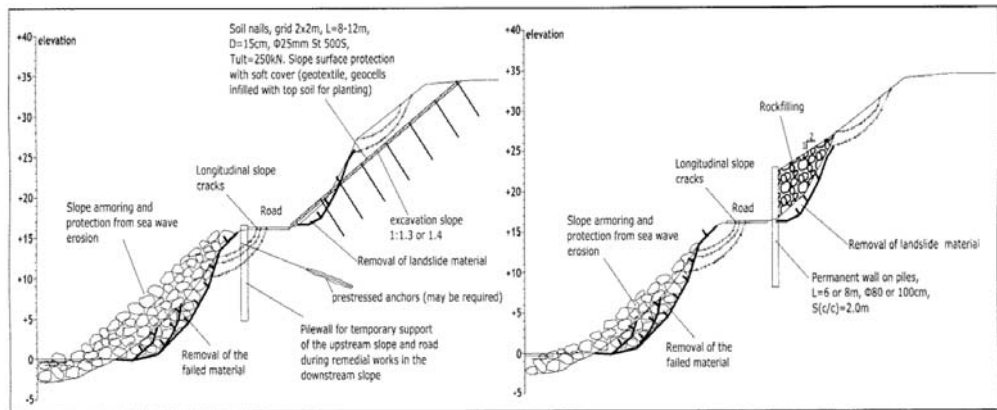
Fig. 5: Schematic reconstruction of solutions A (left) and B (right)

Solution A presupposes the possibility of limited surpassing the existing limits of expropriation. Firstly a cleaning of the slope surface is carried out removing the loose failed material involved in the slides. Afterwards an excavation of the slopes with milder slopes, minimizing as much as possible the surpassing of the existing limits of expropriation of the upper slope and more specifically in the Eastern part of the slope where houses exist. For the reinforcement of the newly formed slopes and in order to achieve the required factors of safety in static and seismic loading, the placement of passive soil nails is anticipated. Finally, for the protection of clay from the surface erosion and water infiltration and for the minimization of the probability of future loss of resistance of the surficial clay layers, a cover of “soft” type (soft cover) is placed on the slope surface comprising a needle punched geotextile and a geocell cover in filled and planted with vegetation. At the crest and the slope berms a suitable collection and dewatering system (eg. ditches) of the surface water is anticipated, for the fastest possible removal of the water from the slopes (Fig. 5, left).

For the case where it is not possible to exceed the existing limits of expropriation of the upper slopes, a continuous retaining wall with a variable height is constructed at the upper slope toe. The wall will be founded on piles. The piles on one side contribute on the total stability and in the same time help in the significant reduction of required excavations in slope toe for the construction of the wall shoe, which can trigger new slides. The area between the wall and slope surface will be backfilled with granular material (eg. rock fill). The backfill slope will be 1:2 (h:b). In the crest of the backfill embankment a suitable water collection system will be constructed (eg. ditches) in order to lead all surface waters outside the wall region (Fig. 5, right).

It is pointed out that in the case of Solution A, when remedial and stabilization works will be specified for the lower slopes, due to the additional excavations needed for the removal of failed materials, in order to ensure the stability of the road and upper slopes additional temporary retaining works may have to be constructed. In such an event, a construction of a pile wall at the crest of the lower slope maybe necessary along with the placement of prestressed anchors. In the event that Solution B will be applied, due to the presence of the wall foundation piles, it is not necessary to construct a temporary retaining pile wall (Fig. 5, left).
