## LANDSLIDES IN VITSI (FLORINA) TERRITORY

**Keywords:** Slope failure, Drosopigi- Florina, seismicity, rainfalls, geotechnical investigations.

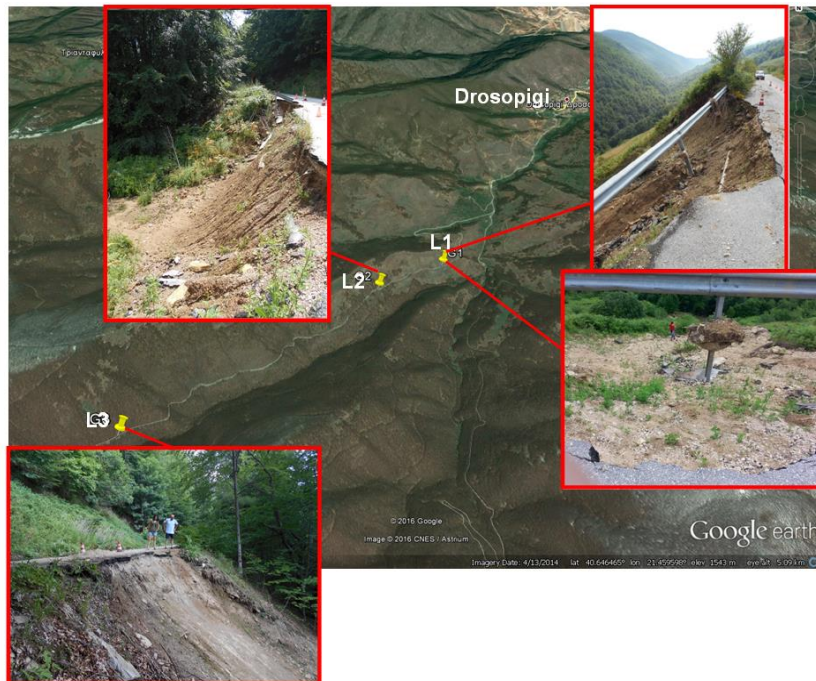
In our case, three landslides are observed and investigated (L1, L2 and L3), as indicated in Figure 5. The landslide (L1) is about 10.0m long in the longitudinal direction, 1 m wide in the latitudinal direction and is occurred in a slope with gradient 23°. It is a combination of debris slide, rock slide and rock topple. Landslide (L2) is a debris flow, about 5.0m long in the longitudinal direction, and 1m wide in the latitudinal direction and is occurred in a slope with gradient 21°. Landslide (L3) is about 6.0m long in the longitudinal direction; 0.3-0.7m wide in the latitudinal direction, is translation type slide but develops into debris flow. The gradient of the slope in L3 site is 45° and the area beside the landslide is mostly covered by vegetation and trees. The altitude of the area ranges between 1080 and 1260m.

Figure 5 - A general view of Vitsi landslides (L1, L2, L3).

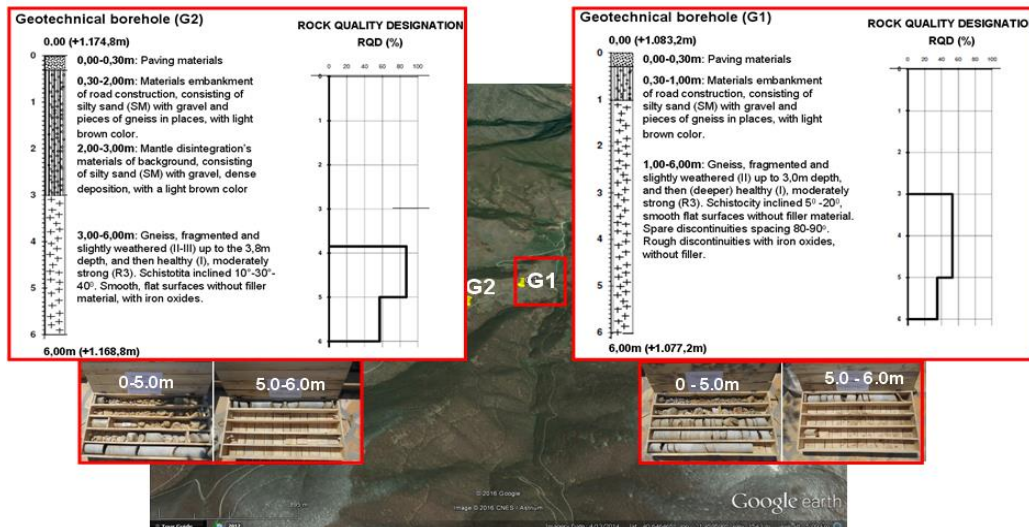
Figure 6 - Typical soil profiles in G1 and G2 location/ Photos of Test Samples (Tsirekas, 2015).

According to laboratory tests, three soil layers were identified. The 1<sup>st</sup> layer is the Embankment fill with depths ranges from 0.30m to 1.0m (G1) and 0.30m to 2.0m (G2). The 2<sup>nd</sup> layer is the disintergradated gneiss or silty sand (SM) with gravel ( $N_{SPT} \square = 50/15$  and  $50/5$ - in two tests) with  $LL=28.1\%$ ,  $PL=23.6\%$ ,  $PI = 4.5\%$  and with average 16% of gravels, 62% of sand and 22% of silty-clay. The 3<sup>rd</sup> layer is Gneiss with different degree of fragmentation with  $Is_{(50)}$  ranges between 0,75-2,1 MPa in 3 Point Load Tests. Groundwater level, in landslides' area, is below 20m.

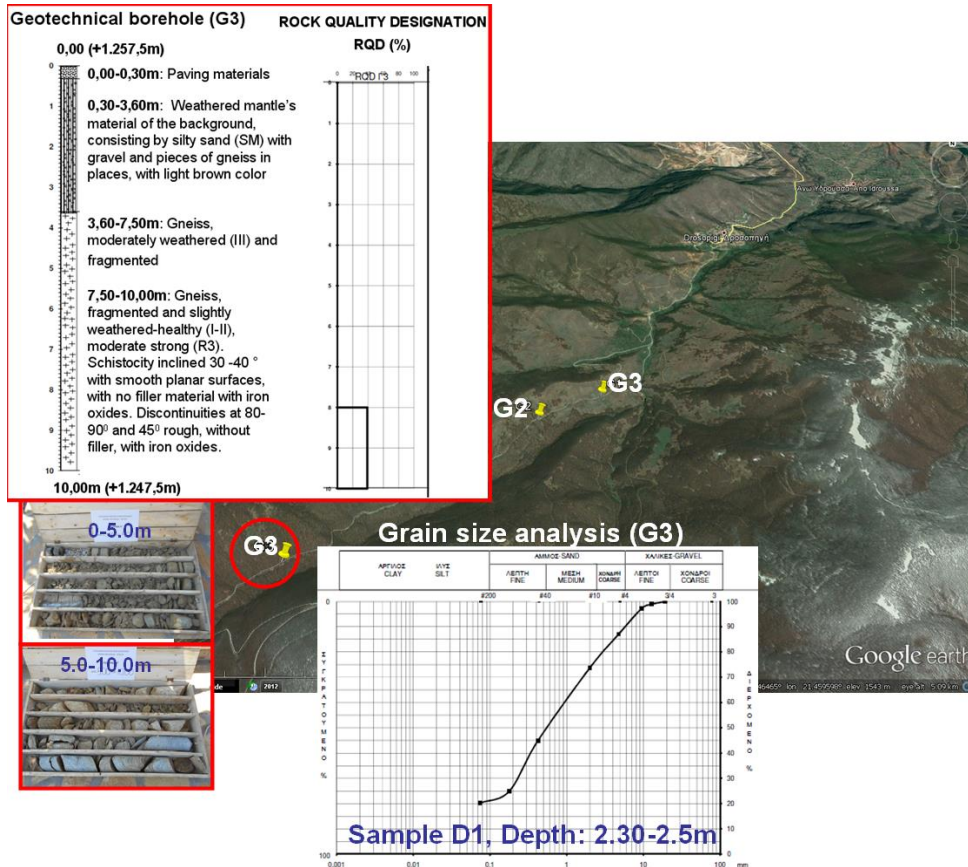
Figure 7 - Typical soil profile (G3 location)/ Photos of Test Samples/ Grain size analysis (Tsirekas, 2015).
