AN ENGINEERING GEOLOGICAL ASSESSMENT USING TERRESTRIAL LASER SCANNING FOR THE STABILIZATION OF A VOLCANIC SLOPE IN SANTORINI ISLAND

Abstract

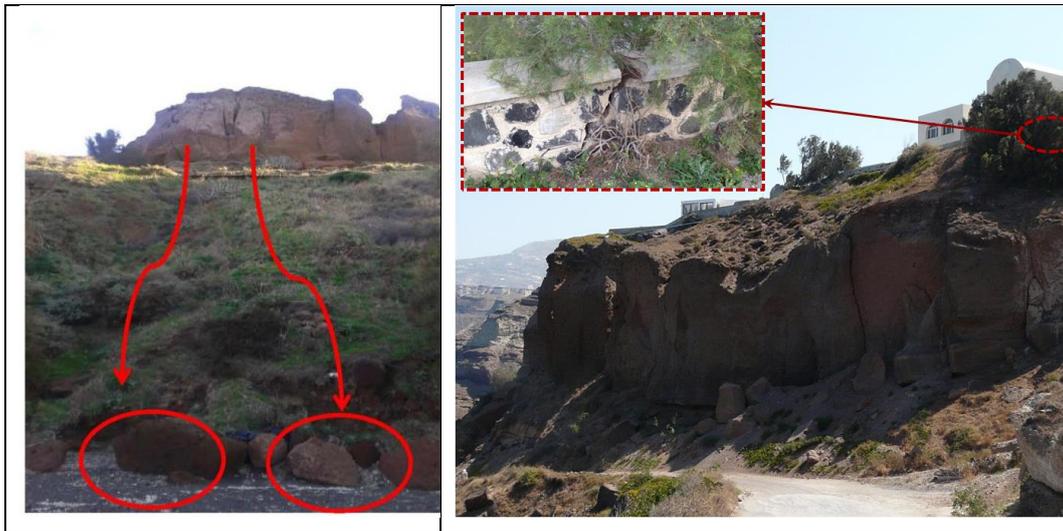
Figure 2 - Blocks are likely to propagate downhill up to the sea level, passing twice over the local road and finally reaching the public beach. The rock block detachment may also create significant problems to the adjacent residences.

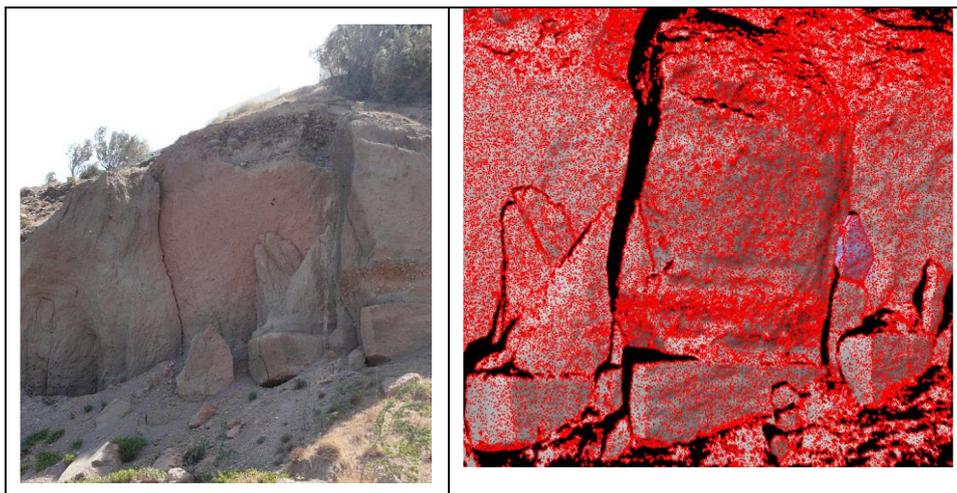
Figure 3 - Point cloud of the area showing some of the unstable rocks and the developed tension cracks in detail.

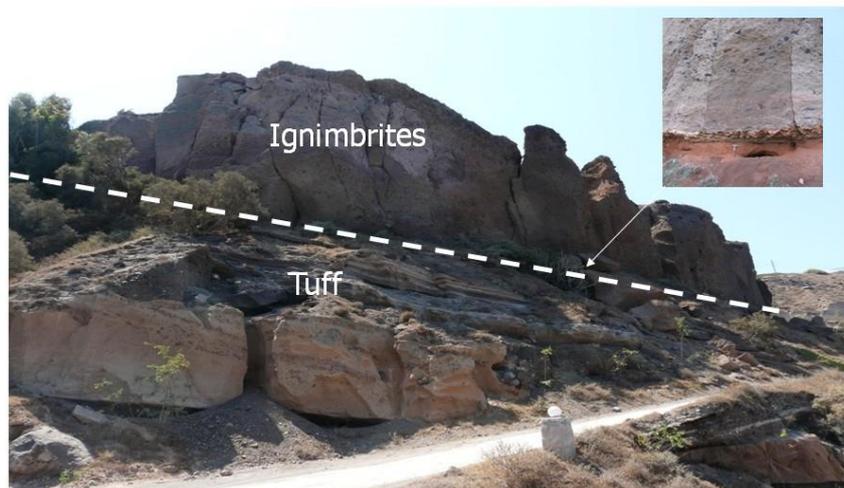
Ignimbrites have high strength but are based on soft and highly erodible tuffs and paleosol. Paleosol is composed of medium dense sandy material with clay. Water infiltrates along the joints of the hard rocks but stops along the impermeable tuffs. Thus, water softens the weak geomaterial, generates pore water pressure but also builds hydrostatic pressures along the open joints.

Figure 5 - The differential erosion is caused along the contact of the hard ignimbrite columns and the looser paleosol. This weak surface of erosion generates tensile cracks that are extending with the force of water and wind with time. Picture in frame shows a detailed contact of the ignimbrite body on the paleosol.

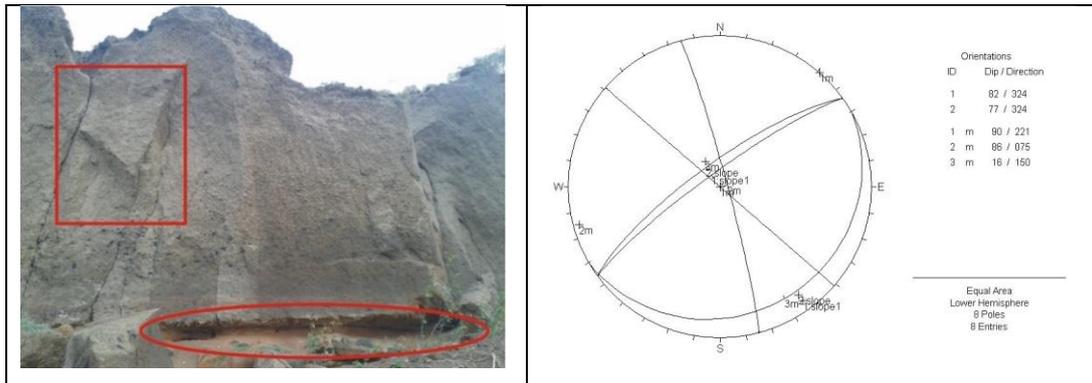
Figure 6 - The paleosol and the underlied tuffs defined as the prime surface of the instability, is illustrated in the ellipse. The discontinuities are either cooling joints or are originated from tectonism or are resulted from stress relief.

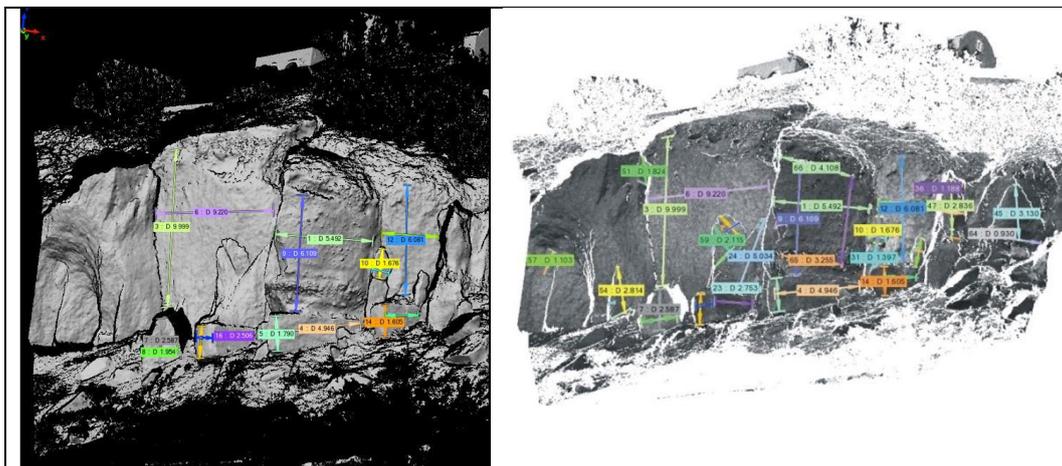
The process of the LiDar image of “Apothikes” location had as central axe the determination and measurement of the dimension of blocks. The software provides the possibility to measure the exact volume of a block instead of making assumptions and comparisons to basic shapes. Thereafter, we classified the thickness in order to determine the major class. It was found out that the maximum thickness of the pillars was 5 m and the 95% of blocks had thickness below 4 m. Therefore, for our analysis we used the value 4 m in order to make a realistic model (Figure 7).

Figure 7 - LiDar image showing the estimation process of dimension of the unstable or fallen blocks (right).

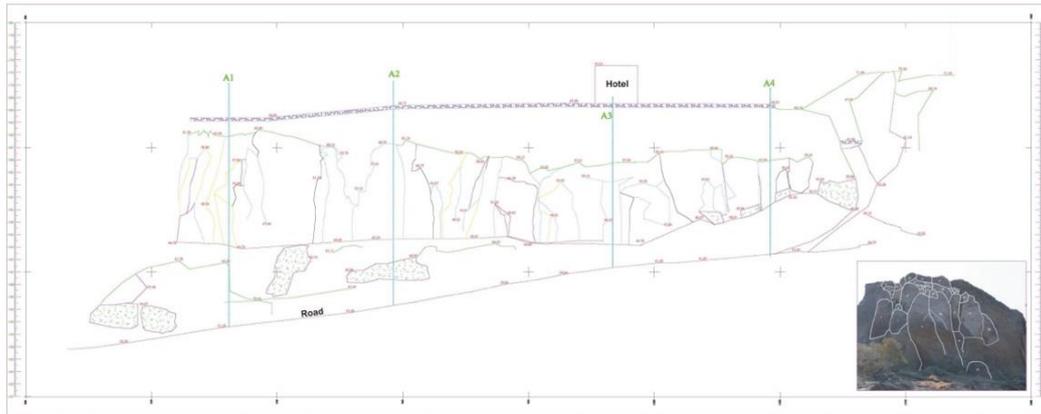
Having completed the alignment of the point clouds, a measuring of the dimensions of the unstable rocks was performed. The dimensions of the largest boulders are 10X9m (height X width) while smaller ones are also measured. A segmentation of the rock pillars that are likely to fail were mapped in order to assist the rock fall hazard assessment and the design of the remedial measures (Figure 8).

The hazard of new rock slides is very high, since several unstable rock blocks are present, either already moved or unloaded by recent instabilities. Indeed, instabilities have been recorded in the whole length of the road, several blocks are found along the beach, while wide open joints are present.

Figure 8 - The façade depicting all the unstable blocks along the studied area.

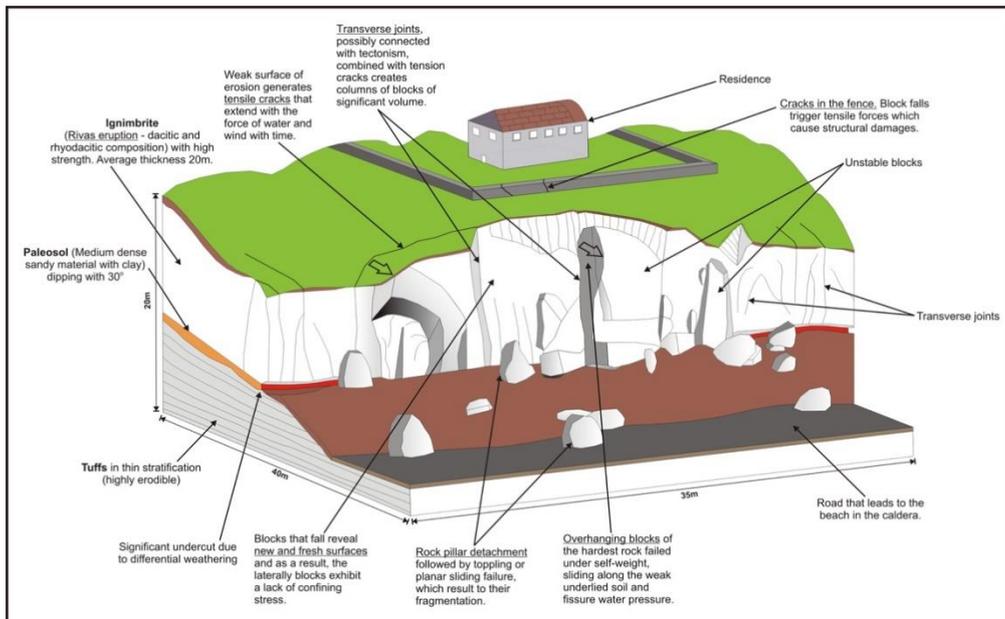
The main failure mode consists of rock pillar detachment followed by toppling or planar sliding failure, which result to their fragmentation. As the morphology is steep, blocks are likely to propagate downhill until sea level, passing three times over the local road and finally through the public beach. It has been concluded that the slopes are likely to collapse due to differential weathering. The differential erosion is caused along the contact of the hard ignimbrite and the looser paleosol. This weak surface of erosion generates tensile cracks that extend with the force of water and wind with time. Thus, erosion is then accelerated. These tension cracks combined with other transverse joints, possibly connected with tectonism, creates columns of blocks of significant volume. As an outcome overhanging blocks of the hardest rock failed under self-weight, sliding along the weak underlied soil and fissure water pressure. The blocks that fall reveal new and fresh surfaces and as a result, the laterally blocks exhibit a lack of confining stress. Therefore, new cracks begin to appear and the same process accelerates. An engineering geological conceptual model of the studied area is presented in Figure 9.

Figure 9 - An engineering geological conceptual model of the studied area.

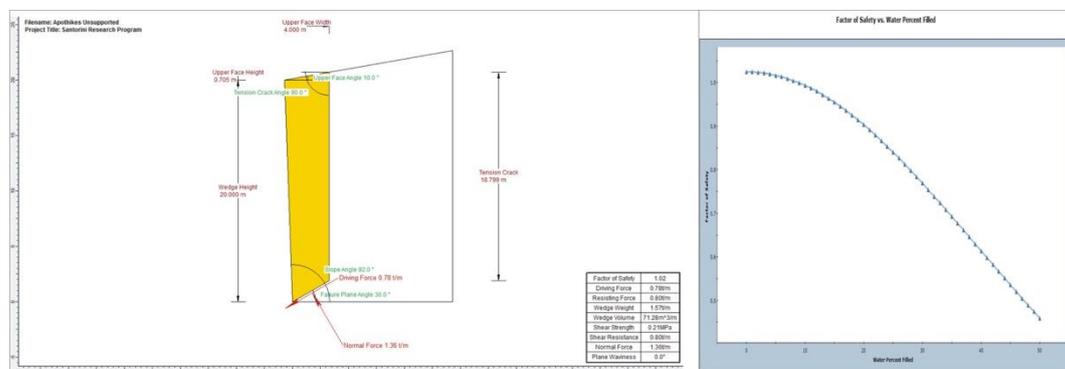
The model consists of a 20m height and slightly overhanging slope (92°). The planar surface was simulated with an exaggerated inclination of 30°, since signs of prior failures indicated that the critical plane passes through the weak underlying layer. Material properties were determined by field and laboratory tests, resulting to the equivalent Mohr-Coulomb parameters that were used for the analyses ($c=5\text{kPa}$ and $\phi=30^\circ$). Vertical discontinuities (persistent throughout the whole slope's height; therefore, filled with water) were simulated 4m behind the crest. In order to design the full face nailing pattern, static and pseudo-dynamic analyses were conducted for various water heights within the discontinuities.

Figure 10 - Sliding analysis with RocPlane software from RockScience's suite shows that safety factor (F) is 1.02 (left). Diagram Factor of Safety-Water Percent Filled, shows that safety factor (F) drops below 1.0 with a small percentage of water (right).

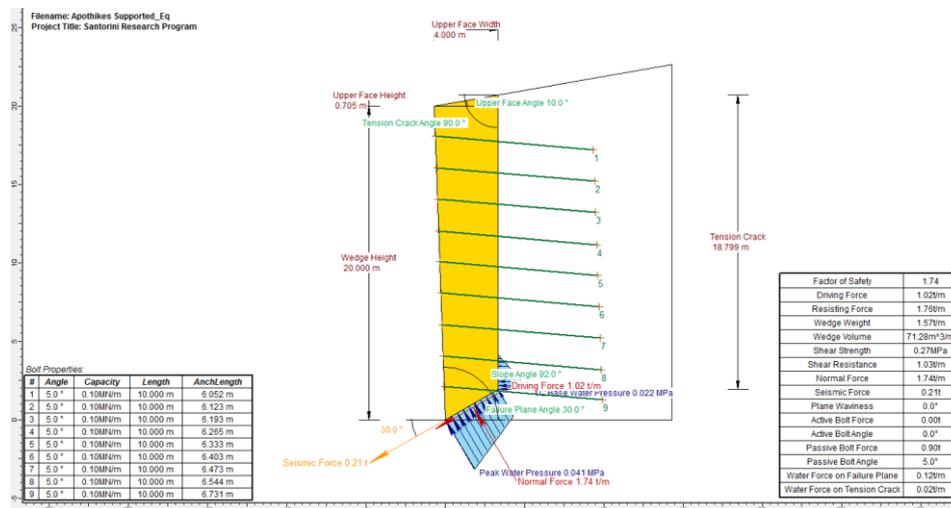
Figure 11 - Sliding analysis with RocPlane software from RockScience's suite, after the implementation of the remedial measures.

In order to prevent failure and the accompanied consequences, various mitigation methods were examined based on the site's geological and geotechnical conditions, cost, local architecture restrictions and constructability. The principle of the proposed measures are: a. Extensive mechanical scaling in order to create a safe working environment and slope free of tension cracks; b. Nailing with fully bonded anchors ($d=25\text{mm}$, $l=10\text{m}$) on a 2×2 pattern and c. Steel nets, in case of local poor rockmass conditions, that will be anchored to the nails and lashed by transversal wire ropes.
