## SOIL SUITABILITY ESTIMATION FOR HOUSING PURPOSES IN LANDSLIDE-PRONE AREAS. THE CASE OF KARYA VILLAGE, PATRAS, W. GREECE

Koukis G.<sup>1</sup>, Sabatakakis N.<sup>1</sup>, and Lainas S.<sup>1</sup>

**Key words:** Geotechnical Survey, Slope Stability analysis, Soil Suitability, Western Greece.

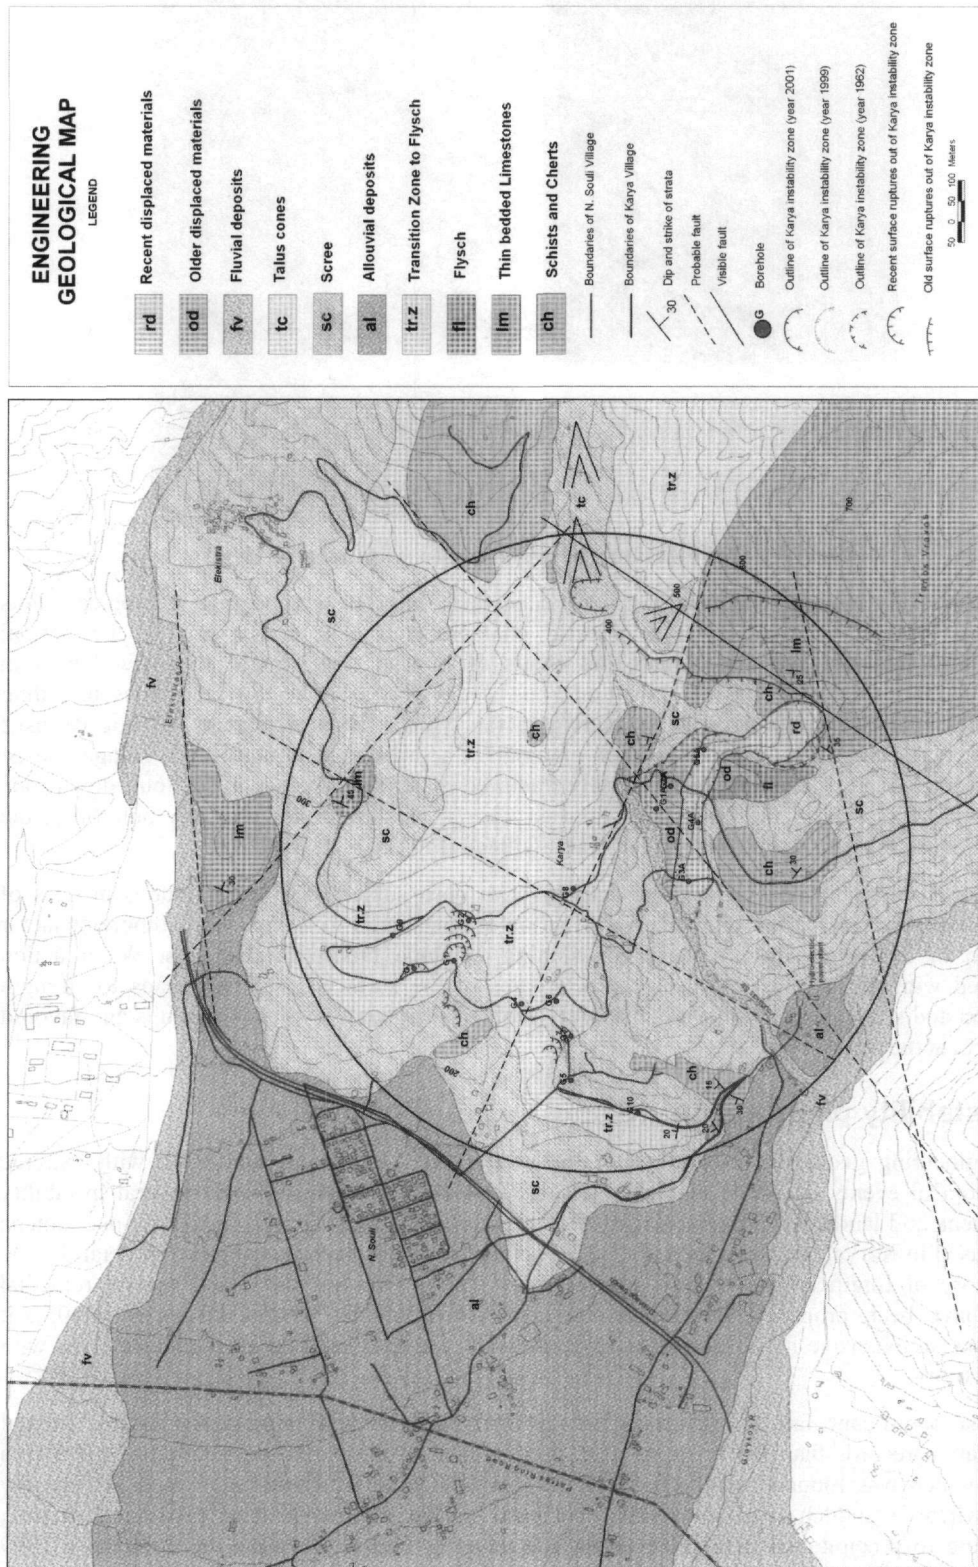
The various formations encountered were classified into ten engineering geological units according to their relative age and physical characteristics. The lower part of the normal sedimentary sequence includes schists and cherts of Jurassic age, which are covered by thin bedded Cretaceous limestones. A transition zone is developed above the limestones including limestones, shales, scherts and marls, leading to the typical flysch sediments. Clastic deposits including scree and debris overlay bedrock materials. The hillslopes around Karya village consist mainly of scree and transition zone intensely fractured materials, whereas in N. Souli downslope area feature Pleistocene and Holocene deposits. Cherts and limestones typically outcrop at the mountaneous area near the SE margins of Karya village (Fig. 2).

**Figure 2 – Engineering geological map of Karya and Neo Souli villages area**

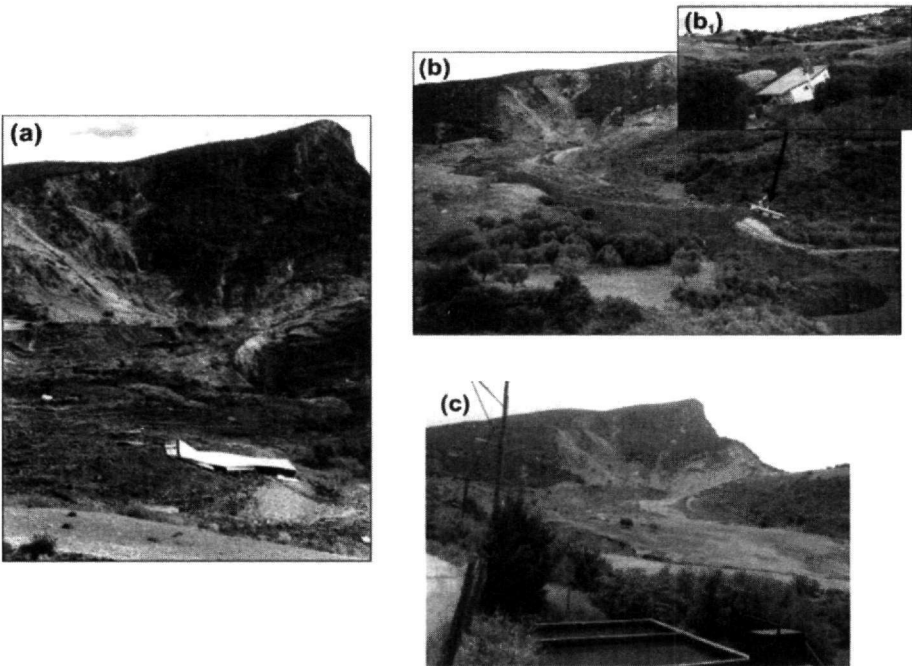
The first significant failure was recorded in 1962, a year with almost the double annual precipitation records than the previous year, and resulted to the partial destruction of old Karya village which was founded on the head of the landslide. The landslide reactivated in February 1999, where a sudden mass movement occurred during an intense and prolonged rainfall. According to precipitation data recorded by the gauging station of Patras the February's 1999

rainfall was 250 % greater than the mean monthly value. The event was a debris flow followed by a translational multiple slide involving recent debris, older sliding materials and weathered zone of Flysch. The main road connecting nearby villages was destroyed, while the streamlet at the base of the gully was blocked by debris materials forming a 4-meter deep lake.

In December 2001, an intense rainfall of about 94 mm in less than 24 hours resulted to a sudden failure of a large volume of debris material that triggered a new extensive landslide. The debris flowed rapidly on the slope causing a “tongue” of saturated material to slip down and overtop the slope face. A translational slide was also activated in the lower part of the landslide. A newly constructed house founded inside older sliding materials was totally destroyed, while the main road connecting nearby villages was destroyed for a second time.

The 2001 event is the latest reactivation of the landslide. During and after the construction of the remedial works inclinometer tubes were installed inside the landslide body. Their role was to access the effectiveness of the remedial works and indicate a probable reactivation of the landslide. An almost two-year period of systematic measurement (June 2003 till March 2005) showed a continuous movement in the central part of the instability zone (borehole G2A), particularly at depths of 7 and 19 m with maximum displacement of about 7.5 and 3.6 mm respectively. Based on the inclinometer data it can be assumed that the landslide area has not been stabilized after the latest events. According to (Cruden and Varnes 1996) it can be classified as an landslide of an extremely slow rate of movement.

**Figure 3 – Karya Landslide (a) 1999 event, (b) 2001 event (b<sub>1</sub>) damaged house and (c) current condition**

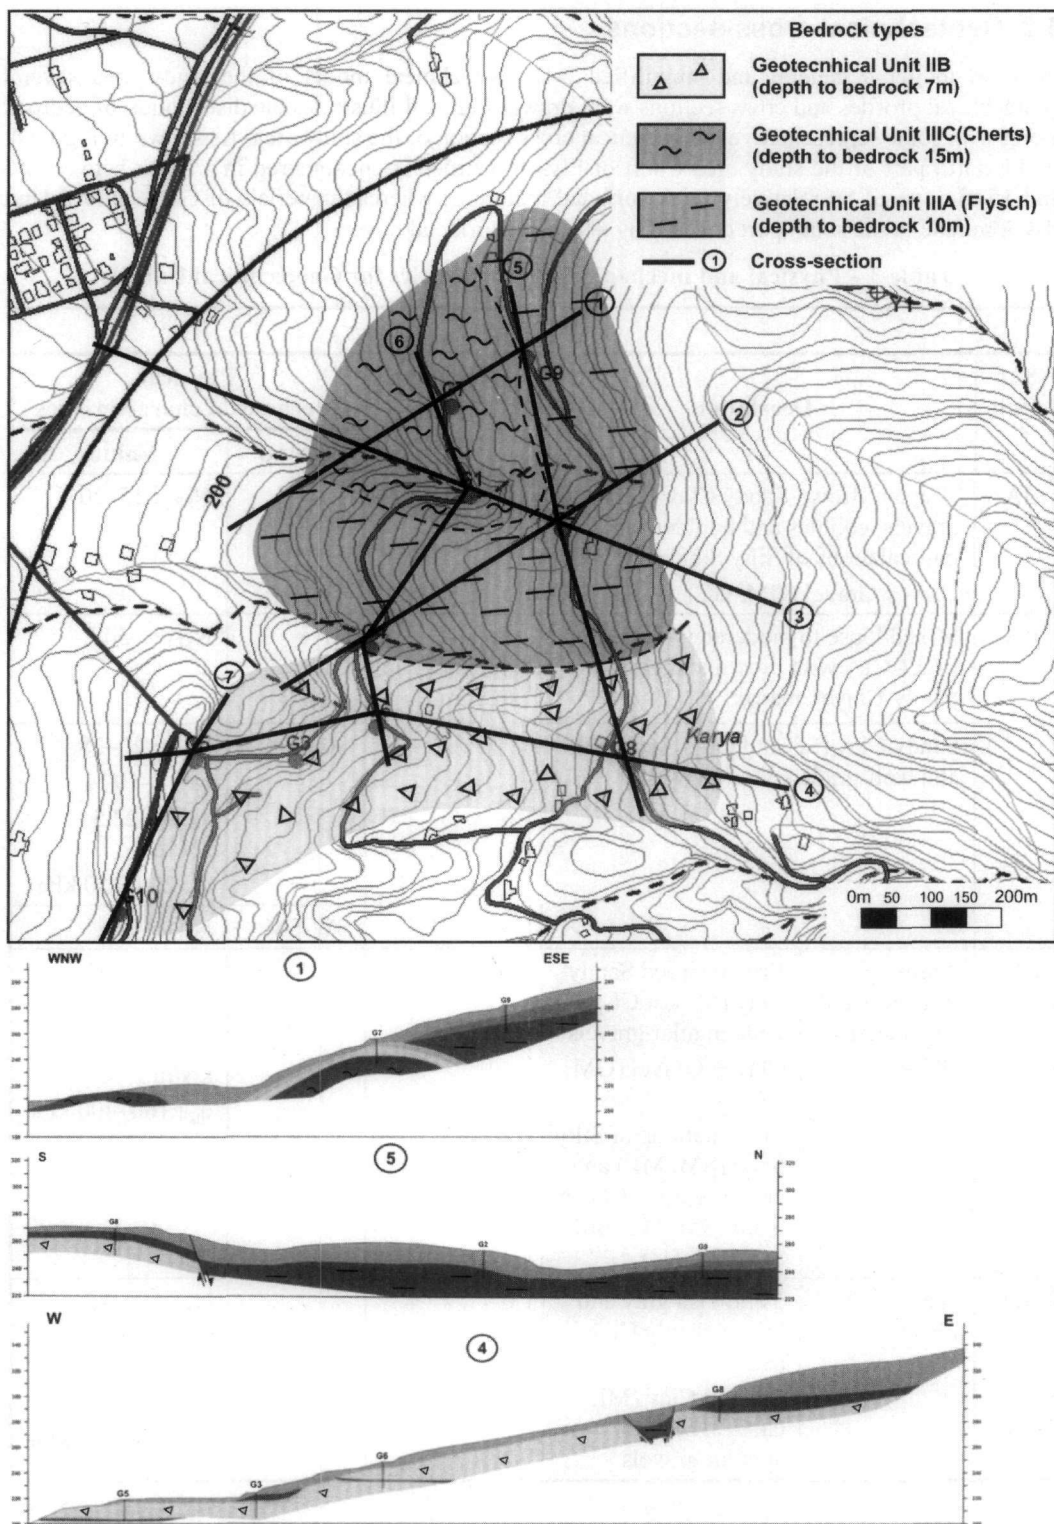
In order to get a general and simplified 2-D geotechnical model of the study area several geotechnical profiles and cross sections were drawn. Figure 4 illustrates the distribution of bedrock along with some representative Geotechnical cross section of the study area. As shown in Figure 4, in the north part of the study area Chert of Flysch bedrock is encountered in a depth between 10 and 15 m covered by relatively thick surfacial materials, whereas materials of Geotechnical Unit IIB dominate in the south part covered by a 7-meter surfacial cover.

**Figure 4 - Geotechnical cross-sections and distribution of bedrock types**

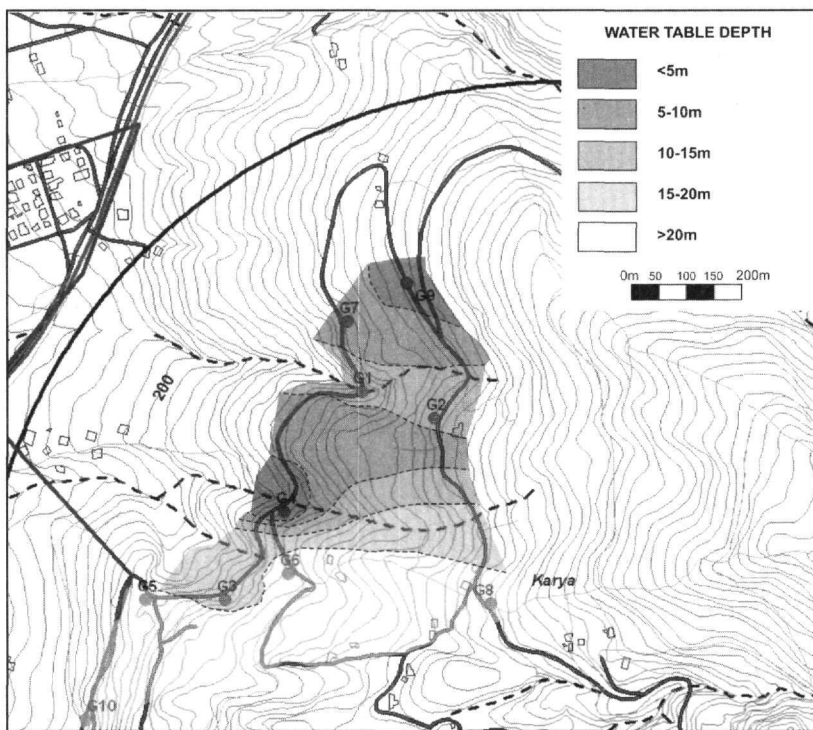
Water table depth measurements saw differential groundwater conditions between the north and the south part of the study area. Moderate to high water table (less than 10m from surface) was measured in the north part sometimes near soil surface. On the other hand, the south part is characterized by low water table (more than 15 m from surface) or absence of water up to 20 meters (Fig. 5). The impermeable Flysch or Chert bedrock contributes to high water table conditions, whereas the intensely fractured and more permeable materials of Geotechnical Unit II are characterized by low water table or regional dry conditions.

**Figure 5–Water table depth distribution**

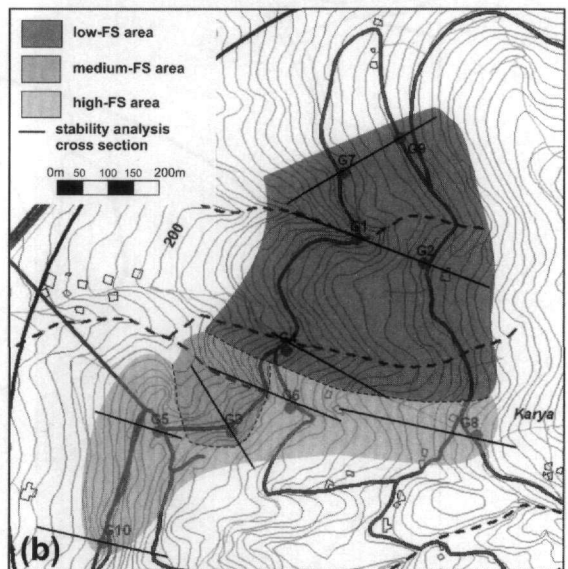
As shown in Figure 6, low Safety Factor values were computed in the north part of the area so, according to the results, it is more susceptible than the rest region for instability problems under extremely high pore-water pressure conditions, caused by heavy and prolonged rainfalls.

**Figure 6 – (a) Slope stability analyses results (b) distribution of estimated Safety Factors**

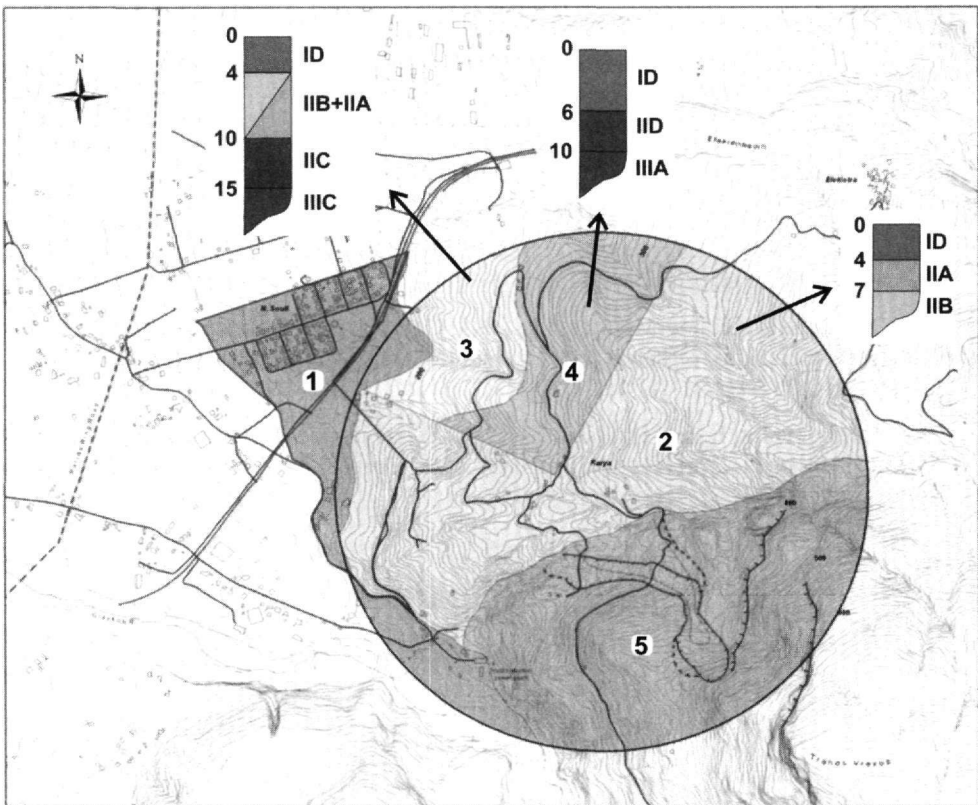
Based on the engineering geological and geotechnical investigation the village area was finally divided into five zones according to the encountered ground for housing purposes (Fig. 7):

- Zone 1 was classified as suitable for housing since it is relative flat, it consists of stiff recent Pleistocene-Holocene deposits and has not instability problems.
- Zone 2 consists of coarse grained Unit IIB materials covered by up to 5 m-thick scree and weathered materials. It is characterized by low water table, absence of instability problems and has relatively high Safety Factor values according to slope stability analyses.
- Zone 3 consists of weathered Chert bedrock covered by about 4-meter thick surfacial materials and 11-meter thick various intensely fractured materials of Unit II. It is characterized by high water table, small-scale instability problems and lower Safety Factor values according to slope stability analyses.

- Zone 4 consists of weathered Flysch bedrock covered by up to 12-meter thick surficial scree materials. It is characterized by high water table, small-scale instability problems and has the lower Safety Factor values according to slope stability analyses.
- Zone 5 represents soil formations and engineering geological conditions unsuitable for housing, due to active Karya landslide inside it.

**Figure 7 – Soil suitability division in village area and typical geotechnical columns of the three zones to which housing requirements were specified**

Several housing requirements and suggestive guidelines for housing were specified for Zones 3, 4 and 5 regarding foundation, excavation and drainage. Zone 4 was considered as the worst among them for housing. Specified requirements and guidelines aim to prevent from instability phenomena caused by static loading, ground water conditions or excavation. The general guidelines suggest:

- Avoidance of surficial fine-grained soils of Unit ID as foundation materials
- Avoidance of mechanical excavation in slopes with inclinations exceeding 35%. For slopes inclined less than 35%, a 3m maximum height of excavation is suggested supported with retaining walls.
- Surface water runoff with net of diversion ditches.
- Construction of interceptor drains parallel to the road sides.
- Protection and preservation of streamlets' flow zones.
