SOIL SUITABILITY ESTIMATION FOR HOUSING PURPOSES IN LANDSLIDE-PRONE AREAS. THE CASE OF KARYA VILLAGE, PATRAS, W. GREECE

Koukis G.¹, Sabatakakis N.¹, and Lainas S.¹

Abstract

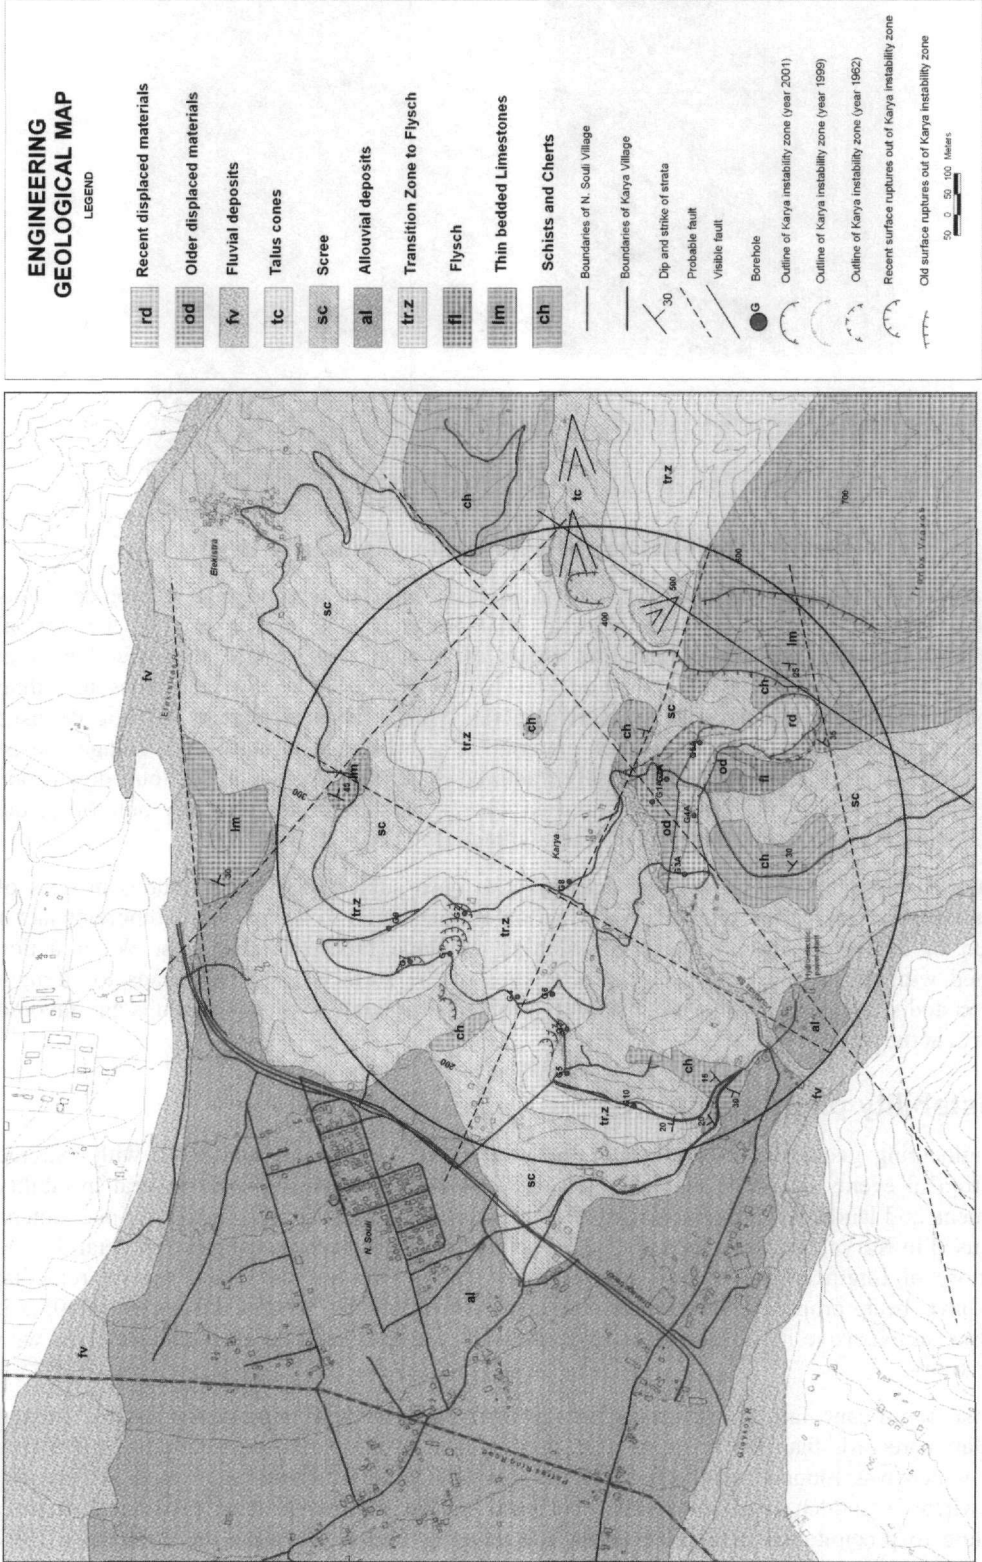
Figure 2 – Engineering geological map of Karya and Neo Souli villages area

The various formations encountered were classified into ten engineering geological units according to their relative age and physical characteristics. The lower part of the normal sedimentary sequence includes schists and cherts of Jurassic age, which are covered by thin bedded Cretaceous limestones. A transition zone is developed above the limestones including limestones, shales, scherts and marls, leading to the typical flysch sediments. Clastic deposits including scree and debris overlay bedrock materials. The hillslopes around Karya village consist mainly of scree and transition zone intensely fractured materials, whereas in N. Souli downslope area feature Pleistocene and Holocene deposits. Cherts and limestones typically outcrop at the mountaneous area near the SE margins of Karya village (Fig. 2).

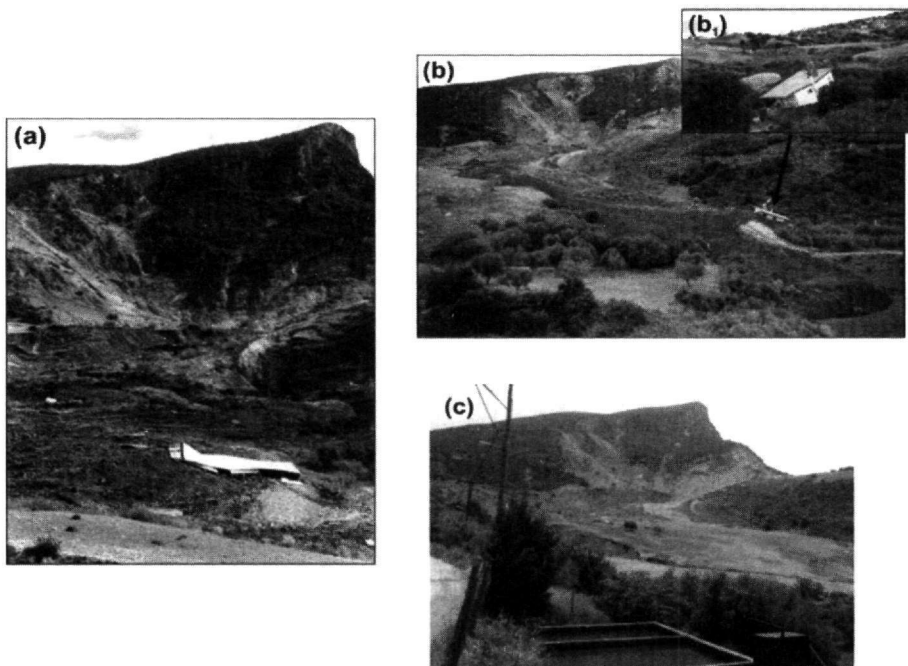
The first significant failure was recorded in 1962, a year with almost the double annual precipitation records than the previous year, and resulted to the partial destruction of old Karya village which was founded on the head of the landslide. The landslide reactivated in February 1999, where a sudden mass movement occurred during an intense and prolonged rainfall. According to precipitation data recorded by the gauging station of Patras the February's 1999

rainfall was 250 % greater than the mean monthly value. The event was a debris flow followed by a translational multiple slide involving recent debris, older sliding materials and weathered zone of Flysch. The main road connecting nearby villages was destroyed, while the streamlet at the base of the gully was blocked by debris materials forming a 4-meter deep lake.

In December 2001, an intense rainfall of about 94 mm in less than 24 hours resulted to a sudden failure of a large volume of debris material that triggered a new extensive landslide. The debris flowed rapidly on the slope causing a “tongue” of saturated material to slip down and overtop the slope face. A translational slide was also activated in the lower part of the landslide. A newly constructed house founded inside older sliding materials was totally destroyed, while the main road connecting nearby villages was destroyed for a second time.

The 2001 event is the latest reactivation of the landslide. During and after the construction of the remedial works inclinometer tubes were installed inside the landslide body. Their role was to access the effectiveness of the remedial works and indicate a probable reactivation of the landslide. An almost two-year period of systematic measurement (June 2003 till March 2005) showed a continuous movement in the central part of the instability zone (borehole G2A), particularly at depths of 7 and 19 m with maximum displacement of about 7.5 and 3.6 mm respectively. Based on the inclinometer data it can be assumed that the landslide area has not been stabilized after the latest events. According to (Cruden and Varnes 1996) it can be classified as an landslide of an extremely slow rate of movement.

Figure 3 – Karya Landslide (a) 1999 event, (b) 2001 event (b₁) damaged house and (c) current condition

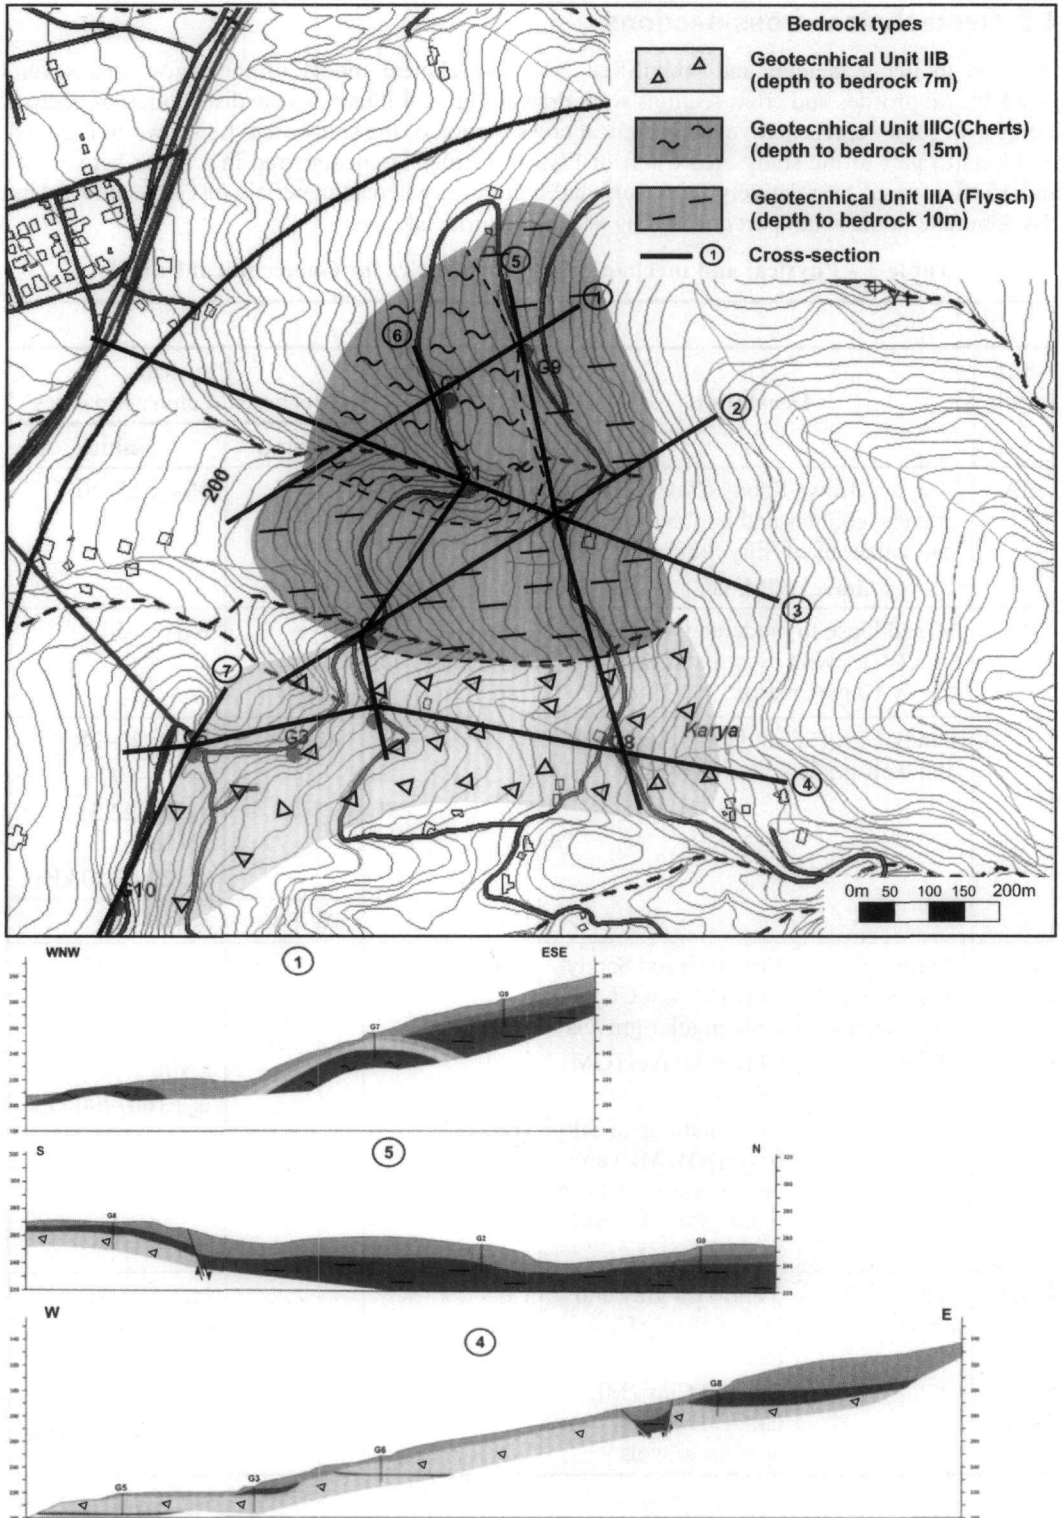
Figure 4 - Geotechnical cross-sections and distribution of bedrock types

In order to get a general and simplified 2-D geotechnical model of the study area several geotechnical profiles and cross sections were drawn. Figure 4 illustrates the distribution of bedrock along with some representative Geotechnical cross section of the study area. As shown in Figure 4, in the north part of the study area Chert of Flysch bedrock is encountered in a depth between 10 and 15 m covered by relatively thick surficial materials, whereas materials of Geotechnical Unit IIB dominate in the south part covered by a 7-meter surficial cover.

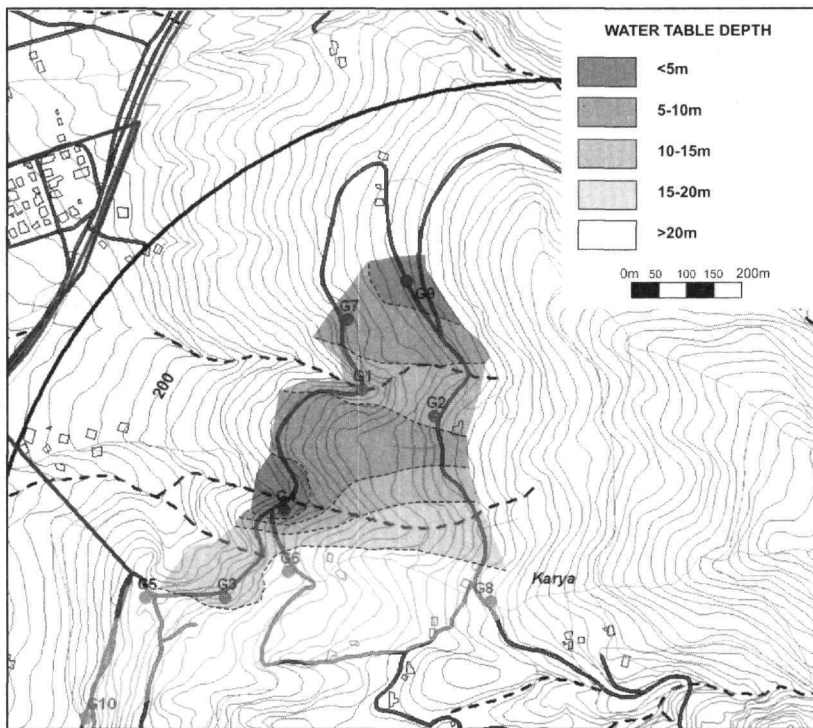
Figure 5–Water table depth distribution

Water table depth measurements saw differential groundwater conditions between the north and the south part of the study area. Moderate to high water table (less than 10m from surface) was measured in the north part sometimes near soil surface. On the other hand, the south part is characterized by low water table (more than 15 m from surface) or absence of water up to 20 meters (Fig. 5). The impermeable Flysch or Chert bedrock contributes to high water table conditions, whereas the intensely fractured and more permeable materials of Geotechnical Unit II are characterized by low water table or regional dry conditions.

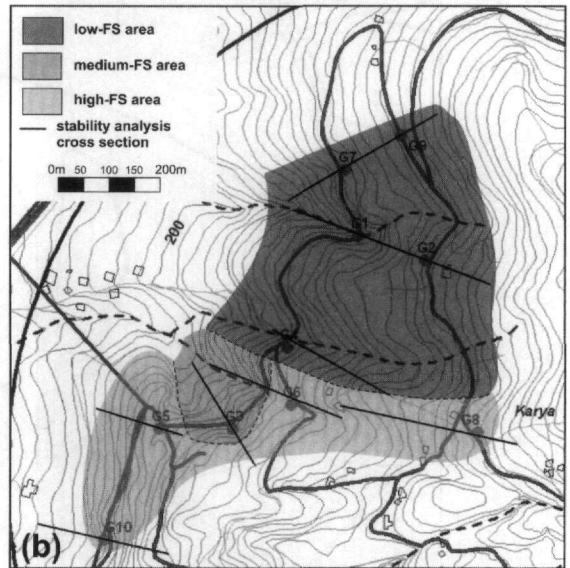
Figure 6 – (a) Slope stability analyses results (b) distribution of estimated Safety Factors

As shown in Figure 6, low Safety Factor values were computed in the north part of the area so, according to the results, it is more susceptible than the rest region for instability problems under extremely high pore-water pressure conditions, caused by heavy and prolonged rainfalls.

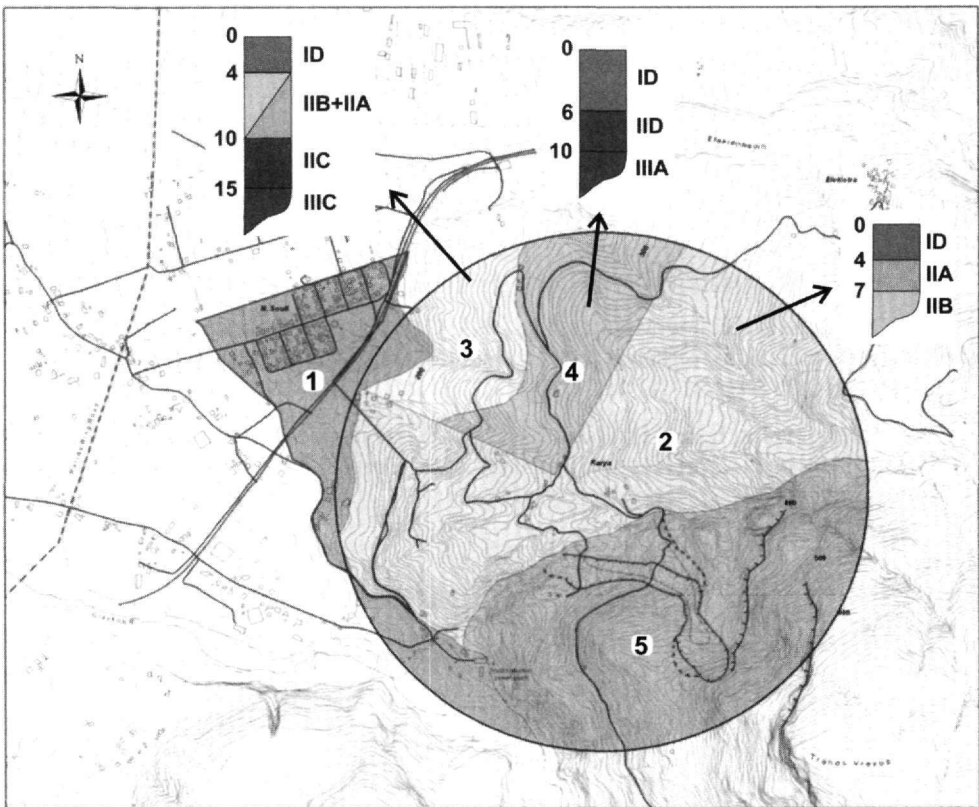
Figure 7 – Soil suitability division in village area and typical geotechnical columns of the three zones to which housing requirements were specified

Based on the engineering geological and geotechnical investigation the village area was finally divided into five zones according to the encountered ground for housing purposes (Fig. 7):

- Zone 1 was classified as suitable for housing since it is relative flat, it consists of stiff recent Pleistocene-Holocene deposits and has not instability problems.
- Zone 2 consists of coarse grained Unit IIB materials covered by up to 5 m-thick scree and weathered materials. It is characterized by low water table, absence of instability problems and has relatively high Safety Factor values according to slope stability analyses.
- Zone 3 consists of weathered Chert bedrock covered by about 4-meter thick surfacial materials and 11-meter thick various intensely fractured materials of Unit II. It is characterized by high water table, small-scale instability problems and lower Safety Factor values according to slope stability analyses.

- Zone 4 consists of weathered Flysch bedrock covered by up to 12-meter thick surficial scree materials. It is characterized by high water table, small-scale instability problems and has the lower Safety Factor values according to slope stability analyses.
- Zone 5 represents soil formations and engineering geological conditions unsuitable for housing, due to active Karya landslide inside it.

Several housing requirements and suggestive guidelines for housing were specified for Zones 3, 4 and 5 regarding foundation, excavation and drainage. Zone 4 was considered as the worst among them for housing. Specified requirements and guidelines aim to prevent from instability phenomena caused by static loading, ground water conditions or excavation. The general guidelines suggest:

- Avoidance of surficial fine-grained soils of Unit ID as foundation materials
- Avoidance of mechanical excavation in slopes with inclinations exceeding 35%. For slopes inclined less than 35%, a 3m maximum height of excavation is suggested supported with retaining walls.
- Surface water runoff with net of diversion ditches.
- Construction of interceptor drains parallel to the road sides.
- Protection and preservation of streamlets' flow zones.
