SAFETY ASSESSMENT AND PROTECTION OF MONUMENTS LOCATED IN CAVES – A CASE STUDY FROM THE CITY OF VOLOS, GREECE

Loupasakis C.¹, and Nikolaou N.¹

Abstract

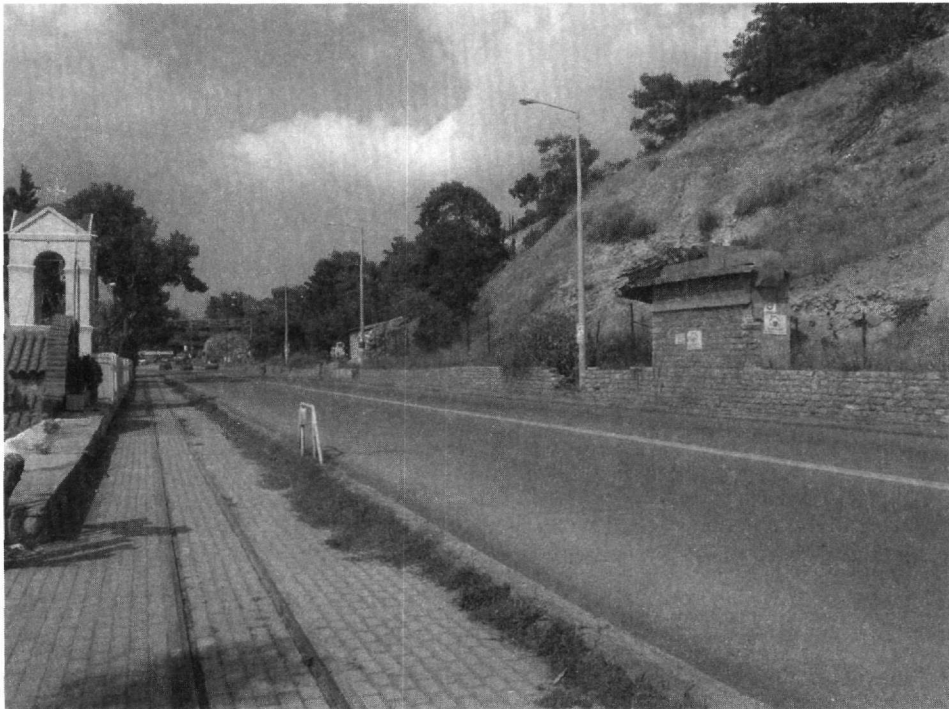
Figure 3 - The national road and the railway line passing over the ceiling of the cave

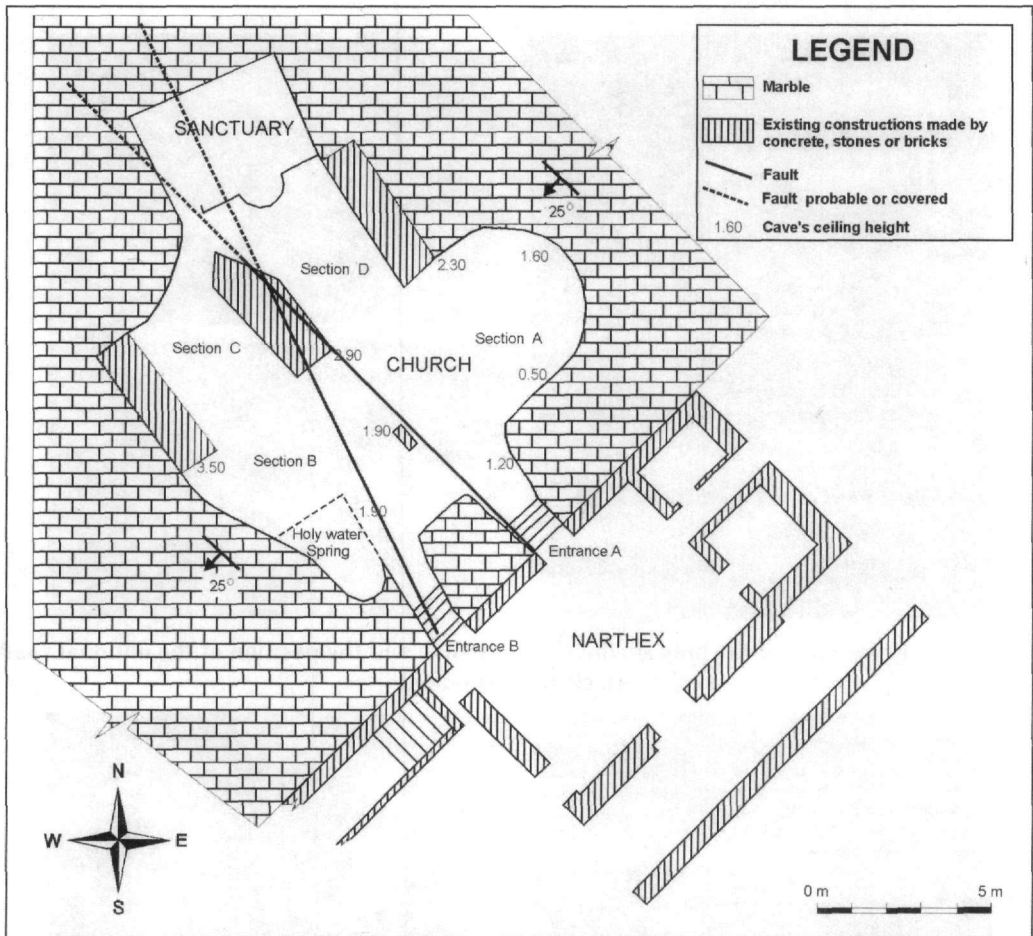
The cave is intersected by two faults, F_1 : 334/82 and F_2 : 315/70 (Fig. 4). The generation mechanism of the cave is related directly with the existence of those faults. As mentioned before

Figure 4 - Top view of the holy shrine presenting the morphological and the geological settings of the cave

Based on the stability of the roof, the cave can be distinguished in two main sections. The first one includes sections C, D and the Sanctuary and the second one the sections A and B. The main difference between the two sections is the distance between the ceiling of the cave and the level of the over crossing road. The inner section of the cave (consisting of sections C, D and the Sanctuary) is higher and as a result the marble layer on the ceiling is thin. On the contrary, the outer section of the cave (consisting of sections A and B) is shorter and the marble layer is much thicker. Generally, the height of the cave decrease respectively to the dip direction of the bedding and the thickness of the marble on the roof decrease proportionally to the height (Fig. 4).

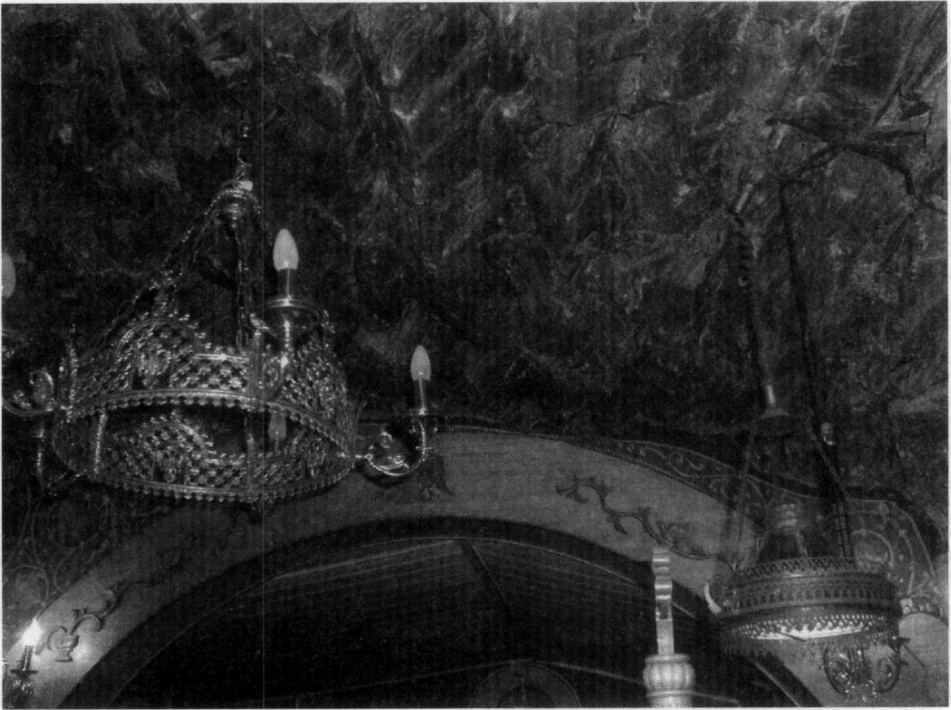
The reduced thickness of the marble layer on the ceiling of several sections caused, in the past, serious stability problems. Those problems were probably located during or right after the construction of the over crossing road and they led to the construction of rigid arcs consisting of marble blocks and concrete. In figure 4 it is shown that those arcs extent only in the sections C, D and the Sanctuary. Sections C and D are separated by a column constructed in the middle of the inner section in order to decrease the span between the walls and in order to increase the bearing capacity of the arcs. The Sanctuary, because of its reduced size, is supported only by one arc. The inner section of the cave is sufficiently supported by those arcs. The oversized columns, the reduced height of the cave and the reduced span of the arcs provide a stable and safe environment. No rock falls have been reported in this section of the cave.

Those arcs are covered by stones of the surrounding marble, by wood or by hagiography and they fit completely with the interior of the holy shrine. Figure 5 presents a view of the ceiling on section D and on the Sanctuary (section D is covered by marble stones and the Sanctuary is covered by wood). Also, figure 6 presents a side view of the arc covered by hagiography.

Figure 5 - Ceiling view of the Sanctuary and of section D. Sections supported by rigid arcs constructed by marble blocks and concrete. The Sanctuary is covered additionally by wood

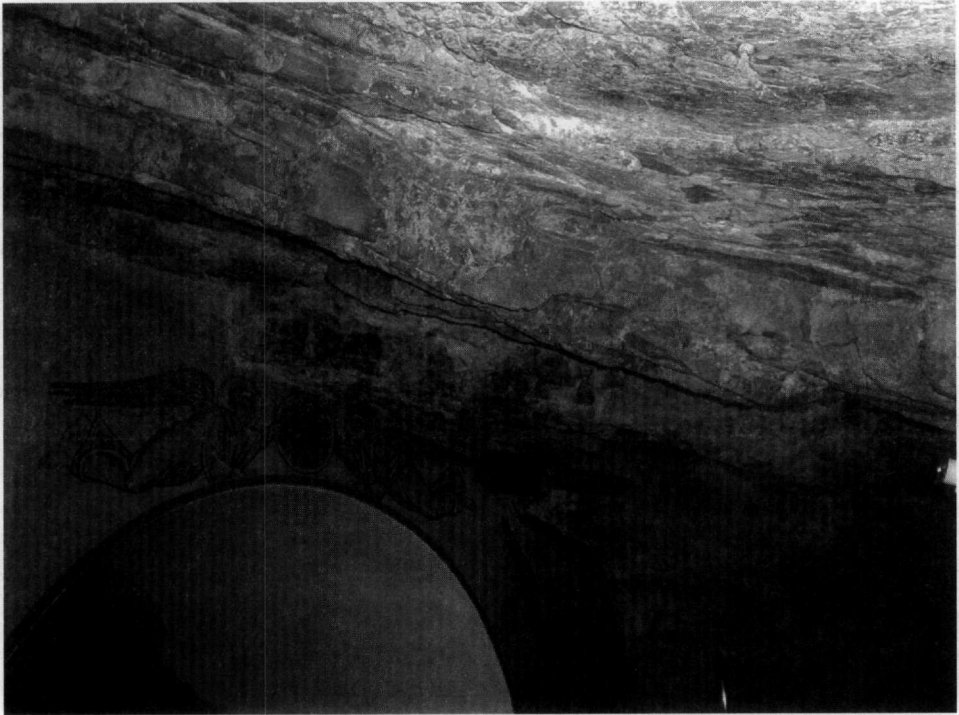
The outer section of the cave is unsupported and the shape of the ceiling is completely formed by the bedding surfaces. Although that, the mechanical characteristics of the marble rock mass are very good, the intersection of the cave's roof by the faults, the relatively large unsupported bedding plates and the extensive spans between the walls of the section generated several stability problems.

Figure 6 - Ceiling view of section A. Unsupported Section. This picture clearly presents a side view of the arc supporting section D, covered by hagiography

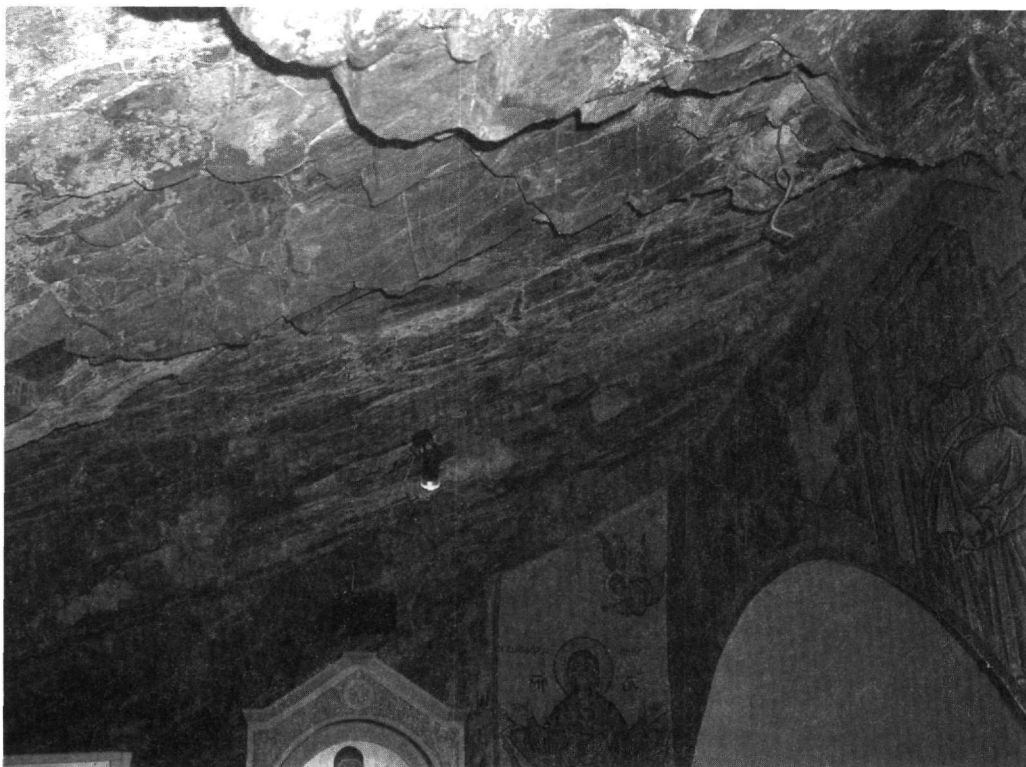
According to the church-wardens, numerous small to medium size gravels failed from the ceiling during the last year, causing relatively small damages to the floor and to the pews of the church. Luckily no injuries were reported. Those gravels were detached from the areas surrounding the two faults and from the north western corner of section B (Fig. 7). Mylonitic materials or joints with very low spacing characterize the intensive fracturing of the rock mass in those areas.

Figure 7 - Ceiling view of section B. Unsupported Section. The north western corner of the section, appearing the rock falls, is clearly presented

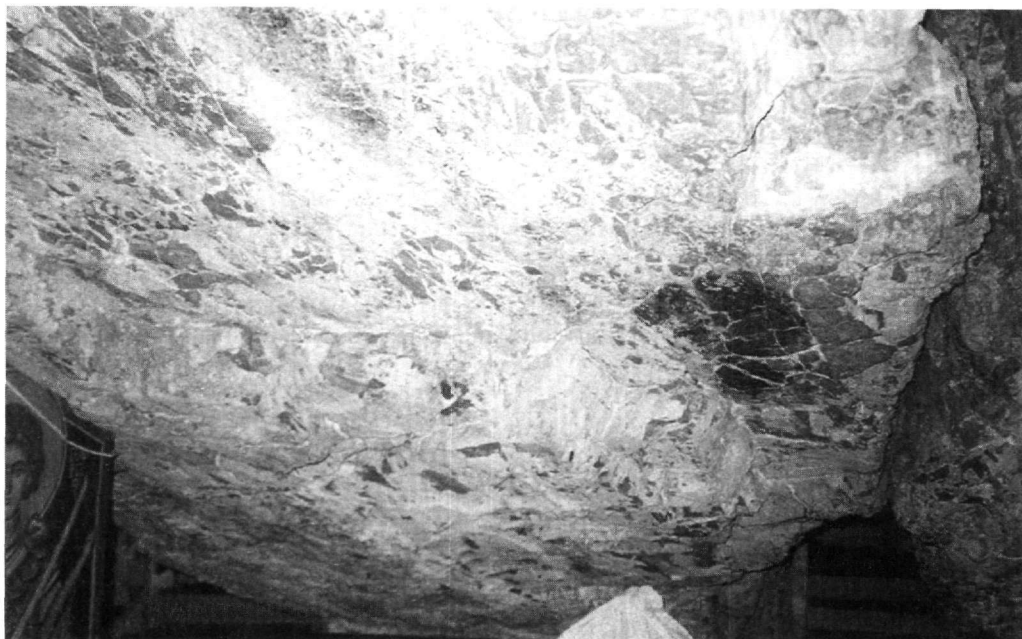
The stability of the wedge does not appear to be a threat because it is supported by three columns. Two of them are constructed by concrete or by marble stones and concrete and the other one constitutes a natural extension of the wedge's marble. Those columns are clearly presented in figure 9.

Figure 8 - View of the wedge formed by the faults intersecting the cave. The concrete column constructed for the support of the wedge is visible on the left side of the figure

- Installation and systematic observation of geodesic mark along the ceiling of the cave, for the prevention of large rock mass movements. Although that, the stability of the wedge does not appear to cause any problems, all extra precautional measures must be taken in order to reassure the safety of the numerous visitors.

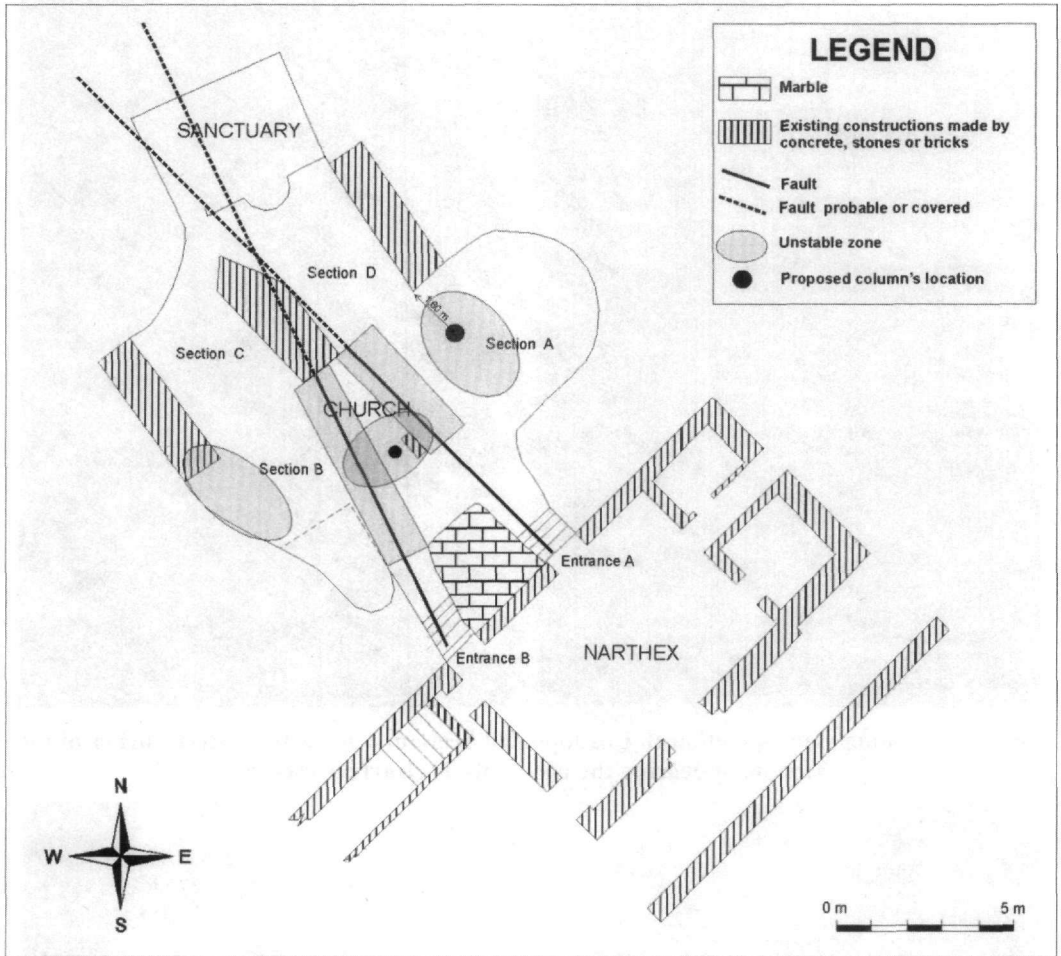
Except from the areas with the intensive fracturing, there were located two areas where gradual bending of the bedding plates and proportional loosening of the rockmass along the bedding surfaces is observed. Those areas are located in the middle of wide unsupported arcs. The first one of the above mentioned arcs is located in the middle of section A and the second in the middle of the wedge located between sections A and B (Fig. 8). Although that, along the wedge a concrete column was constructed for the prevention of the loosening of the rock mass, the position and the orientation of the column did not efface the problem. The exact locations of all the above mentioned unstable areas are pointed on the top view of figure 9.

Figure 9 - Top view of the holy shrine presenting the position of the unstable zones and the proposed support measures (Loupasakis and Nikolaou 2005)

- Construction of one concrete column in the middle of each one of the two unsupported arcs, for the prevention of the rock mass loosening. The exact locations of the columns are presented in the top view of figure 9.
- Systematic inspection and removal of the over hanging rock blocks, especially along the intensively fractured zones. The rock blocks must be removed without the imposition of force which can cause further loosening of the rock mass.
- Application of soldering resins along the zones with the mylonitic materials. The intensive fracturing of the rock mass along the faults makes the hand collection of the blocks impossible.
