Post-earthquake assessment of monumental building in Croatia by 3Muri software

Roko Žarnić¹ and Vlatka Rajčić²

Abstract. A series of earthquakes in and close to city of Zagreb, Croatia during the 2020 severely damaged the masonry cultural heritage buildings built in the 19th century. The article presents the assessment of post-earthquake design of retrofitting of damaged historic masonry structure of the former synagogue in city of Sisak, Croatia erected in 1890. The former synagogue was severely damaged during the recent earthquake. For the purposes of the post-earthquake retrofitting and strengthening, an analysis of the damaged and retrofitted structure has been carried out to justify the selected retrofitting measures that included a partial reconstruction of heavily damaged structure. The equivalent frame model based on the discretization in terms of piers and spandrels was created (SEM - Structural Elements Model) to obtain the simulation of earthquake response of structure using the 3Muri 13.9 software. In this paper the procedure and results of the analysis of seismic resistance of the strengthened structure is presented because of the successful cooperation of structural

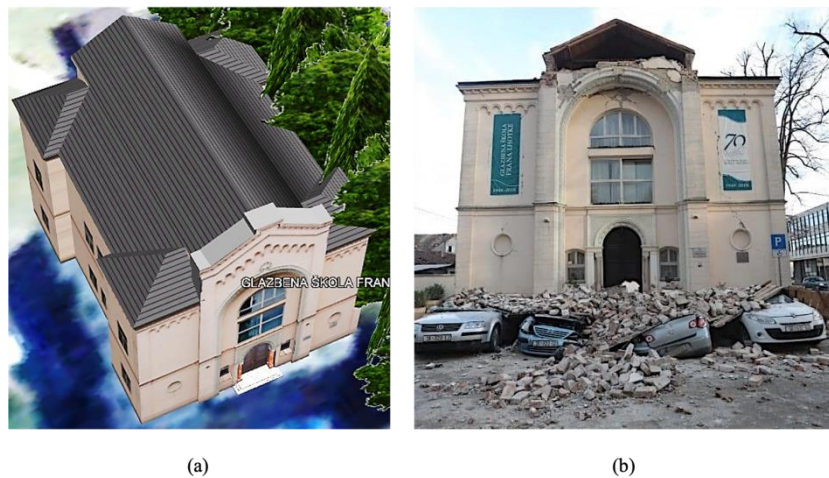
Fig. 2. Building before (a) and its front façade after (b) the earthquake of December 2020

Earthquake of 29. December 2020 seriously damaged masonry walls. Gamble of western façade collapsed and façade walls severely cracked (Fig.2 (b)). Other façade walls sustained less damages concentrated merely along the contacts of original and infilled parts of walls in the original openings. Similar patterns of damage developed in the first-floor walls (Fig.4 (a)) where masonry arches cracked along their perimeter lines. Lightweight timber dome (Fig.4 (b)) supported by masonry arches remained undamaged. In general, the western massive part of buildings sustained mayor structural damages. Assumably it may be the consequence of tilting of the western part of building due to local ground properties where phenomenon of liquefaction might develop during the earthquake excitation.

Learning from the earthquake response of building the concept of partial reconstruction and retrofitting was developed as joint endeavor of asset owner, architects, conservators, and structural engineers. The main suggestion of structural engineers was to use lightweight materials where possible to reduce future inertial horizontal forces due to earthquake excitation and to reduce vertical loading transferred to problematic ground.

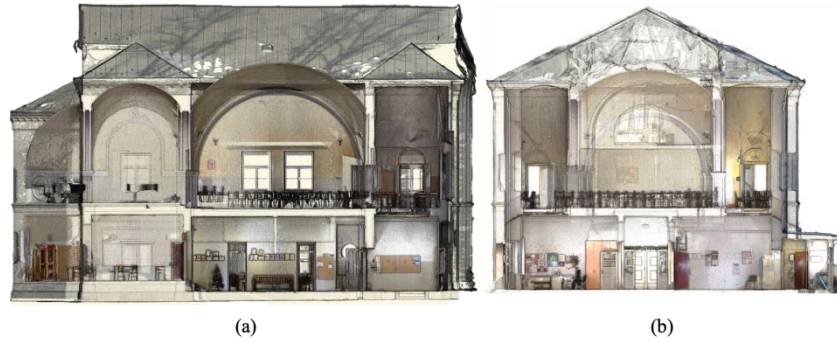
After expropriation of synagogue during the WW2, the ground floor interior was changed by adding partition walls of different thickness. The central open space was divided in height by massive new floor structures (see Fig.3(a)). Façade windows were partially or entirely closed by masonry infills. The massive masonry arches supporting the timber domes and domes themselves were preserved in the original form while passages between rooms were partially or entirely closed (see Fig.4).

Fig. 3. Longitudinal (East-West) (a) and lateral (South-North)(b) cross-section of building acquired from 3D point cloud model after earthquake of December 2020

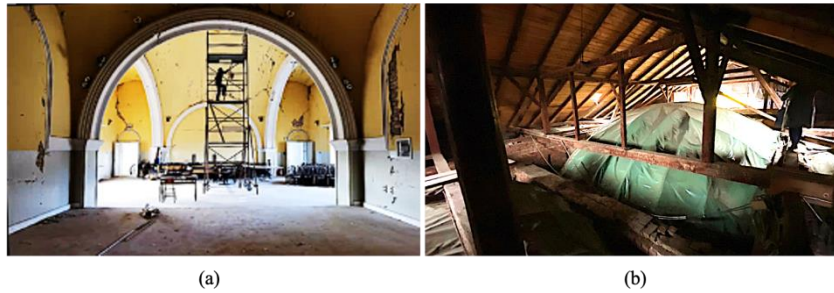
Fig. 4. The first floor (view towards West) damaged by the December 2020 earthquake (a) and attic with upper surface of the main timber dome (view towards West) (b)

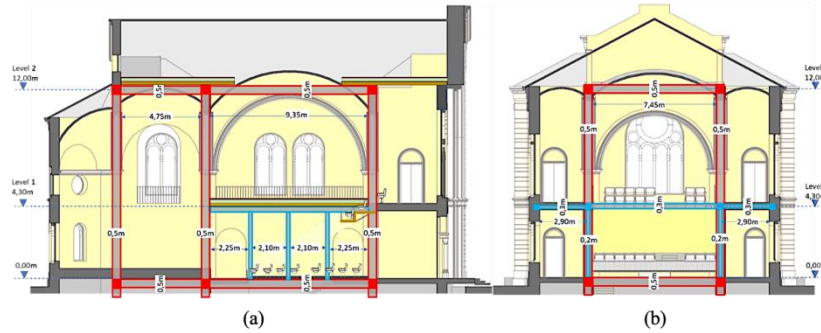
Fig. 5. Concept of retrofitted and added structural elements: longitudinal (East-West) (a) and lateral (South-North)(b) cross-section of building.

- Removal of ground floor inner walls, floor structures above the ground floor and walls of the first floor including masonry arches, timber domes and roof structure.
- Restoring window openings on the ground floor to their original shape adding the r.c. encirclements.

- Repairing of ground floor façade walls by grouting and partial replacing of weak mortar and construction of the inner r.c. frames (see Fig.5) and laying of horizontal r.c. tie beams atop the repaired ground floor façade walls.
- Construction of the first-floor inner masonry walls and façade walls extended to roof knee and gable walls with horizontal r.c. tie beams.
- Installation of laminated timber arches and domes on the first floor and CLT floor diaphragms (see Fig.6). Poz.1 and 2 are 15 cm thick CLT panel, Poz. 3 is 18 cm thick CLT panel, Poz. 4, 5 and 6 are timber domes.

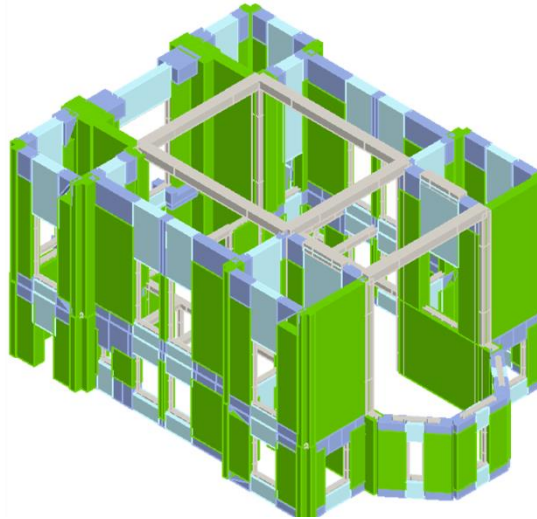
In addition to seismic analysis, 3Muri program enables the static analysis. Load bearing capacity of masonry is checked according to Eurocode 6. In herein described case, all walls and reinforced concrete element meets required capacity as it is presented in Fig.11. In table below N_{ed} represents the design value of the applied axial force on the masonry pier, while N_{Rd} represents the resistance of the masonry pier to the applied force. All piers satisfy the requested criteria, since the ratio $N_{ed} / N_{Rd} < 1.0$. Parameter h_{ef} refers to the effective height of masonry pier and t_{ef} stands for the effective thickness of masonry element. The limit slenderness ratio h_{ef} / t_{ef} should not exceed the value of 20 for the unreinforced masonry. In our case the values are just slightly exceeded at some masonry piers.

Fig. 11. Results of static analysis of structure

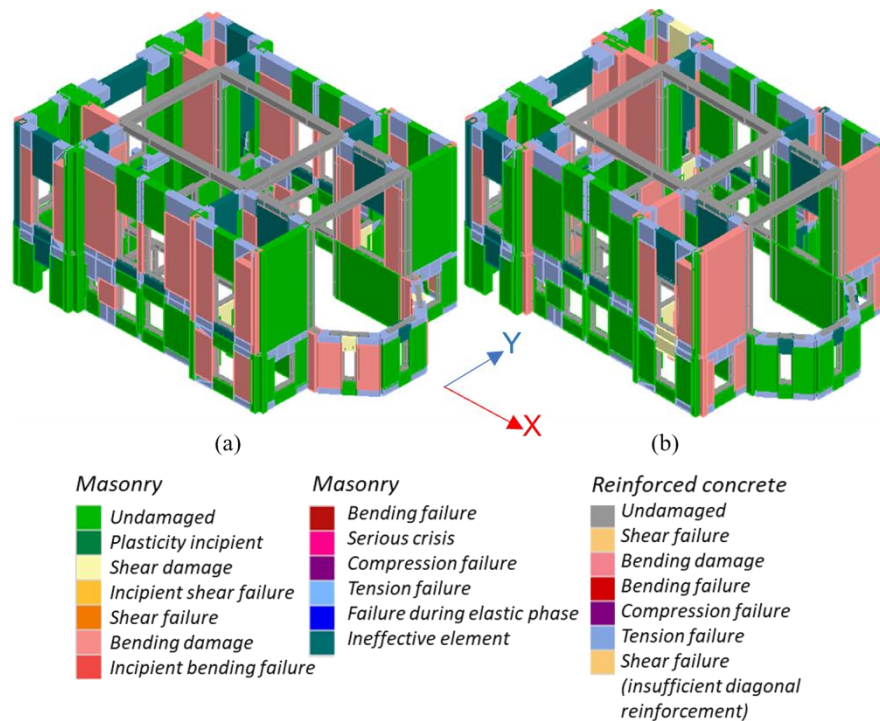
The distribution of damages at significant damage (SD) limit state due to action of earthquake action in longitudinal (X) and transversal (Y) direction is presented in Fig. 12 where the legend of different damage stages of structural elements is added. More than half of masonry piers and walls as well as all reinforced concrete columns and beams are undamaged. The rest of masonry pier suffered shear failures that did not jeopardize the stability and integrity of structure as a whole. The global stability and integrity of the structure is provided by the strong inner reinforced concrete frames.

Fig. 12. Damage pattern of structural elements resulted from the seismic analysis at achieved story displacement d of 48.8 mm and base shear force V of 3.20 MN in X direction (a) and story displacement d of 115.0 mm and base shear force V of 2.39 MN in Y direction (b).

The presented damage pattern of structural elements provides information on the critical parts of building and its global response to earthquake action. This information is crucial for the design of structure as whole because the weak parts can be identified and strengthened if needed. However, in the presented case there is no need for further strengthening of structural element because in configuration as presented it fulfills the requirements of Eurocode 8 as justified by data in Table 3 above.
