Post-earthquake assessment of monumental building in Croatia by 3Muri software

Roko Zarnic, Vlatka Rajcic

Keywords: Earthquake 2020 Croatia, Monumental Building, Retrofitting, Structural Elements Model, Assessment, 3Muri program

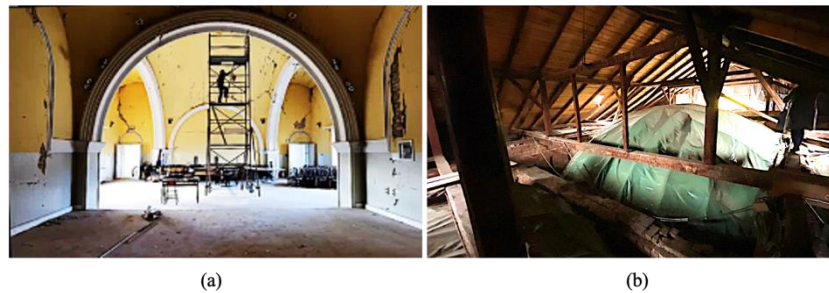
Fig. 4. The first floor (view towards West) damaged by the December 2020 earthquake (a) and attic with upper surface of the main timber dome (view towards West) (b)

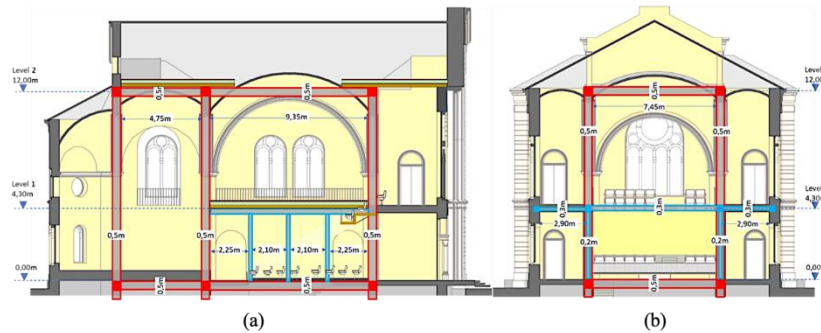
Fig. 5. Concept of retrofitted and added structural elements: longitudinal (East-West) (a) and lateral (South-North)(b) cross-section of building.

- Removal of ground floor inner walls, floor structures above the ground floor and walls of the first floor including masonry arches, timber domes and roof structure.
- Restoring window openings on the ground floor to their original shape adding the r.c. encirclements.

- Repairing of ground floor façade walls by grouting and partial replacing of weak mortar and construction of the inner r.c. frames (see Fig.5) and laying of horizontal r.c. tie beams atop the repaired ground floor façade walls.
- Construction of the first-floor inner masonry walls and façade walls extended to roof knee and gable walls with horizontal r.c. tie beams.
- Installation of laminated timber arches and domes on the first floor and CLT floor diaphragms (see Fig.6). Poz.1 and 2 are 15 cm thick CLT panel, Poz. 3 is 18 cm thick CLT panel, Poz. 4, 5 and 6 are timber domes.

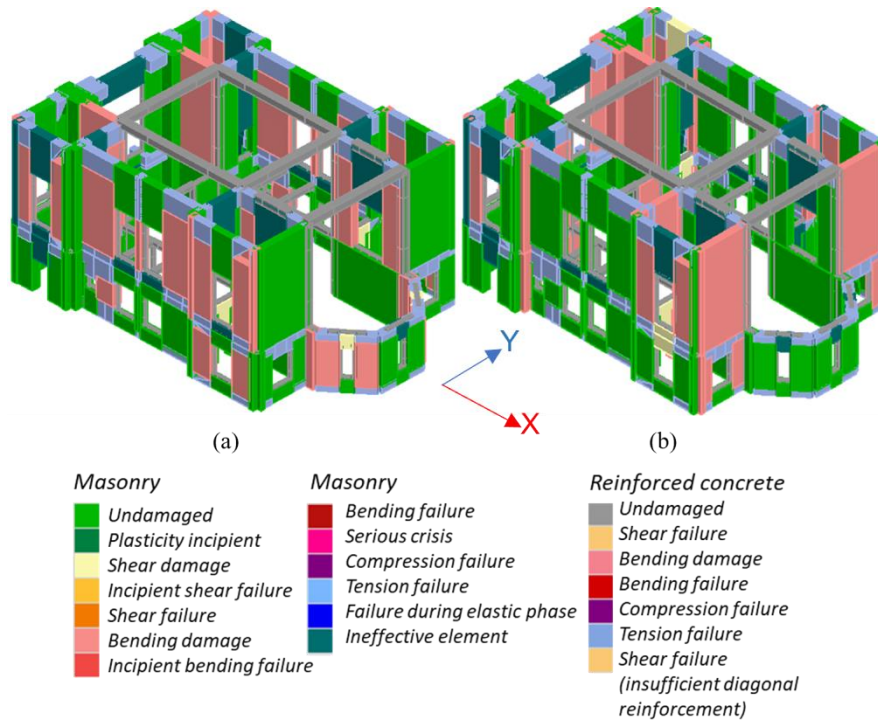
The distribution of damages at significant damage (SD) limit state due to action of earthquake action in longitudinal (X) and transversal (Y) direction is presented in Fig. 12 where the legend of different damage stages of structural elements is added. More than half of masonry piers and walls as well as all reinforced concrete columns and beams are undamaged. The rest of masonry pier suffered shear failures that did not jeopardize the stability and integrity of structure as a whole. The global stability and integrity of the structure is provided by the strong inner reinforced concrete frames.

Fig. 12. Damage pattern of structural elements resulted from the seismic analysis at achieved story displacement d of 48.8 mm and base shear force V of 3.20 MN in X direction (a) and story displacement d of 115.0 mm and base shear force V of 2.39 MN in Y direction (b).

The presented damage pattern of structural elements provides information on the critical parts of building and its global response to earthquake action. This information is crucial for the design of structure as whole because the weak parts can be identified and strengthened if needed. However, in the presented case there is no need for further strengthening of structural element because in configuration as presented it fulfills the requirements of Eurocode 8 as justified by data in Table 3 above.
