Technical Annals

Vol 1, No 3 (2023)

The interventions for the main dome of Hagia Sophia throughout its history and a preservation proposal

Hasan Fırat Diker, Mehmet Halis Günel, Beyza Kapucu Güzelbulut

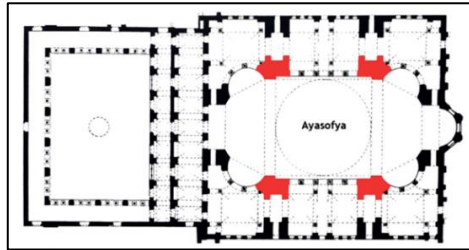
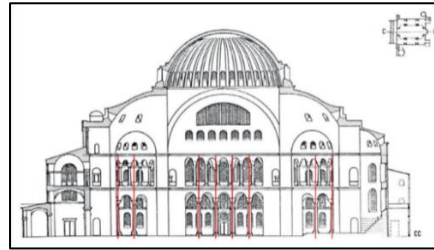
Despite the symmetrical placement of the four piers supporting the main dome, their asymmetric edges in multiple directions pose challenges in equitably withstanding horizontal loads. The arrangement makes it challenging to unify them, adversely impacting the structure's earthquake resistance [1]. Another evident static issue, notably observed

in the southeast-northwest section, lies in the columns' numerical arrangement between the ground and gallery floors. The ground floor features a 5-arcade arrangement between the main buttresses, whereas the gallery floor exhibits a pattern of 7 arcades. This discrepancy, stemming from the varied column sizes between floors, disrupts the vertical load transfer from the main dome and body walls in an intermittent and discontinuous manner [2] (see Fig. 1-2 [3]).

Fig. 1. Main piers in the plan of Hagia Sophia **Fig. 2.** Northwest-southeast cross-section
(Impressions in red are made by the authors.)

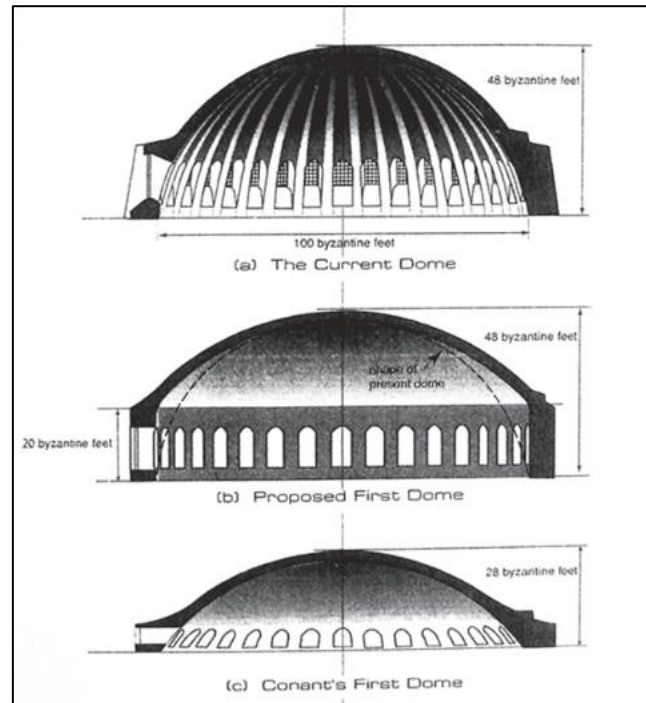
Following the earthquakes in August 553 and December 557, both the main dome and the southeastern semi-dome collapsed [4] due to a 6 magnitude earthquake on May 7, 558 [5] around 21 years after the consecration of Hagia Sophia. This destruction was linked to multiple factors, including the inadequate curvature in the initial dome's design, deformation of the main supporting pillars, and distortion of the dome caused by shear forces [6, 7]. Emperor Justinian (r. 527-565), witnessing the dome's collapse during his reign, appointed Isidorus, a young architect and nephew of one of Hagia Sophia's initial architects, for repairs. The prevailing belief regarding the restoration activity on December 24, 563, was that it involved altering the dome's shape and increasing its height by 20 Byzantine feet (equivalent to approximately 6.24 meters) [7, 8]. However, recent research indicates that the modified design of the restored dome did not increase its height but maintained the same height while curving the tambour with the dome [6, 9, 10] (see Fig. 3 [9]).

Fig. 3. Sections of (a) the current dome, (b) proposed first dome, (c) pre-proposed first dome

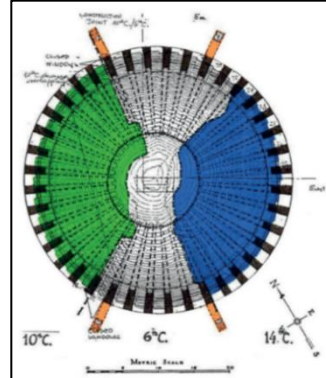
In the fall of 1343, a series of earthquakes struck the city, followed by another on October 6, 1344, resulting in structural weaknesses within Hagia Sophia. Subsequently, on May 19, 1346, one-third of the main dome collapsed along with the southeastern semi-dome. The restoration efforts were overseen by Stratopedarch Astras and Giovanni Peralta, with completion in 1354 [7]. Notably, within this repair, the main dome was supported by flying buttresses in four directions. These buttresses, displaying Gothic characteristics depicted in Hagia Sophia's descriptions, can be specifically attributed to the repairs in the 14th century (see Fig. 4 [12]). The integration of these flying buttresses with the connections of the remaining 6th-century dome and the reconstructions from the 10th and 14th centuries display the meaningful support they offered to the main dome (see Fig. 5 [2]).

Fig. 5. Flying buttresses colored in orange

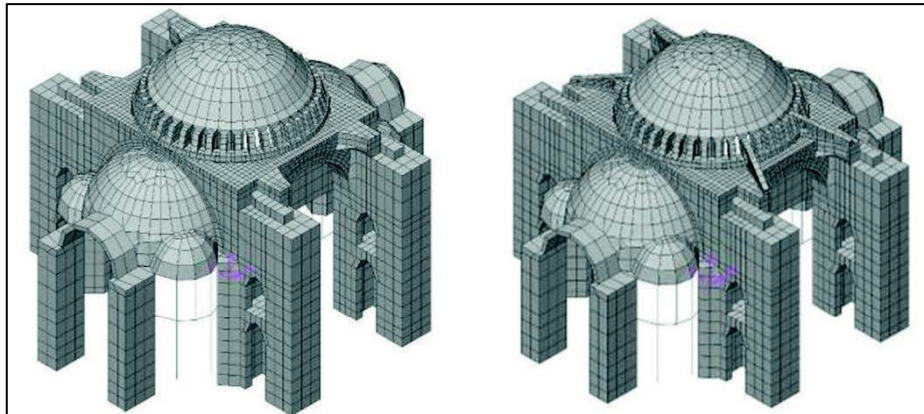
In the modeling work conducted in 2010 to investigate the functionality of the flying buttresses removed by the Fossati at Hagia Sophia, both the existing models and the structure itself were tested via static simulations using finite elements in a computer environment. The analysis aimed to examine the structural contribution of the buttresses to the main dome (see Fig. 8 [2]). This limited modeling study demonstrated that the flying buttresses serve an important structural function and contribute to the stability of the main dome [2, 16].

Fig. 8. View of the models of the current state and with the flying buttresses

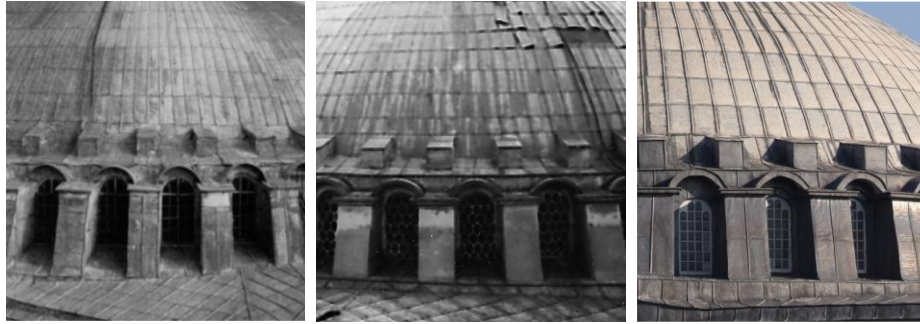
The most recent structural alteration to the main dome of Hagia Sophia involves the installation of vaults over the windows. A Japanese team from Tsukuba University identified these vaults as reinforced concrete elements in 1995 [17]. This intervention aligns with early 20th-century building technology. Historical records indicate that in 1909 [18], the windows appeared to be covered only with lead, whereas by 1936 [19], each window was observed to be covered with vaults similar to those seen today [20]

(see Fig. 9). While there isn't specific documentation detailing this intervention, visual evidence suggests that the installation of vaults over the windows likely occurred during the early years of the Turkish Republic, established in 1923.

Fig. 9. Detail views from the dome windows in row from 1909, 1936 and 2010.

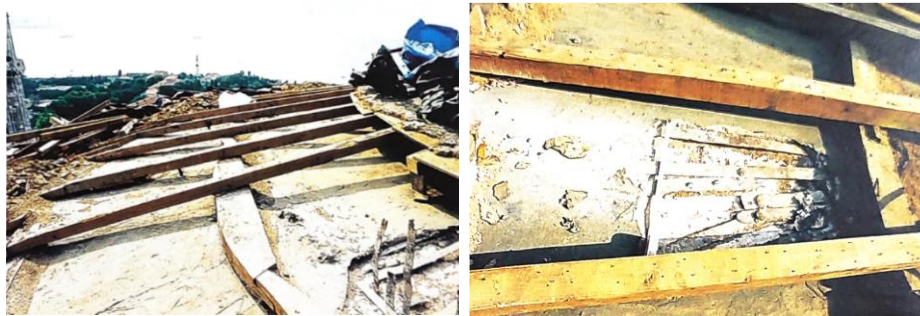
In a study conducted in 1993, it was observed that wooden construction was built on lower level to reduce the flatness of dome, which occurred due to the fact that the 10th century segment in the western part of the main dome was higher than the 6th century segment in the southern part of the dome about 10-12 cm (see Fig. 10 [17]). The effect of this intervention, which is understood to have been made to show the main dome of Hagia Sophia symmetrically, which is actually asymmetrical due to its repairs, in city silhouette, should be questioned in Hagia Sophia modelings.

Fig. 10. Views from the partial wooden sub construction under the lead cover

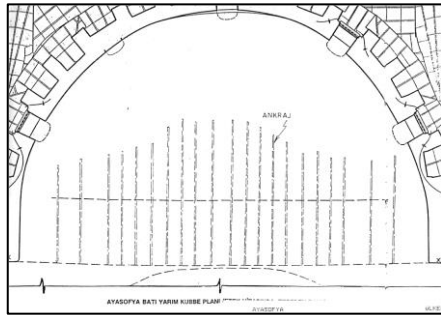
Fig. 11. Depiction of the anchors in plan

Fig. 12. Depiction of the anchors in cross-section

The last retrofitting project for the Hagia Sophia dome structure during the Republic period was proposed by Prof. Dr. Mustafa Erdik and Ülker Engineering and Consultancy in 1993 [14]. The proposal aimed to enable the semi-domes and main arches to work in unison during potential earthquakes by establishing a robust connection between them. The recommended method suggested for reinforcing the bond between the southeast and northwest main arches, upon which the semi-domes rely, was the use of anchors (see Fig. 11-12). The project proposed embedding the bodies of the anchors entirely into the semi-domes, with the heads designed to conceal the image without disrupting the facades of the southeast and northwest main arches. Modeling revealed that the planned anchoring bars would provide the required safety for the main dome. Despite this, the project was not accepted due to concerns about the radical structural interventions it would necessitate.

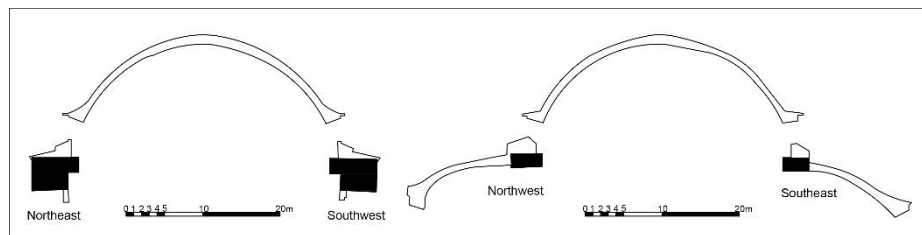
The significant disparity in cross-sectional areas—where the northwest arch measures less than 1/3 of the northeast and southwest arches, and the southeast arch

constitutes almost $\frac{1}{4}$ of their areas—highlights the structural issues within the main dome. Contrary to expectations, the cross-sectional areas of the northeastern and southwestern arches are not double that of the others. The notably thin sections of the northwest and especially southeast arches define the dome's asymmetrical structure, a result of its destruction and varied reconstruction over time. This structurally irreparable situation may be attributed to the reconstructions during the 10th and 14th centuries (see Fig. 13).

Fig. 13. The occupations of the main arches through the northeast-southwest and northwest-southeast cross-sections of the main dome

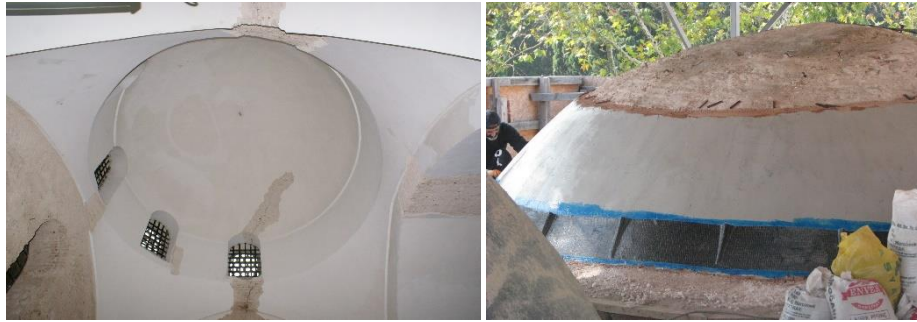
Topkapı Palace in 2009. The Outer Treasury that is a rectangular, one-story structure was built in the 16th century and covered with eight domes arranged in two rows. During the restoration process, the recent 20th-century concrete plasters inside the structure were completely removed, exposing the domes and walls along with traces of cracks. Over the centuries, ground movements might have exerted stress on the structure, potentially causing cracks above and below the domes. After extensive discussions, it was decided to reinforce each dome of the structure by applying carbon fiber tapes above the surface [28]. That intervention was one of the first CFRP uses for a cultural heritage in Istanbul after the earthquake in 1999 (see Fig.16).

Fig. 26. View from the crack under the dome and CFRP intervention above the dome.

The use of CFRP (Carbon Fiber Reinforced Polymer) as a tension ring may be the most suitable material for the dome due to its superficial features that won't alter its silhouette. This choice also allows CFRP to be concealed beneath the lead covering easily. Similar interventions were made for the domes of the Outer Treasury in the
