The interventions for the main dome of Hagia Sophia throughout its history and a preservation proposal

Abstract. Throughout its history, Hagia Sophia has faced seismic risks due to structural issues. The ambitious design led to the complete collapse of the main dome merely 21 years after its construction, and partial collapses occurred in the 10th and 14th centuries. Over time, the structure underwent various repairs and reinforcements. Following the collapse of the southeastern section during the 1346 earthquake, flying buttresses were installed, attaching to the main dome from four directions. However, during the Fossati repairs (1847-1849), these elements were removed and replaced with iron beams, framing the upper perimeter of the pedestal supporting the main dome. The current challenges faced by the main dome are primarily rooted in the design of the piers and arches rather than the dome itself. Since reconstructing these structural elements is impossible, efforts to address the dome's issues have concentrated on retrofitting the supporting system. This study critically assesses the current state of the main dome, examining past interventions. As a solution, it proposes reinf

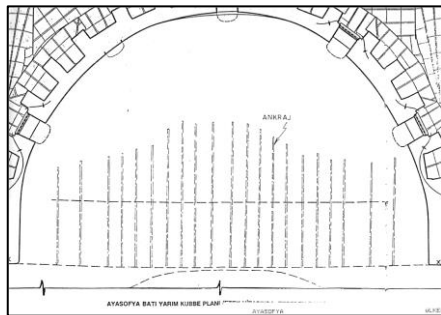
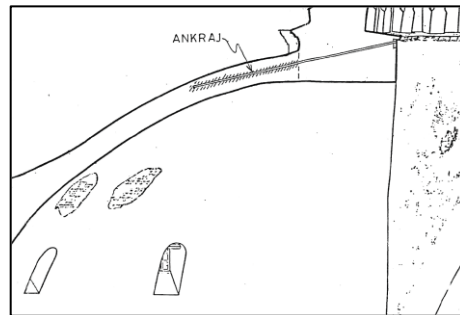
Fig. 11. Depiction of the anchors in plan

Fig. 12. Depiction of the anchors in cross-section

The last retrofitting project for the Hagia Sophia dome structure during the Republic period was proposed by Prof. Dr. Mustafa Erdik and Ülker Engineering and Consultancy in 1993 [14]. The proposal aimed to enable the semi-domes and main arches to work in unison during potential earthquakes by establishing a robust connection between them. The recommended method suggested for reinforcing the bond between the southeast and northwest main arches, upon which the semi-domes rely, was the use of anchors (see Fig. 11-12). The project proposed embedding the bodies of the anchors entirely into the semi-domes, with the heads designed to conceal the image without disrupting the facades of the southeast and northwest main arches. Modeling revealed that the planned anchoring bars would provide the required safety for the main dome. Despite this, the project was not accepted due to concerns about the radical structural interventions it would necessitate.

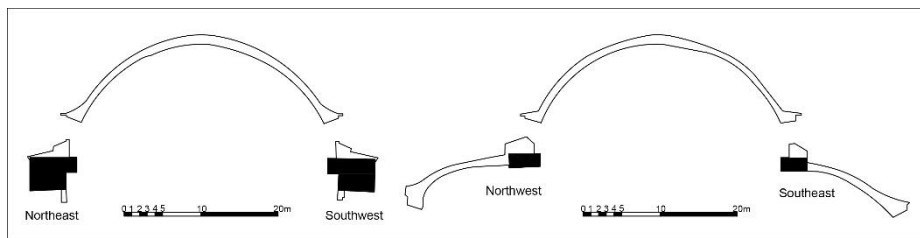
The significant disparity in cross-sectional areas—where the northwest arch measures less than 1/3 of the northeast and southwest arches, and the southeast arch

constitutes almost $\frac{1}{4}$ of their areas—highlights the structural issues within the main dome. Contrary to expectations, the cross-sectional areas of the northeastern and southwestern arches are not double that of the others. The notably thin sections of the northwest and especially southeast arches define the dome's asymmetrical structure, a result of its destruction and varied reconstruction over time. This structurally irreparable situation may be attributed to the reconstructions during the 10th and 14th centuries (see Fig. 13).

Fig. 13. The occupations of the main arches through the northeast-southwest and northwest-southeast cross-sections of the main dome

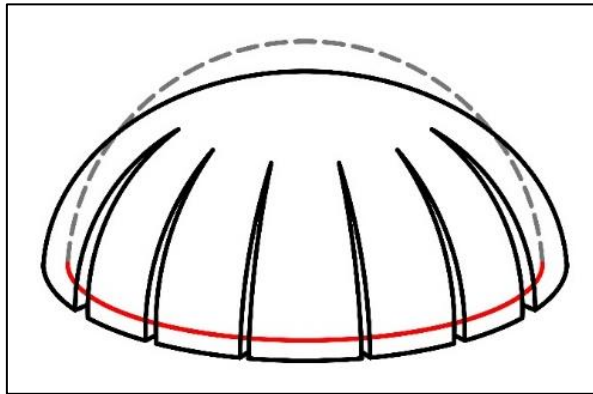
Fig. 14. Deformation of a dome: Tension ring preventing outward thrust

The application of ring beams is a fundamental strategy in the retrofitting of historical masonry structures [27]. In the context of Hagia Sophia, it is identified that the primary collapse mechanism involves the main arches and semi-domes. Results indicate that due to the thrust of the dome the thick arches on the northeastern and the southwestern sides deflect outward while on the southeastern and the northwestern sides, the upper parts of the semi-domes deflect inward. The thrust of the dome arises because of the hoop stresses (peripheral thrust) developed in the lower portion of the dome. To resist lateral thrust, the options include using exceptionally thick walls or, more commonly, employing diagonal support or tension rings at the base. Normally the tension-resisting ring is provided in tension zone to carry the horizontal thrust resulting from the hoop tension. The tension rings prevent the dome walls from thrusting outward (see Fig.14). To minimize the cross-sectional sizes of reinforcing materials, composite materials based on high-strength fibers, mainly carbon, are used. An important
