Vol 1, No 3 (2023)

The interventions for the main dome of Hagia Sophia throughout its history and a preservation proposal

Hasan Firat Diker, Mehmet Halis Günel, Beyza Kapucu Güzelbulut

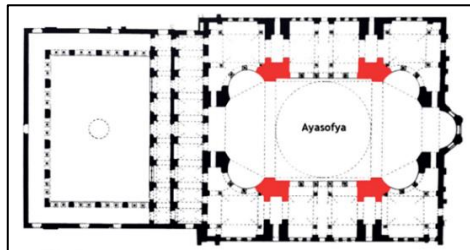
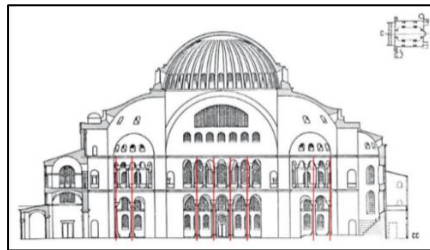
Despite the symmetrical placement of the four piers supporting the main dome, their asymmetric edges in multiple directions pose challenges in equitably withstanding horizontal loads. The arrangement makes it challenging to unify them, adversely impacting the structure's earthquake resistance [1]. Another evident static issue, notably observed

in the southeast-northwest section, lies in the columns' numerical arrangement between the ground and gallery floors. The ground floor features a 5-arcade arrangement between the main buttresses, whereas the gallery floor exhibits a pattern of 7 arcades. This discrepancy, stemming from the varied column sizes between floors, disrupts the vertical load transfer from the main dome and body walls in an intermittent and discontinuous manner [2] (see Fig. 1-2 [3]).

Fig. 1. Main piers in the plan of Hagia Sophia **Fig. 2.** Northwest-southeast cross-section
(Impressions in red are made by the authors.)

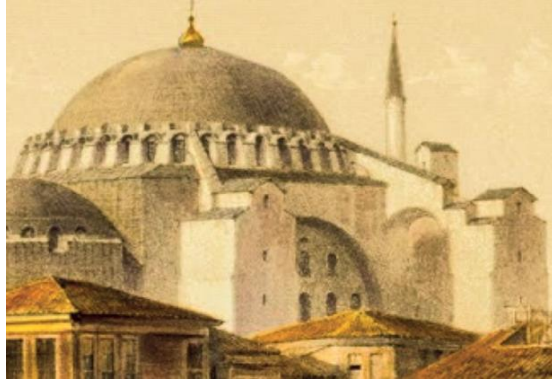
Fig. 4. Detail from Fossati's depiction before restoration

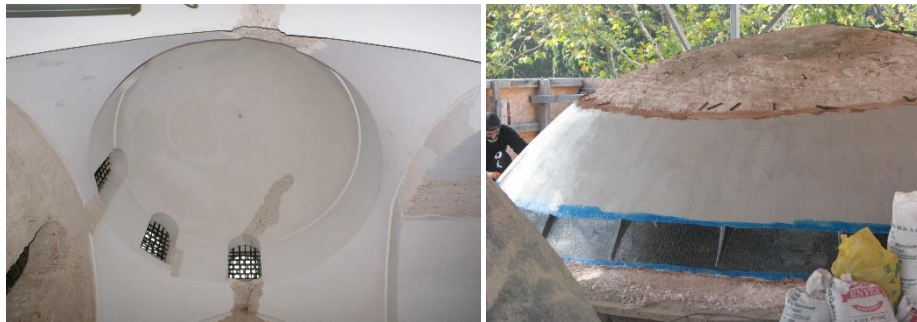
Topkapı Palace in 2009. The Outer Treasury that is a rectangular, one-story structure was built in the 16th century and covered with eight domes arranged in two rows. During the restoration process, the recent 20th-century concrete plasters inside the structure were completely removed, exposing the domes and walls along with traces of cracks. Over the centuries, ground movements might have exerted stress on the structure, potentially causing cracks above and below the domes. After extensive discussions, it was decided to reinforce each dome of the structure by applying carbon fiber tapes above the surface [28]. That intervention was one of the first CFRP uses for a cultural heritage in Istanbul after the earthquake in 1999 (see Fig.16).

Fig. 26. View from the crack under the dome and CFRP intervention above the dome.

The use of CFRP (Carbon Fiber Reinforced Polymer) as a tension ring may be the most suitable material for the dome due to its superficial features that won't alter its silhouette. This choice also allows CFRP to be concealed beneath the lead covering easily. Similar interventions were made for the domes of the Outer Treasury in the

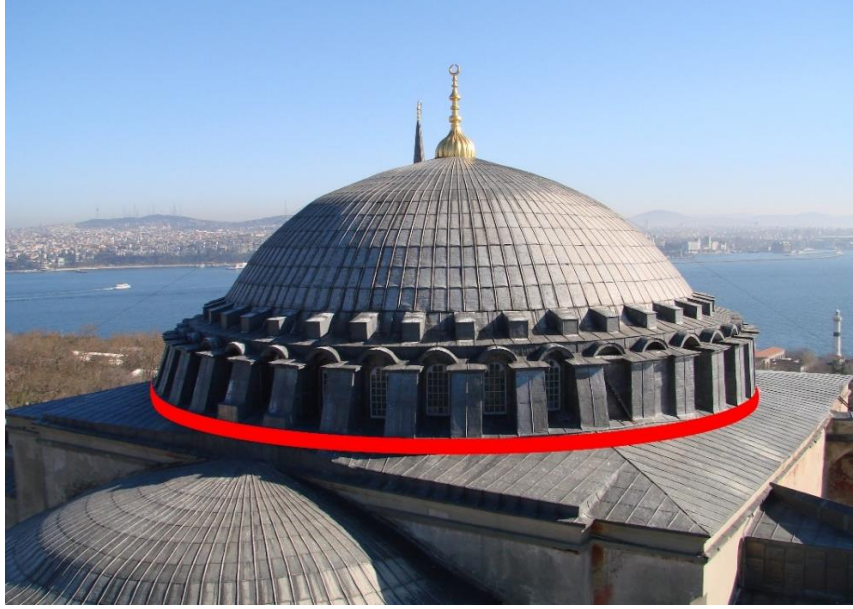
Fig. 17. Representation of the tension ring around the main dome of Hagia Sophia

Therefore, a comprehensive modeling study will prove the effect of using CFRP for the proposed tension ring, aiming to minimize interference with the visual integrity of Hagia Sophia. This proposal aims to deliver effective earthquake protection for the main dome of Hagia Sophia while preserving its appearance through the intervention of a ring of CFRP beneath the lead coverings. The preservation of Hagia Sophia's three-part structure, reflecting different historical periods, is crucial for its integrity (see Fig. 5). Hence, preservation efforts must align with its existing form, emphasizing retrofitting methods that uphold the dome's structural integrity and visual appeal. The study proposes a theoretical preservation method - tension ring encircling the main dome from the exterior (see Fig. 17). This proposed approach aims to provide supplementary support to the existing structure without altering its historical integrity, offering a potential solution to maintain its stability and safeguard its architectural significance.
