The interventions for the main dome of Hagia Sophia throughout its history and a preservation proposal

Keywords: Hagia Sophia; dome; arch; retrofitting; tension ring; earthquake

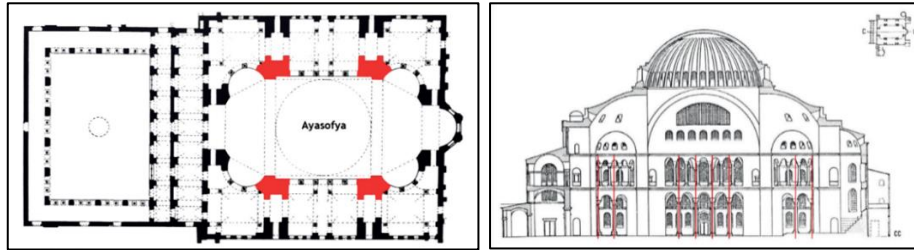
Despite the symmetrical placement of the four piers supporting the main dome, their asymmetric edges in multiple directions pose challenges in equitably withstanding horizontal loads. The arrangement makes it challenging to unify them, adversely impacting the structure's earthquake resistance [1]. Another evident static issue, notably observed

in the southeast-northwest section, lies in the columns' numerical arrangement between the ground and gallery floors. The ground floor features a 5-arcade arrangement between the main buttresses, whereas the gallery floor exhibits a pattern of 7 arcades. This discrepancy, stemming from the varied column sizes between floors, disrupts the vertical load transfer from the main dome and body walls in an intermittent and discontinuous manner [2] (see Fig. 1-2 [3]).

Fig. 1. Main piers in the plan of Hagia Sophia **Fig. 2.** Northwest-southeast cross-section
(Impressions in red are made by the authors.)

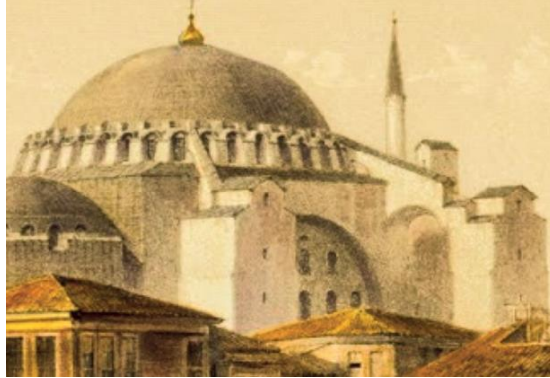
Fig. 4. Detail from Fossati's depiction before restoration

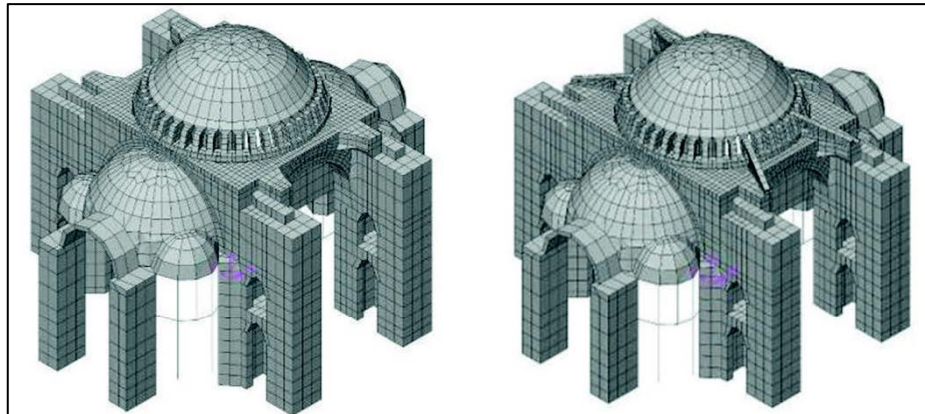
In the modeling work conducted in 2010 to investigate the functionality of the flying buttresses removed by the Fossati at Hagia Sophia, both the existing models and the structure itself were tested via static simulations using finite elements in a computer environment. The analysis aimed to examine the structural contribution of the buttresses to the main dome (see Fig. 8 [2]). This limited modeling study demonstrated that the flying buttresses serve an important structural function and contribute to the stability of the main dome [2, 16].

Fig. 8. View of the models of the current state and with the flying buttresses

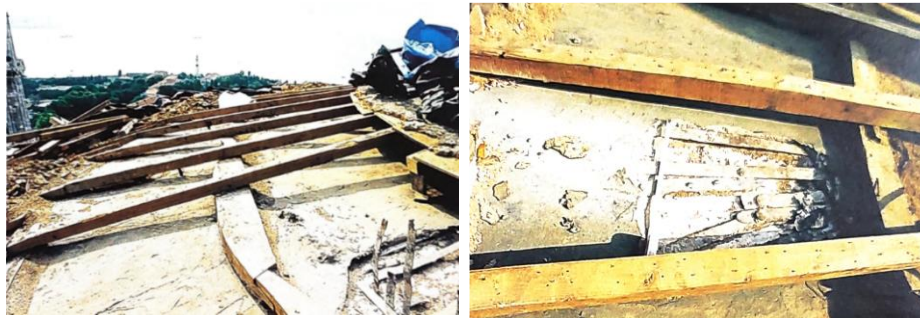
In a study conducted in 1993, it was observed that wooden construction was built on lower level to reduce the flatness of dome, which occurred due to the fact that the 10th century segment in the western part of the main dome was higher than the 6th century segment in the southern part of the dome about 10-12 cm (see Fig. 10 [17]). The effect of this intervention, which is understood to have been made to show the main dome of Hagia Sophia symmetrically, which is actually asymmetrical due to its repairs, in city silhouette, should be questioned in Hagia Sophia modelings.

Fig. 10. Views from the partial wooden sub construction under the lead cover

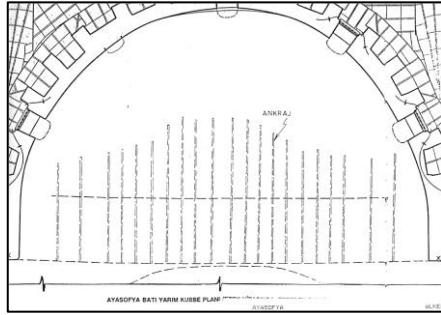
The last retrofitting project for the Hagia Sophia dome structure during the Republic period was proposed by Prof. Dr. Mustafa Erdik and Ülker Engineering and Consultancy in 1993 [14]. The proposal aimed to enable the semi-domes and main arches to work in unison during potential earthquakes by establishing a robust connection between them. The recommended method suggested for reinforcing the bond between the southeast and northwest main arches, upon which the semi-domes rely, was the use of anchors (see Fig. 11-12). The project proposed embedding the bodies of the anchors entirely into the semi-domes, with the heads designed to conceal the image without disrupting the facades of the southeast and northwest main arches. Modeling revealed that the planned anchoring bars would provide the required safety for the main dome. Despite this, the project was not accepted due to concerns about the radical structural interventions it would necessitate.

Fig. 11. Depiction of the anchors in plan

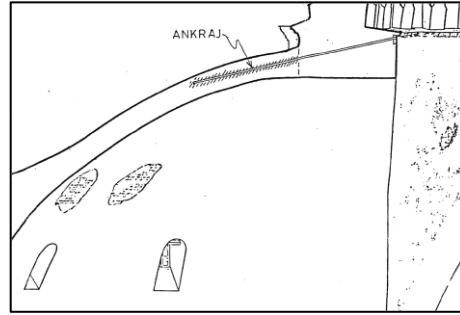
Fig. 12. Depiction of the anchors in cross-section

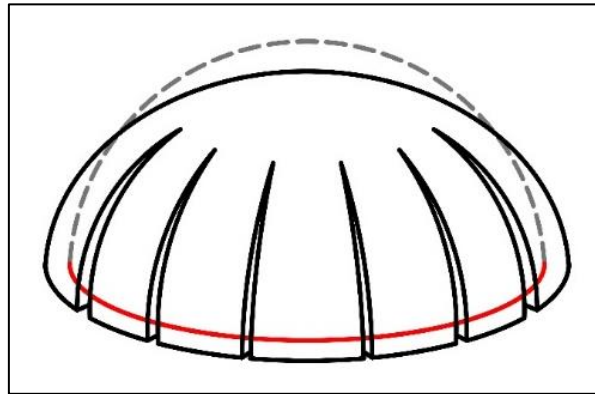
Fig. 14. Deformation of a dome: Tension ring preventing outward thrust

The application of ring beams is a fundamental strategy in the retrofitting of historical masonry structures [27]. In the context of Hagia Sophia, it is identified that the primary collapse mechanism involves the main arches and semi-domes. Results indicate that due to the thrust of the dome the thick arches on the northeastern and the southwestern sides deflect outward while on the southeastern and the northwestern sides, the upper parts of the semi-domes deflect inward. The thrust of the dome arises because of the hoop stresses (peripheral thrust) developed in the lower portion of the dome. To resist lateral thrust, the options include using exceptionally thick walls or, more commonly, employing diagonal support or tension rings at the base. Normally the tension-resisting ring is provided in tension zone to carry the horizontal thrust resulting from the hoop tension. The tension rings prevent the dome walls from thrusting outward (see Fig.14). To minimize the cross-sectional sizes of reinforcing materials, composite materials based on high-strength fibers, mainly carbon, are used. An important
