The interventions for the main dome of Hagia Sophia throughout its history and a preservation proposal

Hasan Firat Diker, Mehmet Halis Günel, Beyza Kapucu Güzelbulut

Keywords: Hagia Sophia; dome; arch; retrofitting; tension ring; earthquake

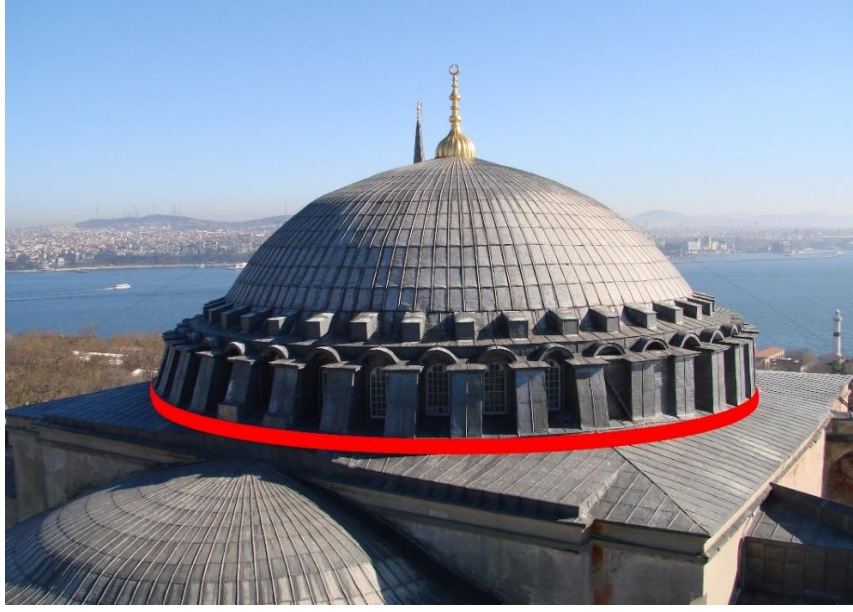
Fig. 17. Representation of the tension ring around the main dome of Hagia Sophia

Therefore, a comprehensive modeling study will prove the effect of using CFRP for the proposed tension ring, aiming to minimize interference with the visual integrity of Hagia Sophia. This proposal aims to deliver effective earthquake protection for the main dome of Hagia Sophia while preserving its appearance through the intervention of a ring of CFRP beneath the lead coverings. The preservation of Hagia Sophia's three-part structure, reflecting different historical periods, is crucial for its integrity (see Fig. 5). Hence, preservation efforts must align with its existing form, emphasizing retrofitting methods that uphold the dome's structural integrity and visual appeal. The study proposes a theoretical preservation method - tension ring encircling the main dome from the exterior (see Fig. 17). This proposed approach aims to provide supplementary support to the existing structure without altering its historical integrity, offering a potential solution to maintain its stability and safeguard its architectural significance.
