Vol 1, No 3 (2023)

Technical Annals

# The interventions for the main dome of Hagia Sophia throughout its history and a preservation proposal

**Abstract.** Throughout its history, Hagia Sophia has faced seismic risks due to structural issues. The ambitious design led to the complete collapse of the main dome merely 21 years after its construction, and partial collapses occurred in the 10th and 14th centuries. Over time, the structure underwent various repairs and reinforcements. Following the collapse of the southeastern section during the 1346 earthquake, flying buttresses were installed, attaching to the main dome from four directions. However, during the Fossati repairs (1847-1849), these elements were removed and replaced with iron beams, framing the upper perimeter of the pedestal supporting the main dome. The current challenges faced by the main dome are primarily rooted in the design of the piers and arches rather than the dome itself. Since reconstructing these structural elements is impossible, efforts to address the dome's issues have concentrated on retrofitting the supporting system. This study critically assesses the current state of the main dome, examining past int

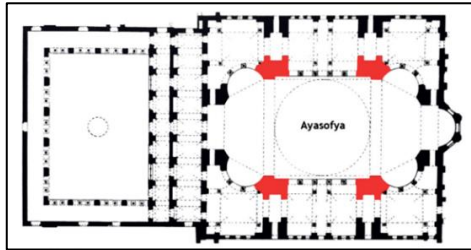
Despite the symmetrical placement of the four piers supporting the main dome, their asymmetric edges in multiple directions pose challenges in equitably withstanding horizontal loads. The arrangement makes it challenging to unify them, adversely impacting the structure's earthquake resistance [1]. Another evident static issue, notably observed

**Fig. 1.** Main piers in the plan of Hagia Sophia      **Fig. 2.** Northwest-southeast cross-section  
(Impressions in red are made by the authors.)

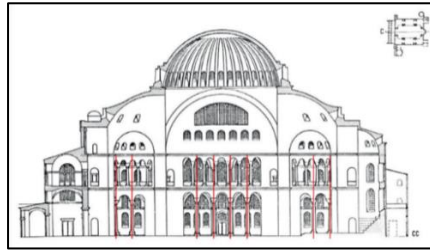
in the southeast-northwest section, lies in the columns' numerical arrangement between the ground and gallery floors. The ground floor features a 5-arcade arrangement between the main buttresses, whereas the gallery floor exhibits a pattern of 7 arcades. This discrepancy, stemming from the varied column sizes between floors, disrupts the vertical load transfer from the main dome and body walls in an intermittent and discontinuous manner [2] (see Fig. 1-2 [3]).

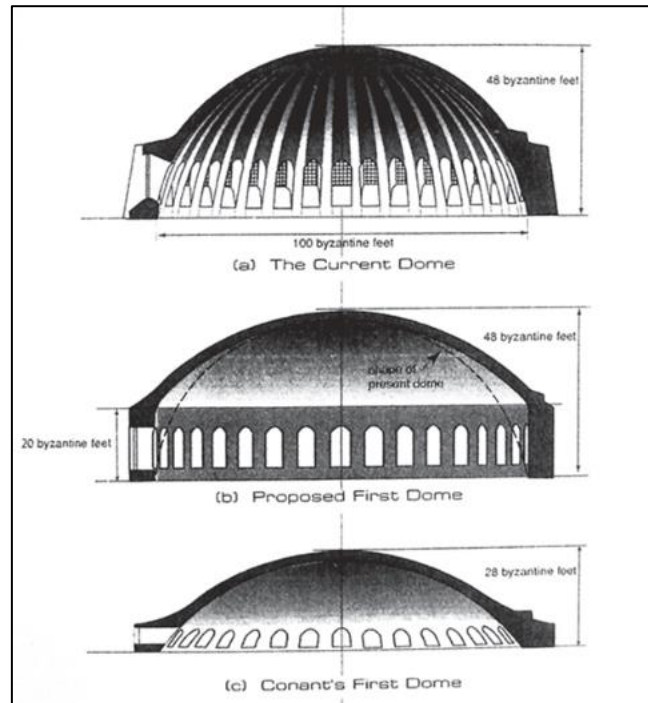
Following the earthquakes in August 553 and December 557, both the main dome and the southeastern semi-dome collapsed [4] due to a 6 magnitude earthquake on May 7, 558 [5] around 21 years after the consecration of Hagia Sophia. This destruction was linked to multiple factors, including the inadequate curvature in the initial dome's design, deformation of the main supporting pillars, and distortion of the dome caused by shear forces [6, 7]. Emperor Justinian (r. 527-565), witnessing the dome's collapse during his reign, appointed Isidorus, a young architect and nephew of one of Hagia Sophia's initial architects, for repairs. The prevailing belief regarding the restoration activity on December 24, 563, was that it involved altering the dome's shape and increasing its height by 20 Byzantine feet (equivalent to approximately 6.24 meters) [7, 8]. However, recent research indicates that the modified design of the restored dome did not increase its height but maintained the same height while curving the tambour with the dome [6, 9, 10] (see Fig. 3 [9]).

**Fig. 3.** Sections of (a) the current dome, (b) proposed first dome, (c) pre-proposed first dome

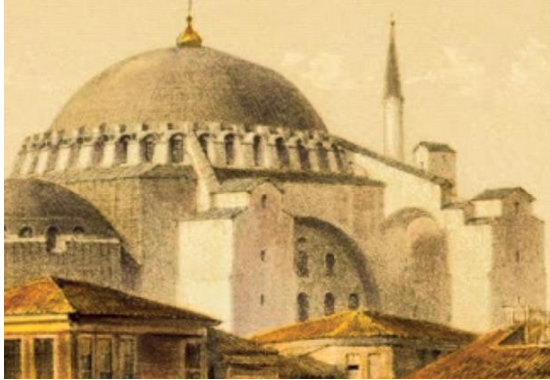
**Fig. 4.** Detail from Fossati's depiction before restoration

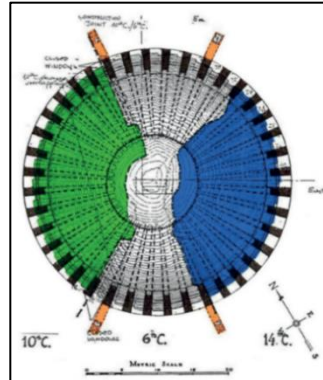
In the fall of 1343, a series of earthquakes struck the city, followed by another on October 6, 1344, resulting in structural weaknesses within Hagia Sophia. Subsequently, on May 19, 1346, one-third of the main dome collapsed along with the southeastern semi-dome. The restoration efforts were overseen by Stratopedarch Astras and Giovanni Peralta, with completion in 1354 [7]. Notably, within this repair, the main dome was supported by flying buttresses in four directions. These buttresses, displaying Gothic characteristics depicted in Hagia Sophia's descriptions, can be specifically attributed to the repairs in the 14th century (see Fig. 4 [12]). The integration of these flying buttresses with the connections of the remaining 6th-century dome and the reconstructions from the 10th and 14th centuries display the meaningful support they offered to the main dome (see Fig. 5 [2]).

**Fig. 5.** Flying buttresses colored in orange

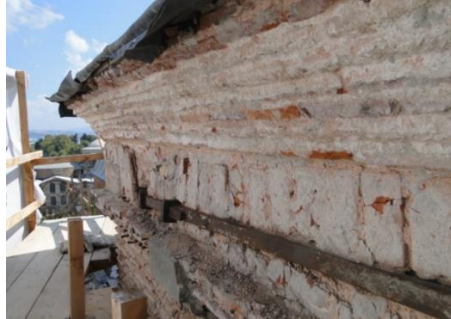
**Fig. 6.** Iron frame intervention under the plaster

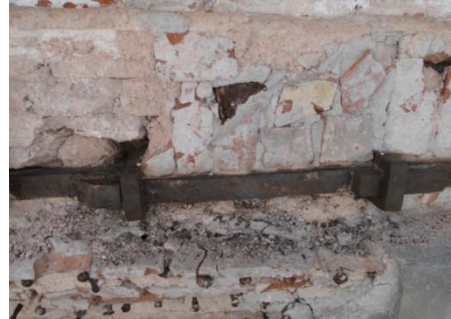
**Fig. 7.** Detail from the joint of the iron bracing

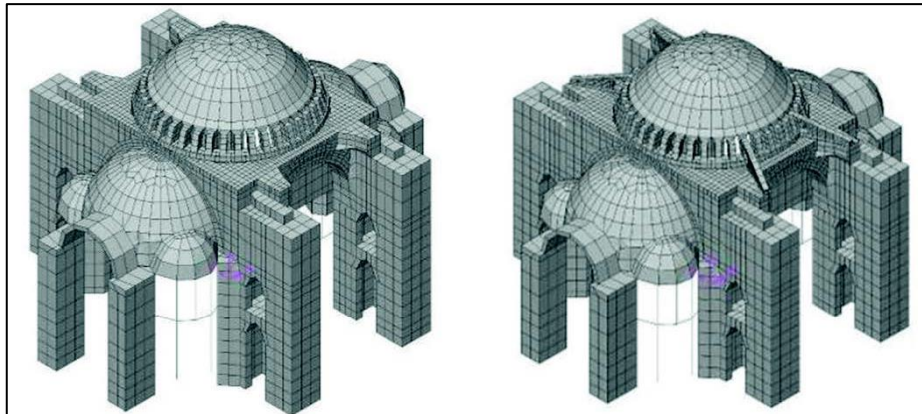
In the modeling work conducted in 2010 to investigate the functionality of the flying buttresses removed by the Fossati at Hagia Sophia, both the existing models and the structure itself were tested via static simulations using finite elements in a computer environment. The analysis aimed to examine the structural contribution of the buttresses to the main dome (see Fig. 8 [2]). This limited modeling study demonstrated that the flying buttresses serve an important structural function and contribute to the stability of the main dome [2, 16].

**Fig. 8.** View of the models of the current state and with the flying buttresses

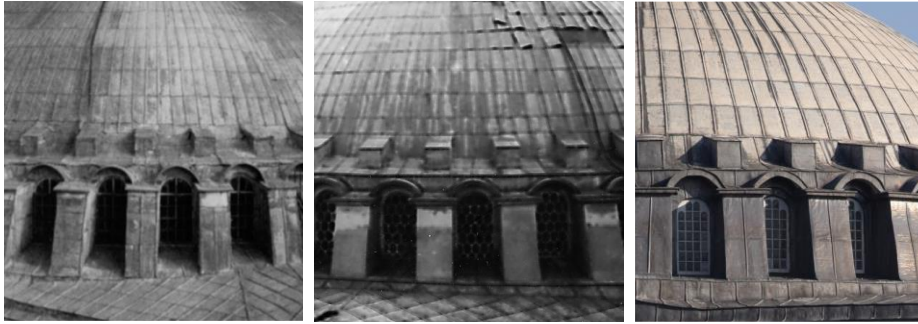
The most recent structural alteration to the main dome of Hagia Sophia involves the installation of vaults over the windows. A Japanese team from Tsukuba University identified these vaults as reinforced concrete elements in 1995 [17]. This intervention aligns with early 20th-century building technology. Historical records indicate that in 1909 [18], the windows appeared to be covered only with lead, whereas by 1936 [19], each window was observed to be covered with vaults similar to those seen today [20]

(see Fig. 9). While there isn't specific documentation detailing this intervention, visual evidence suggests that the installation of vaults over the windows likely occurred during the early years of the Turkish Republic, established in 1923.

**Fig. 9.** Detail views from the dome windows in row from 1909, 1936 and 2010.

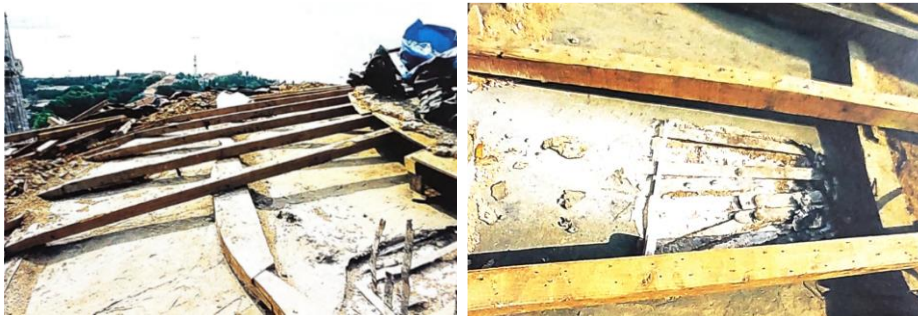
In a study conducted in 1993, it was observed that wooden construction was built on lower level to reduce the flatness of dome, which occurred due to the fact that the 10th century segment in the western part of the main dome was higher than the 6th century segment in the southern part of the dome about 10-12 cm (see Fig. 10 [17]). The effect of this intervention, which is understood to have been made to show the main dome of Hagia Sophia symmetrically, which is actually asymmetrical due to its repairs, in city silhouette, should be questioned in Hagia Sophia modelings.

**Fig. 10.** Views from the partial wooden sub construction under the lead cover

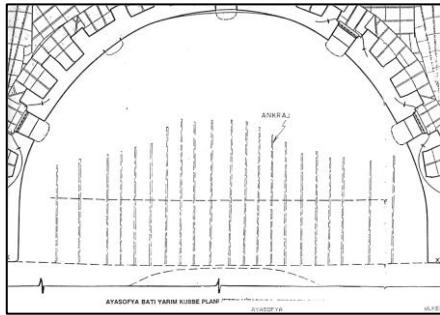
**Fig. 11.** Depiction of the anchors in plan

The last retrofitting project for the Hagia Sophia dome structure during the Republic period was proposed by Prof. Dr. Mustafa Erdik and Ülker Engineering and Consultancy in 1993 [14]. The proposal aimed to enable the semi-domes and main arches to work in unison during potential earthquakes by establishing a robust connection between them. The recommended method suggested for reinforcing the bond between the southeast and northwest main arches, upon which the semi-domes rely, was the use of anchors (see Fig. 11-12). The project proposed embedding the bodies of the anchors entirely into the semi-domes, with the heads designed to conceal the image without disrupting the facades of the southeast and northwest main arches. Modeling revealed that the planned anchoring bars would provide the required safety for the main dome. Despite this, the project was not accepted due to concerns about the radical structural interventions it would necessitate.

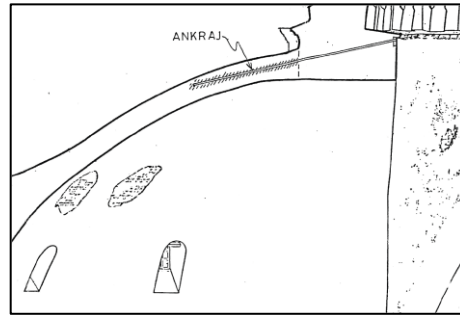
**Fig. 12.** Depiction of the anchors in cross-section

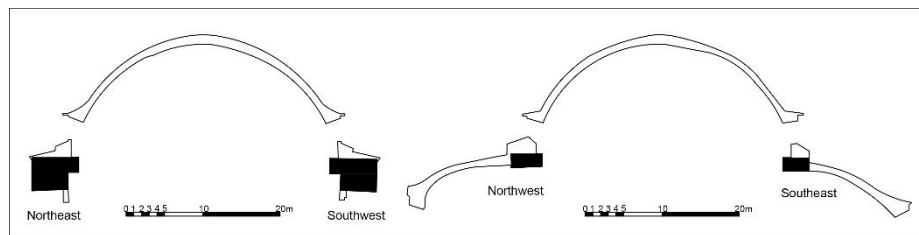
The significant disparity in cross-sectional areas—where the northwest arch measures less than 1/3 of the northeast and southwest arches, and the southeast arch

constitutes almost  $\frac{1}{4}$  of their areas—highlights the structural issues within the main dome. Contrary to expectations, the cross-sectional areas of the northeastern and southwestern arches are not double that of the others. The notably thin sections of the northwest and especially southeast arches define the dome's asymmetrical structure, a result of its destruction and varied reconstruction over time. This structurally irreparable situation may be attributed to the reconstructions during the 10th and 14th centuries (see Fig. 13).

**Fig. 13.** The occupations of the main arches through the northeast-southwest and northwest-southeast cross-sections of the main dome

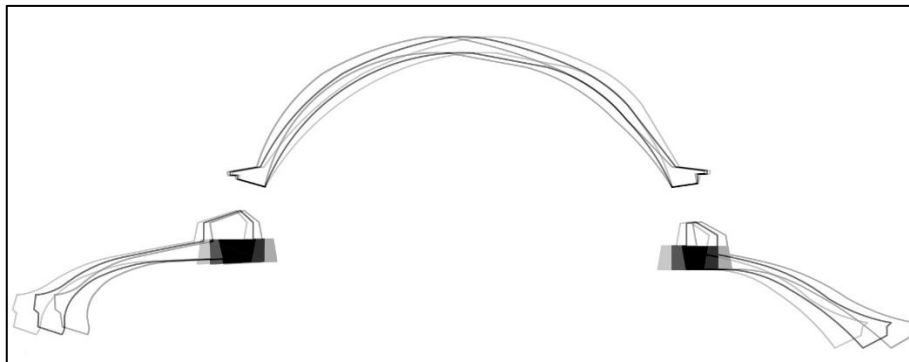
The vulnerability arises during potential major earthquakes, where the main dome and semi-domes oscillate, posing a risk of hammering over the northwest and southeast arches, known to be the most delicate. This hammering effect could lead to the collapse of arches and semi-domes, with potential partial damage to the main dome [27] (see Fig.15). The proposed use of a tension ring introduces a preventive measure to limit the oscillation of the main dome, resulting in a more controlled and one-sided hammering. This approach aims to minimize damage to the semi-domes and slender main arches, crucial elements supporting the main dome. Positioned as an optimum solution, it seeks to protect Hagia Sophia's main dome without necessitating radical structural interventions.

**Fig. 15.** Representation of the hammering effect on the main dome of Hagia Sophia

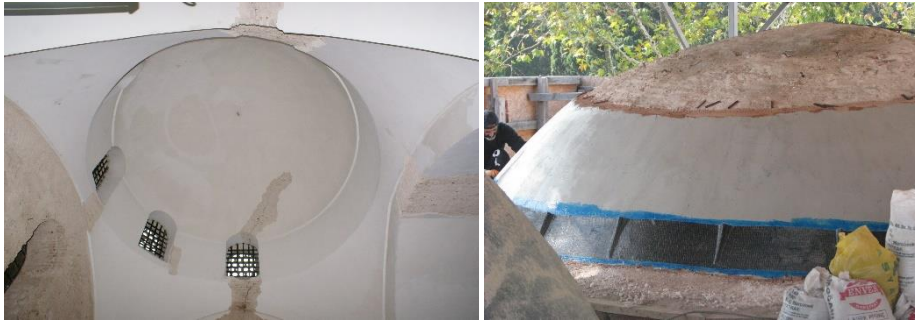
**Fig. 26.** View from the crack under the dome and CFRP intervention above the dome.

Topkapı Palace in 2009. The Outer Treasury that is a rectangular, one-story structure was built in the 16th century and covered with eight domes arranged in two rows. During the restoration process, the recent 20th-century concrete plasters inside the structure were completely removed, exposing the domes and walls along with traces of cracks. Over the centuries, ground movements might have exerted stress on the structure, potentially causing cracks above and below the domes. After extensive discussions, it was decided to reinforce each dome of the structure by applying carbon fiber tapes above the surface [28]. That intervention was one of the first CFRP uses for a cultural heritage in Istanbul after the earthquake in 1999 (see Fig.16).

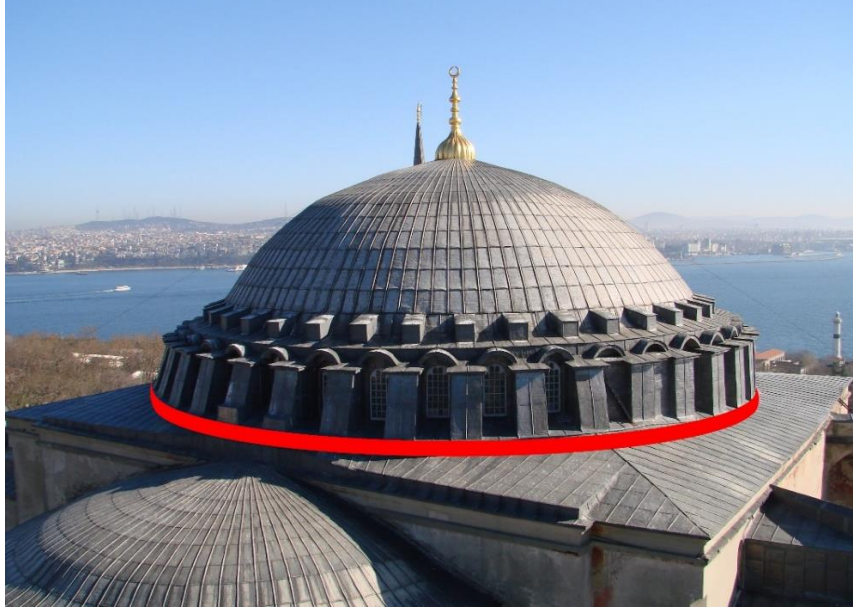
**Fig. 17.** Representation of the tension ring around the main dome of Hagia Sophia

The use of CFRP (Carbon Fiber Reinforced Polymer) as a tension ring may be the most suitable material for the dome due to its superficial features that won't alter its silhouette. This choice also allows CFRP to be concealed beneath the lead covering easily. Similar interventions were made for the domes of the Outer Treasury in the

Therefore, a comprehensive modeling study will prove the effect of using CFRP for the proposed tension ring, aiming to minimize interference with the visual integrity of Hagia Sophia. This proposal aims to deliver effective earthquake protection for the main dome of Hagia Sophia while preserving its appearance through the intervention of a ring of CFRP beneath the lead coverings. The preservation of Hagia Sophia's three-part structure, reflecting different historical periods, is crucial for its integrity (see Fig. 5). Hence, preservation efforts must align with its existing form, emphasizing retrofitting methods that uphold the dome's structural integrity and visual appeal. The study proposes a theoretical preservation method - tension ring encircling the main dome from the exterior (see Fig. 17). This proposed approach aims to provide supplementary support to the existing structure without altering its historical integrity, offering a potential solution to maintain its stability and safeguard its architectural significance.
