Behavior of steel building structures subjected to strong and benchmark seismic actions: An overview of damage from the observations of the last 40 years

Anthimos Anastasiadis¹

¹ASAnastasiadis and Associates, Taskou Papageorgiou 10, 54631, Thessaloniki, Greece
anastasiadis@asacon.eu

Keywords: Steel Buildings, Seismic Performance, Benchmark Earthquakes

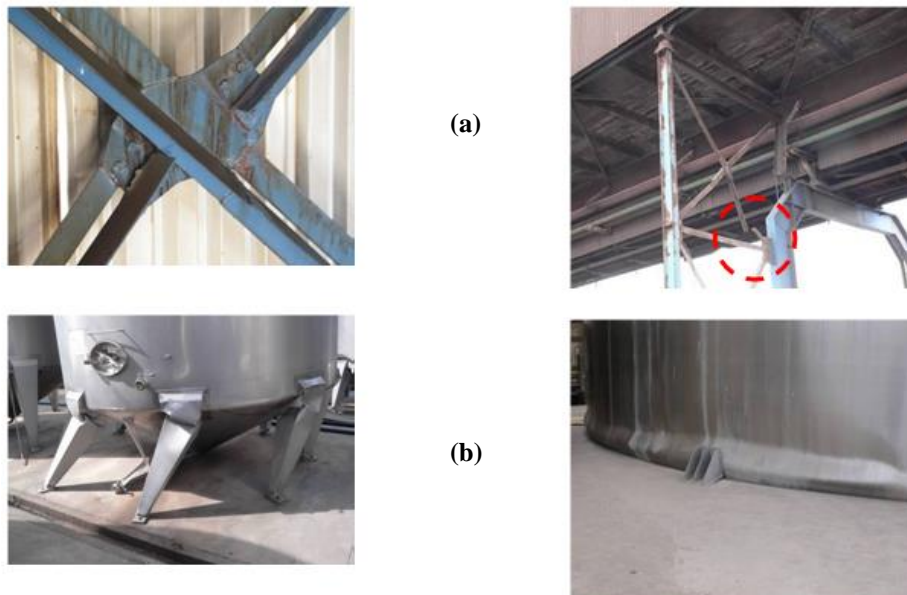
Fig. 7. Maule earthquake failure, (a) brace buckling and fracture, (b) buckling at the base of tanks [53].

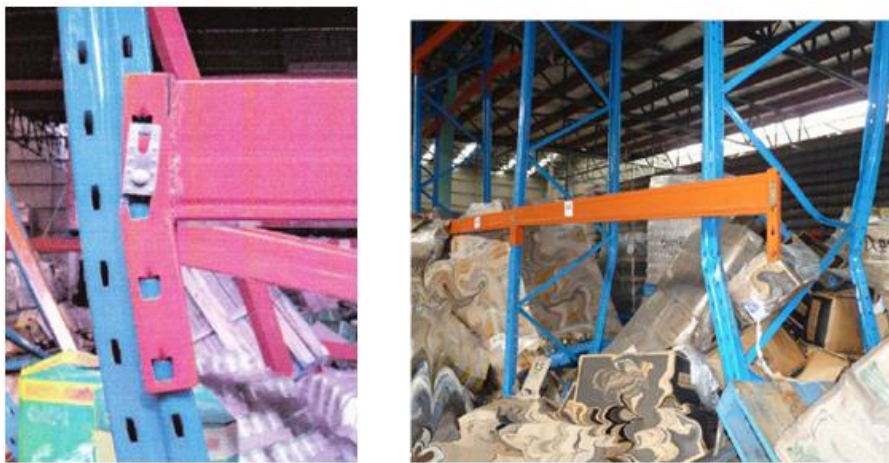
Moreover, typical fractures in braces and local buckling in braces and columns of storage rack pallets were also observed [60], Fig. 9. However, the same damage was also reported in the USA in a series of medium and strong ground motions, such as the Whittier earthquake in 1987, the Loma Prieta earthquake in 1989, the Landers earthquake in 1992, the Northridge earthquake in 1994, the Nisqually earthquake in 2001, and San Simenone in 2003. Storage rack pallets are light, although they carry heavier live loads than dead loads. These structures have complex inelastic behavior due to thin-walled and unsymmetrical cross sections and asymmetry of connections as well, making them prone to buckling. For instance, in the USA, after the repeated and extended damage to the steel storage rack pallets, the FEMA 460 document was published [64] in order to guide the industry.

Fig. 9. Failures of steel rack pallets in Christchurch earthquake, 2011 [60].

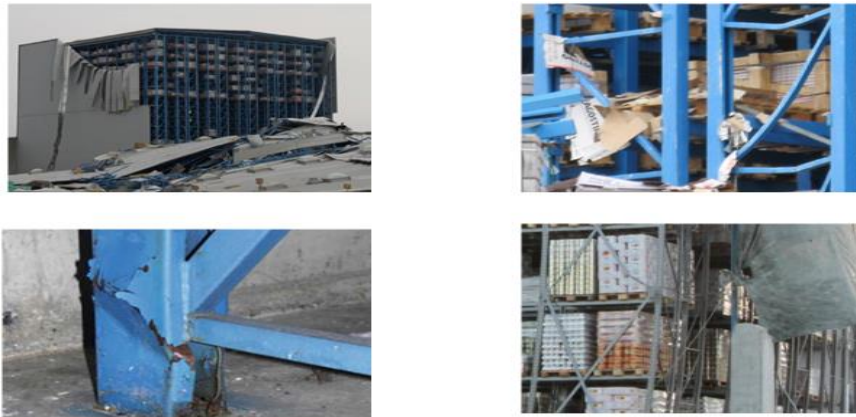
This earthquake affected the urban and industrial areas, where, for the second one, many reinforced concrete one-story precast buildings were severely damaged or collapsed. With regard to steel structures, this quake could be associated with the damage to cold-formed steel racks that are or are not part of the lateral load-resisting system of the building (Fig. 10). Column local buckling, plastification of connections, anchor failure, and buckling of braces are the main types of damage [63,70]. This earthquake unveiled, once again, the lack of seismic design for such structures.

Fig. 10. Failure of steel racks making part, or not of the lateral load resisting system, Emilia earthquake, 2012 [70].

In response to the aforementioned failures, in Europe, after intensive research, [71,72], the EN 16681 design code for “Steel static storage systems. Adjustable pallet racking systems. Principles for seismic design” was developed and implemented as a European regulation, [73].
