Vol 1, No 6 (2024)

# Behavior of steel building structures subjected to strong and benchmark seismic actions: An overview of damage from the observations of the last 40 years

Anthimos Anastasiadis<sup>1</sup>

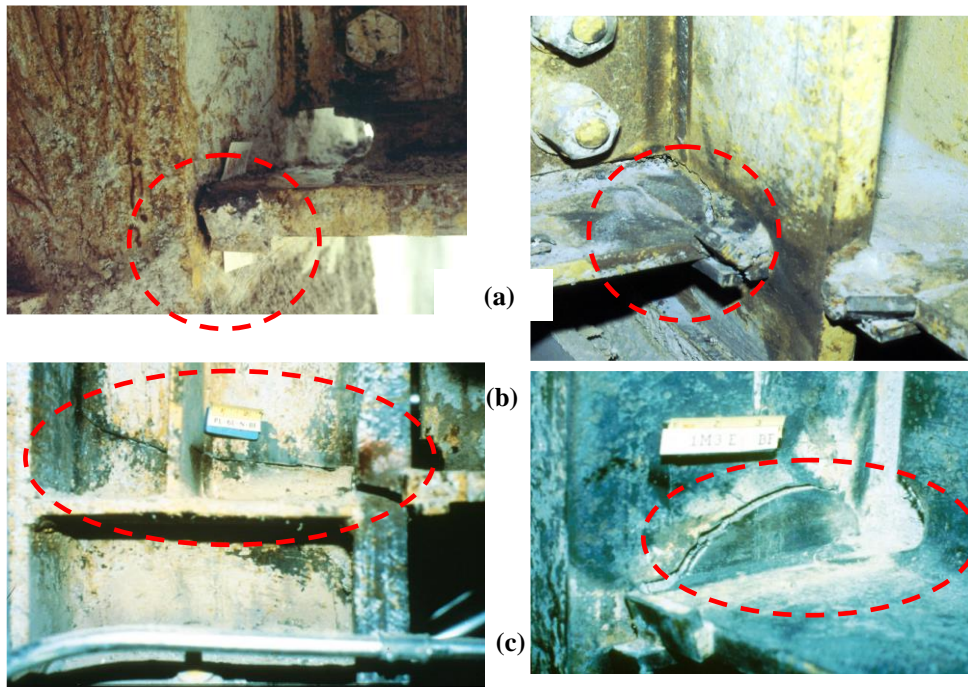
**Fig. 3.** Typical damage observed after the Northridge earthquake, (a) Fracture at fuse zone, (b) column fracture, and (c) column flange "divot" fracture [10].

The Northridge earthquake, 1994, USA, is a benchmark point in the history of seismic design of steel structures, especially steel welded moment-resisting frames. The unexpected damage greatly surprised the US structural engineering community [20]. The response was immediate and radical; a great research program was initiated, starting in 1994 and ending in 2000, through the cooperation of The Structural Engineers Association of California (SEAOC), Applied Technology Council (ATC), and California Universities for Earthquake Engineering (CUREE) in cooperation with the Federal Emergency Management Agency (FEMA), forming the SAC Joint Venture with the main goal of “developing reliable, practical, and cost-effective guidelines and standards of practice for the repair or upgrading of damaged steel moment frame buildings, the design of new steel buildings, and the identification and rehabilitation of at-risk steel buildings” [21, 22]. It was an exemplary program; the result was design-oriented, namely, the development of guidelines, which were the basis for the further processing of new standards and codes not only for new structures and for the rehabilitation of existing ones [23, 24,25], but also sound information related to the metallurgy of structural steel, welding, inspection, and quality control [26,27,28].

It was realized that the column face, at the connection, is a highly stressed zone; therefore, constructional detailing using the concept of weakening (reducing the upper and lower flanges at a selected distance from the column face) [29,30] or strengthening (adding ribs, cover plates, and haunches) could be applied [31]; the plastic hinge must be removed from the column face to a zone of lesser stress. In addition, the detrimental effect of the slab, when it is coupled compositely with the beam, which converts the strong column-weak beam concept into a weak column-strong beam mechanism, was also evaluated [32,33].

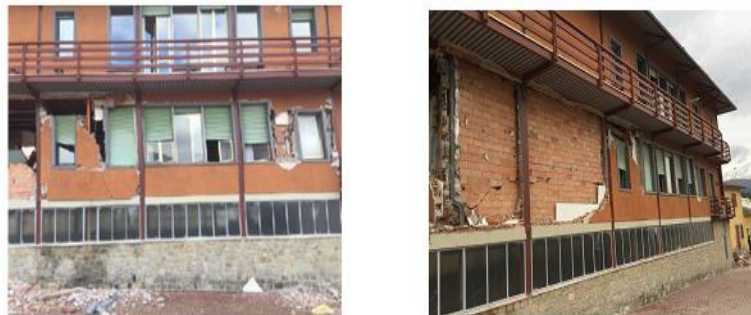
Related to the steel buildings, a characteristic failure was pointed out in the case of an moment resisting frame interacting with masonry infill, Fig. 11, [74]. There are many situations where infill masonry is used instead of braces to limit lateral deformation. However, for such cases, special detailing should be used; for instance, we can distinguish between two main ways: (i) detaching the infill masonry from the main frame and filling the gap with a compressible material, or (ii) connecting it with steel angles or other steel elements anchored to the main frame. In both cases, out-of-plan bending of the infill masonry must be ensured.

**Fig. 11.** Steel frame with infill masonry interaction, Amatrice earthquake, 2016, [74].
