Behavior of steel building structures subjected to strong and benchmark seismic actions: An overview of damage from the observations of the last 40 years

Anthimos Anastasiadis¹

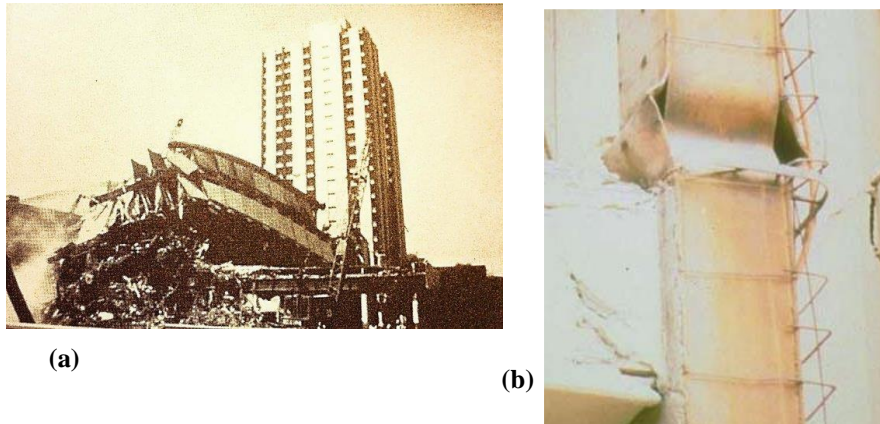
The Pino Suarez complex was constructed in early 1970 and consisted of five steel moment resisting frames, (three central buildings of 21-stories and two of 14-stories). The structural system of the 21-story collapsed building, which failed onto the 14-story building, was a moment-resisting frame consisting of welded plates forming box columns with truss beams and moment-resisting connections. The collapse was attributed to the buckling of the exterior box columns, in the fourth storey [8,9], Fig. 1.

Fig. 1. (a) Collapsed building and (b) buckled column of the Pino Suarez building [3].

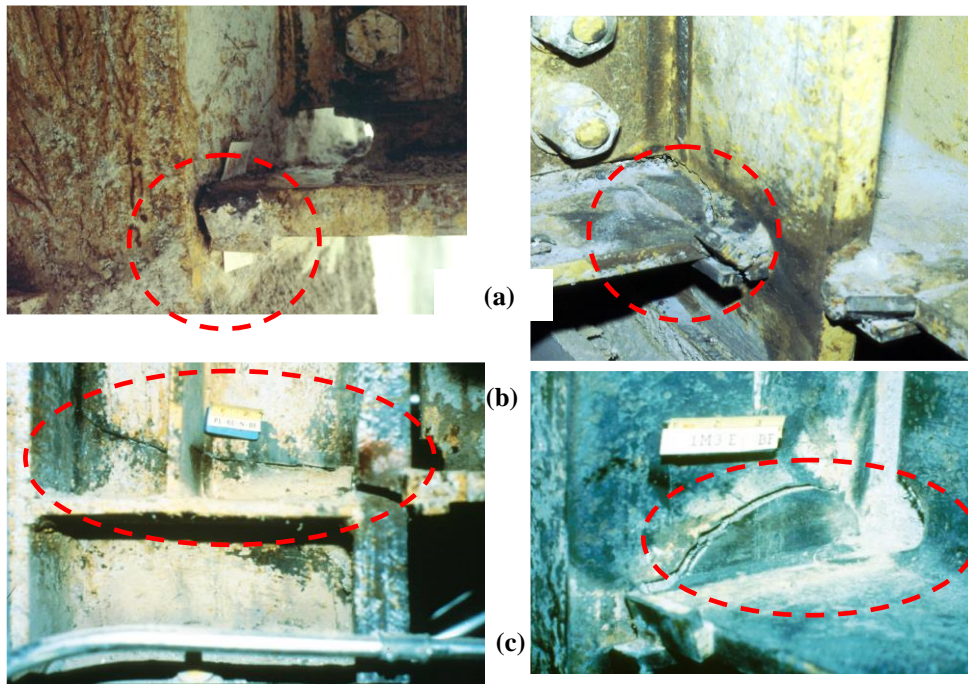
Fig. 3. Typical damage observed after the Northridge earthquake, (a) Fracture at fuse zone, (b) column fracture, and (c) column flange "divot" fracture [10].

The Northridge earthquake, 1994, USA, is a benchmark point in the history of seismic design of steel structures, especially steel welded moment-resisting frames. The unexpected damage greatly surprised the US structural engineering community [20]. The response was immediate and radical; a great research program was initiated, starting in 1994 and ending in 2000, through the cooperation of The Structural Engineers Association of California (SEAOC), Applied Technology Council (ATC), and California Universities for Earthquake Engineering (CUREE) in cooperation with the Federal Emergency Management Agency (FEMA), forming the SAC Joint Venture with the main goal of “developing reliable, practical, and cost-effective guidelines and standards of practice for the repair or upgrading of damaged steel moment frame buildings, the design of new steel buildings, and the identification and rehabilitation of at-risk steel buildings” [21, 22]. It was an exemplary program; the result was design-oriented, namely, the development of guidelines, which were the basis for the further processing of new standards and codes not only for new structures and for the rehabilitation of existing ones [23, 24,25], but also sound information related to the metallurgy of structural steel, welding, inspection, and quality control [26,27,28].

It was realized that the column face, at the connection, is a highly stressed zone; therefore, constructional detailing using the concept of weakening (reducing the upper and lower flanges at a selected distance from the column face) [29,30] or strengthening (adding ribs, cover plates, and haunches) could be applied [31]; the plastic hinge must be removed from the column face to a zone of lesser stress. In addition, the detrimental effect of the slab, when it is coupled compositely with the beam, which converts the strong column-weak beam concept into a weak column-strong beam mechanism, was also evaluated [32,33].

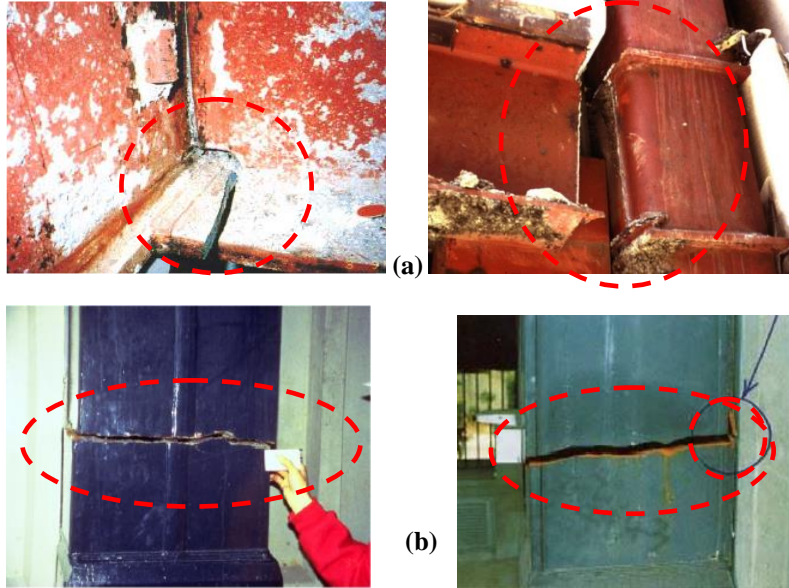
It was surprising that the same brittle damage at the beam-column connection, as it was in the case of the Northridge earthquake exactly a year ago, was observed. The same failure at the welds, heat-affected zone, and base material fracture is recorded, although the general conformation of a typical joint between US and Japanese practice is different, Fig. 4. Moreover, brittle failure also occurred at: (i) columns (of square hollow section mainly cold formed), with fracture at the base material of approximately 50–55 mm thickness, at welded column splices, and beam to brace connections; (ii) column bases at anchor bolts; and (iii) braces of small cross section and large slenderness like rods, angles, and flat plates for older buildings, while for modern buildings with larger cross sections, the damage was concentrated at the connection zone [46,47,48,49], Fig. 5,6.

The causes of damage attributed to the fracture toughness of steel material, general configuration and detailing of the beam to column connection, low toughness of weld metal and the severity of the strong ground motion having strong pulses and high V/H PGA ratio as well. The repeatability of the damage observed for both Northridge, 1994, USA, and Kobe 1995, Japan, unveiled the enhanced vulnerability of the welded beam-to column connection of the steel moment resisting frames. Moreover, the practice was to execute the welding on site. Hence, considering that joints are severely stressed, then the weldments that characterized by a potential brittleness, must be very well executed, inspected and assured the quality control; this was not the case. It was a failure of the seismic design and construction practice for both countries.

Fig. 5. Brittle damage from Kobe earthquake, (a) beam to column fracture, (b) column fractures [48,49].

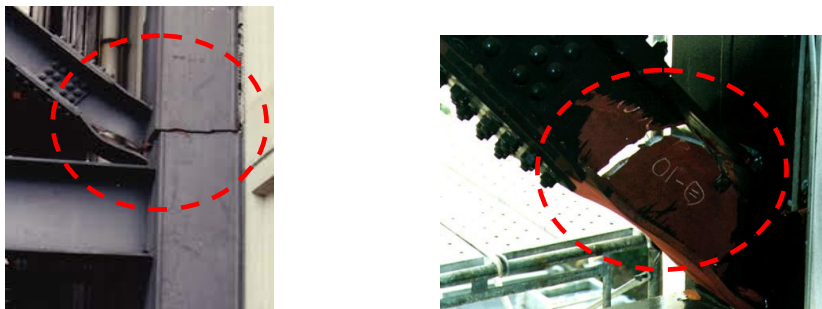
Fig. 6. Brittle damage from Kobe earthquake, brace fracture [48,49].

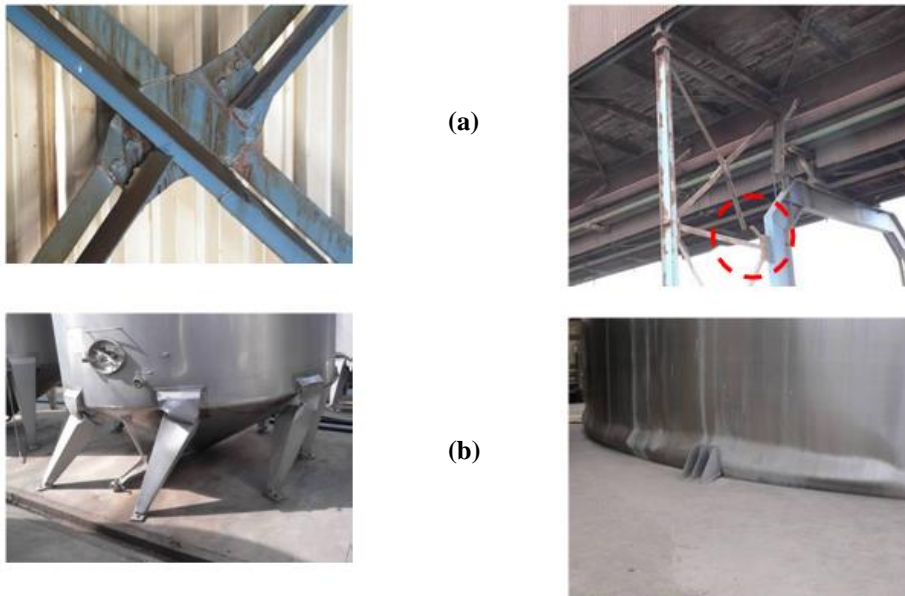
Fig. 7. Maule earthquake failure, (a) brace buckling and fracture, (b) buckling at the base of tanks [53].

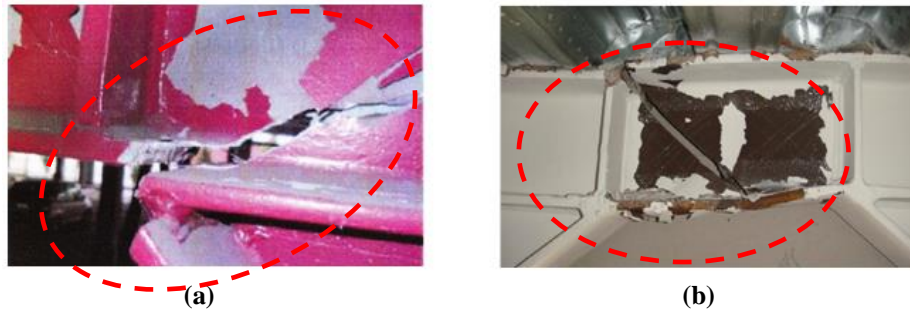
With regard to steel structures, they generally performed well [60]. A specific fracture was observed in the active links of the eccentrically braced frames at Pacific Residential Tower, completed in 2010, with a perimeter EBF as part of a lateral load resisting system, and at a hospital parking garage designed to accommodate two additional floors [60], the first known recording of such failure worldwide, Fig. 8. Related to the EBF links, many studies were performed in order to explain this unexpected fracture, supporting the lack of redundancy, constructional inefficiency, and material inefficiency. However, this type of failure was concentrated on the aforementioned cases and was not a systematic observed fracture. The other types of failure are the classical ones related to steel structures when subjected to severe shaking [46].

Fig. 8. Fracture of EBF's links, a) at hospital parking garage, b) at Pacific Residential Tower, [60].

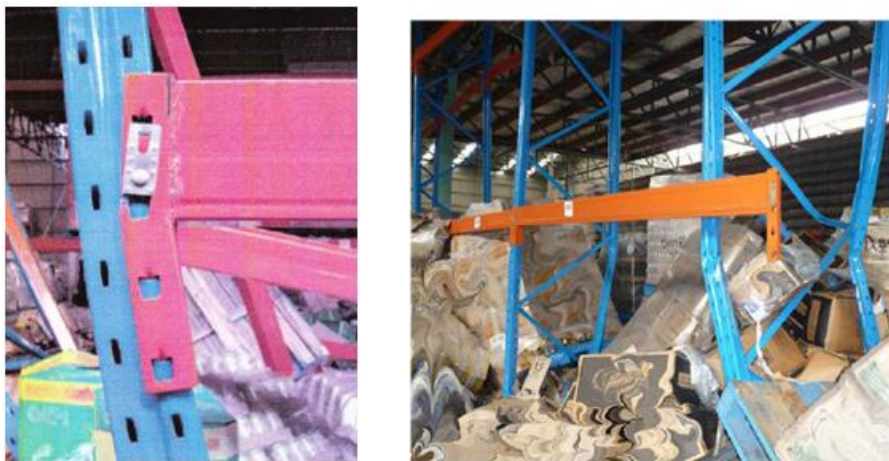
Moreover, typical fractures in braces and local buckling in braces and columns of storage rack pallets were also observed [60], Fig. 9. However, the same damage was also reported in the USA in a series of medium and strong ground motions, such as the Whittier earthquake in 1987, the Loma Prieta earthquake in 1989, the Landers earthquake in 1992, the Northridge earthquake in 1994, the Nisqually earthquake in 2001, and San Simenone in 2003. Storage rack pallets are light, although they carry heavier live loads than dead loads. These structures have complex inelastic behavior due to thin-walled and unsymmetrical cross sections and asymmetry of connections as well, making them prone to buckling. For instance, in the USA, after the repeated and extended damage to the steel storage rack pallets, the FEMA 460 document was published [64] in order to guide the industry.

Fig. 9. Failures of steel rack pallets in Christchurch earthquake, 2011 [60].

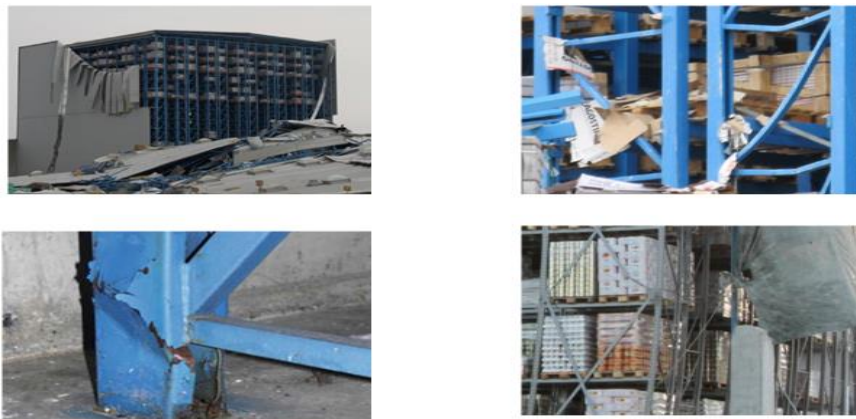
This earthquake affected the urban and industrial areas, where, for the second one, many reinforced concrete one-story precast buildings were severely damaged or collapsed. With regard to steel structures, this quake could be associated with the damage to cold-formed steel racks that are or are not part of the lateral load-resisting system of the building (Fig. 10). Column local buckling, plastification of connections, anchor failure, and buckling of braces are the main types of damage [63,70]. This earthquake unveiled, once again, the lack of seismic design for such structures.

Fig. 10. Failure of steel racks making part, or not of the lateral load resisting system, Emilia earthquake, 2012 [70].

In response to the aforementioned failures, in Europe, after intensive research, [71,72], the EN 16681 design code for “Steel static storage systems. Adjustable pallet racking systems. Principles for seismic design” was developed and implemented as a European regulation, [73].

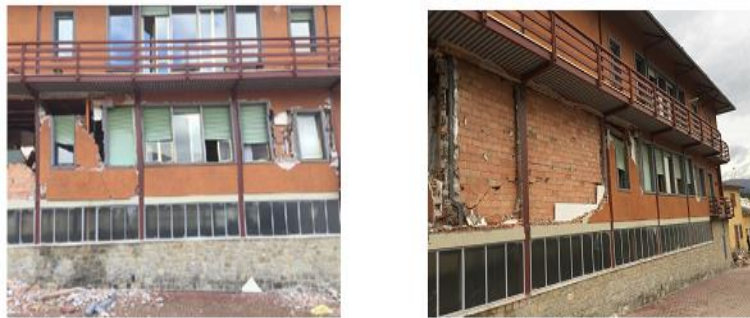
Related to the steel buildings, a characteristic failure was pointed out in the case of an moment resisting frame interacting with masonry infill, Fig. 11, [74]. There are many situations where infill masonry is used instead of braces to limit lateral deformation. However, for such cases, special detailing should be used; for instance, we can distinguish between two main ways: (i) detaching the infill masonry from the main frame and filling the gap with a compressible material, or (ii) connecting it with steel angles or other steel elements anchored to the main frame. In both cases, out-of-plan bending of the infill masonry must be ensured.

Fig. 11. Steel frame with infill masonry interaction, Amatrice earthquake, 2016, [74].
