Vol 1, No 6 (2024)

**Behavior of steel building structures subjected to strong and benchmark seismic actions: An overview of damage from the observations of the last 40 years**

*Anthimos Anastasiadis*

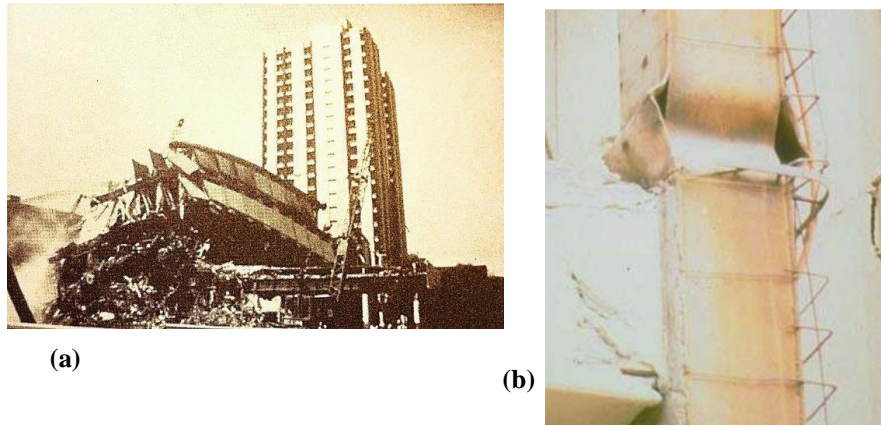
The Pino Suarez complex was constructed in early 1970 and consisted of five steel moment resisting frames, (three central buildings of 21-stories and two of 14-stories). The structural system of the 21-story collapsed building, which failed onto the 14-story building, was a moment-resisting frame consisting of welded plates forming box columns with truss beams and moment-resisting connections. The collapse was attributed to the buckling of the exterior box columns, in the fourth storey [8,9], Fig. 1.

**Fig. 1.** (a) Collapsed building and (b) buckled column of the Pino Suarez building [3].
