Technical Annals

Vol 1, No 6 (2024)

Behavior of steel building structures subjected to strong and benchmark seismic actions: An overview of damage from the observations of the last 40 years

Anthimos Anastasiadis

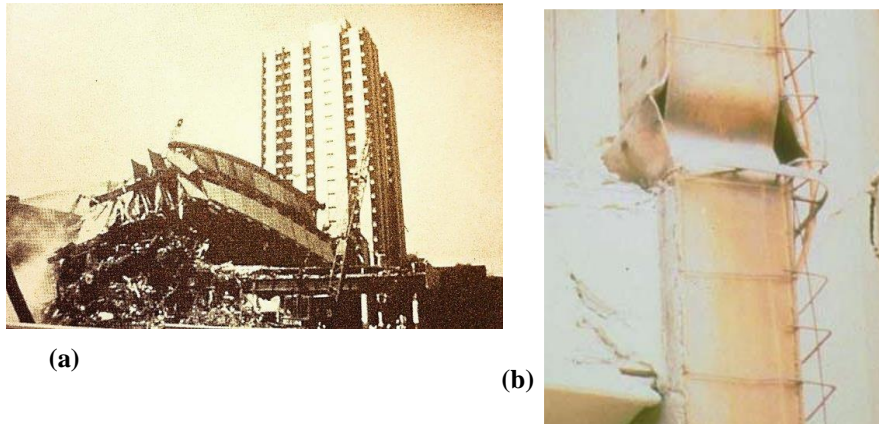
The Pino Suarez complex was constructed in early 1970 and consisted of five steel moment resisting frames, (three central buildings of 21-stories and two of 14-stories). The structural system of the 21-story collapsed building, which failed onto the 14-story building, was a moment-resisting frame consisting of welded plates forming box columns with truss beams and moment-resisting connections. The collapse was attributed to the buckling of the exterior box columns, in the fourth storey [8,9], Fig. 1.

Fig. 1. (a) Collapsed building and (b) buckled column of the Pino Suarez building [3].
