# Behavior of steel building structures subjected to strong and benchmark seismic actions: An overview of damage from the observations of the last 40 years

Anthimos Anastasiadis<sup>1</sup>

**Abstract.** It is well known that steel structures have a high ductility capacity and a high strength-to-weight ratio, which theoretically, by nature, makes them one of the most efficient seismic structural systems against strong earthquakes. However, the recorded experience of failures that have befallen over the last 40 years as a result of strong seismic actions suggests that this by itself isn't always sufficient. Generally, it is essential that an appropriate and preferred conformation and configuration of the structural system, and in particular of its joints, be adopted. In any case, the steel building structures showed local failures without general or complete collapses. The work in this paper presents the seismic performance focused on steel building structures, as revealed by strong earthquakes such as those of Mexico (1985), Northridge (1994), USA, Kobe (1995), Japan, Christchurch (2010–2011), and New Zealand, which affected and changed the design of metal structures, as well as

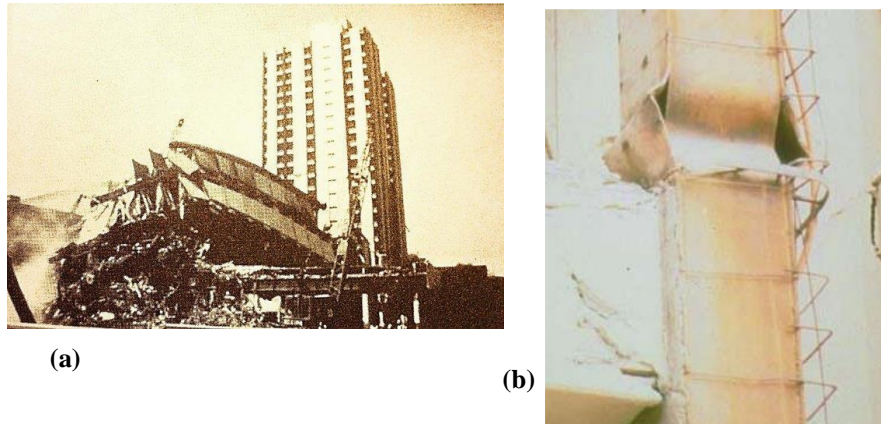
The Pino Suarez complex was constructed in early 1970 and consisted of five steel moment resisting frames, (three central buildings of 21-stories and two of 14-stories). The structural system of the 21-story collapsed building, which failed onto the 14-story building, was a moment-resisting frame consisting of welded plates forming box columns with truss beams and moment-resisting connections. The collapse was attributed to the buckling of the exterior box columns, in the fourth storey [8,9], Fig. 1.

**Fig. 1.** (a) Collapsed building and (b) buckled column of the Pino Suarez building [3].

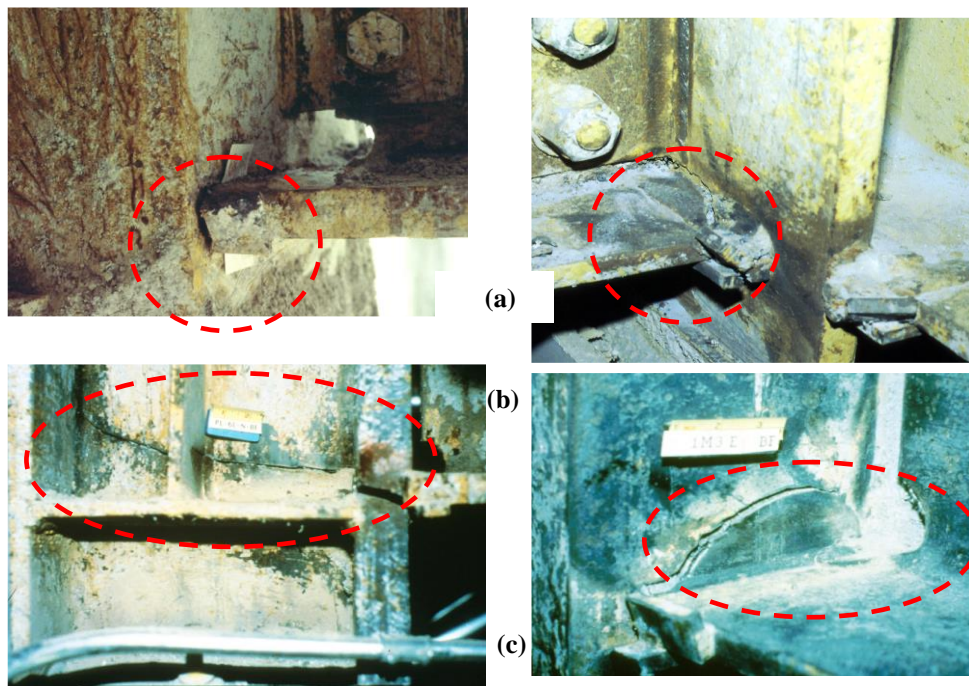
**Fig. 3.** Typical damage observed after the Northridge earthquake, (a) Fracture at fuse zone, (b) column fracture, and (c) column flange "divot" fracture [10].

The Northridge earthquake, 1994, USA, is a benchmark point in the history of seismic design of steel structures, especially steel welded moment-resisting frames. The unexpected damage greatly surprised the US structural engineering community [20]. The response was immediate and radical; a great research program was initiated, starting in 1994 and ending in 2000, through the cooperation of The Structural Engineers Association of California (SEAOC), Applied Technology Council (ATC), and California Universities for Earthquake Engineering (CUREE) in cooperation with the Federal Emergency Management Agency (FEMA), forming the SAC Joint Venture with the main goal of “developing reliable, practical, and cost-effective guidelines and standards of practice for the repair or upgrading of damaged steel moment frame buildings, the design of new steel buildings, and the identification and rehabilitation of at-risk steel buildings” [21, 22]. It was an exemplary program; the result was design-oriented, namely, the development of guidelines, which were the basis for the further processing of new standards and codes not only for new structures and for the rehabilitation of existing ones [23, 24,25], but also sound information related to the metallurgy of structural steel, welding, inspection, and quality control [26,27,28].

It was realized that the column face, at the connection, is a highly stressed zone; therefore, constructional detailing using the concept of weakening (reducing the upper and lower flanges at a selected distance from the column face) [29,30] or strengthening (adding ribs, cover plates, and haunches) could be applied [31]; the plastic hinge must be removed from the column face to a zone of lesser stress. In addition, the detrimental effect of the slab, when it is coupled compositely with the beam, which converts the strong column-weak beam concept into a weak column-strong beam mechanism, was also evaluated [32,33].

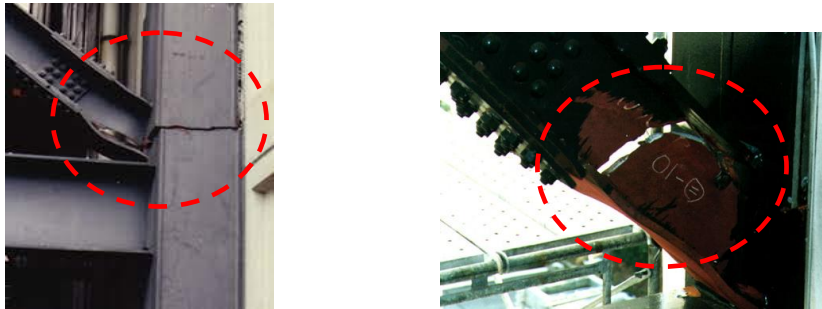
**Fig. 6.** Brittle damage from Kobe earthquake, brace fracture [48,49].

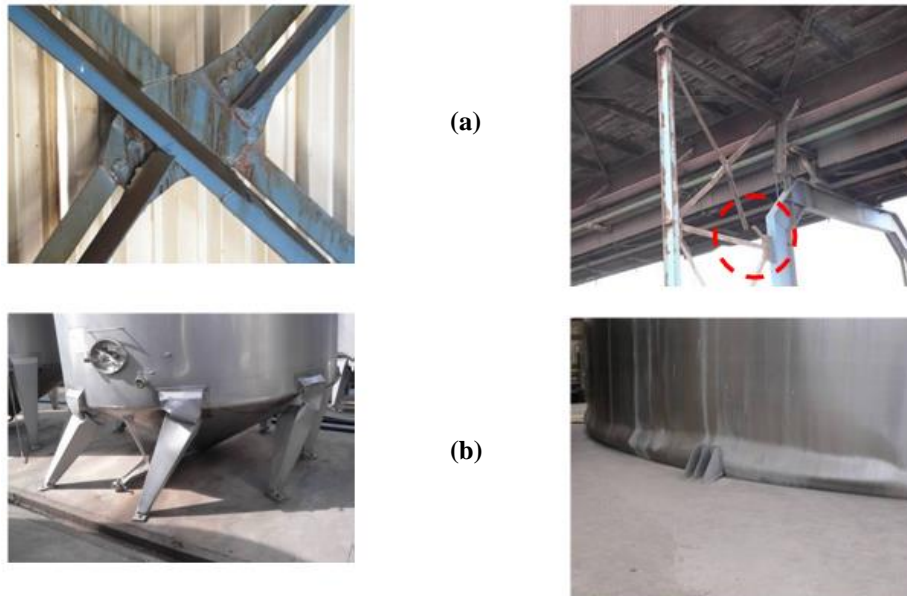
**Fig. 7.** Maule earthquake failure, (a) brace buckling and fracture, (b) buckling at the base of tanks [53].

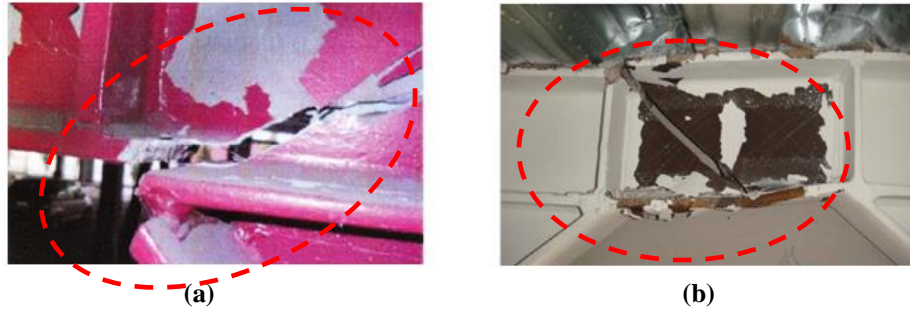
With regard to steel structures, they generally performed well [60]. A specific fracture was observed in the active links of the eccentrically braced frames at Pacific Residential Tower, completed in 2010, with a perimeter EBF as part of a lateral load resisting system, and at a hospital parking garage designed to accommodate two additional floors [60], the first known recording of such failure worldwide, Fig. 8. Related to the EBF links, many studies were performed in order to explain this unexpected fracture, supporting the lack of redundancy, constructional inefficiency, and material inefficiency. However, this type of failure was concentrated on the aforementioned cases and was not a systematic observed fracture. The other types of failure are the classical ones related to steel structures when subjected to severe shaking [46].

**Fig. 8.** Fracture of EBF's links, a) at hospital parking garage, b) at Pacific Residential Tower, [60].

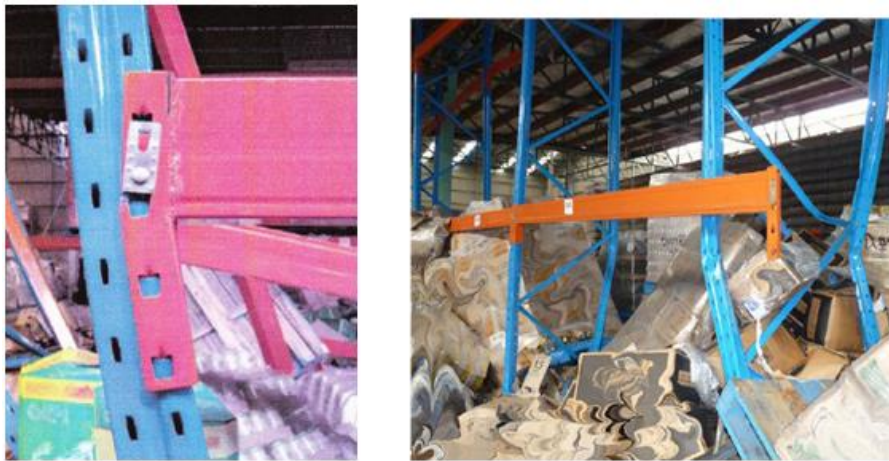
Moreover, typical fractures in braces and local buckling in braces and columns of storage rack pallets were also observed [60], Fig. 9. However, the same damage was also reported in the USA in a series of medium and strong ground motions, such as the Whittier earthquake in 1987, the Loma Prieta earthquake in 1989, the Landers earthquake in 1992, the Northridge earthquake in 1994, the Nisqually earthquake in 2001, and San Simenone in 2003. Storage rack pallets are light, although they carry heavier live loads than dead loads. These structures have complex inelastic behavior due to thin-walled and unsymmetrical cross sections and asymmetry of connections as well, making them prone to buckling. For instance, in the USA, after the repeated and extended damage to the steel storage rack pallets, the FEMA 460 document was published [64] in order to guide the industry.

**Fig. 9.** Failures of steel rack pallets in Christchurch earthquake, 2011 [60].

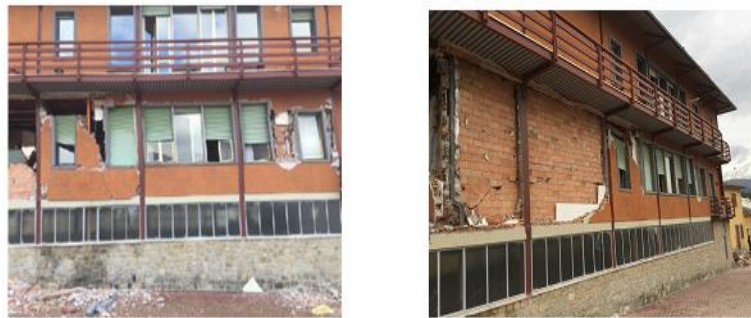
Related to the steel buildings, a characteristic failure was pointed out in the case of an moment resisting frame interacting with masonry infill, Fig. 11, [74]. There are many situations where infill masonry is used instead of braces to limit lateral deformation. However, for such cases, special detailing should be used; for instance, we can distinguish between two main ways: (i) detaching the infill masonry from the main frame and filling the gap with a compressible material, or (ii) connecting it with steel angles or other steel elements anchored to the main frame. In both cases, out-of-plan bending of the infill masonry must be ensured.

**Fig. 11.** Steel frame with infill masonry interaction, Amatrice earthquake, 2016, [74].
