Behavior of steel building structures subjected to strong and benchmark seismic actions: An overview of damage from the observations of the last 40 years

Anthimos Anastasiadis¹

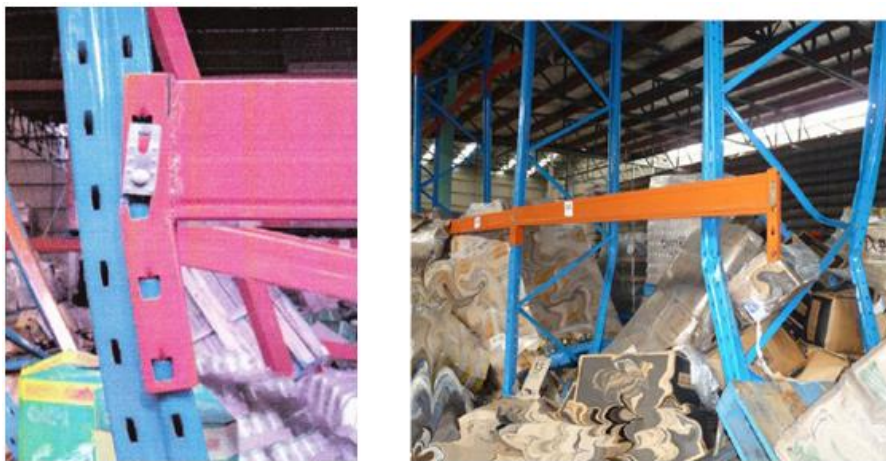
Moreover, typical fractures in braces and local buckling in braces and columns of storage rack pallets were also observed [60], Fig. 9. However, the same damage was also reported in the USA in a series of medium and strong ground motions, such as the Whittier earthquake in 1987, the Loma Prieta earthquake in 1989, the Landers earthquake in 1992, the Northridge earthquake in 1994, the Nisqually earthquake in 2001, and San Simenone in 2003. Storage rack pallets are light, although they carry heavier live loads than dead loads. These structures have complex inelastic behavior due to thin-walled and unsymmetrical cross sections and asymmetry of connections as well, making them prone to buckling. For instance, in the USA, after the repeated and extended damage to the steel storage rack pallets, the FEMA 460 document was published [64] in order to guide the industry.

Fig. 9. Failures of steel rack pallets in Christchurch earthquake, 2011 [60].
