Behavior of steel building structures subjected to strong and benchmark seismic actions: An overview of damage from the observations of the last 40 years

Anthimos Anastasiadis¹

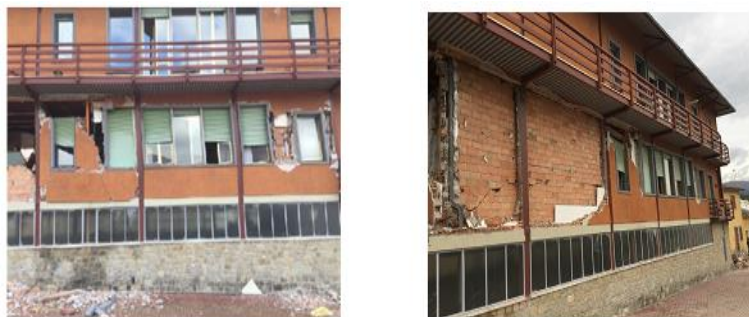
Related to the steel buildings, a characteristic failure was pointed out in the case of an moment resisting frame interacting with masonry infill, Fig. 11, [74]. There are many situations where infill masonry is used instead of braces to limit lateral deformation. However, for such cases, special detailing should be used; for instance, we can distinguish between two main ways: (i) detaching the infill masonry from the main frame and filling the gap with a compressible material, or (ii) connecting it with steel angles or other steel elements anchored to the main frame. In both cases, out-of-plan bending of the infill masonry must be ensured.

Fig. 11. Steel frame with infill masonry interaction, Amatrice earthquake, 2016, [74].
