Seismic Assessment and Proposal for Interventions of a Historical Masonry Building in Rhodes

Andromachi Eleftheriou, Aristidis Papachristidis, Constantinos Repapis

Andromachi Eleftheriou¹, Aristidis Papachristidis² and Constantinos Repapis¹

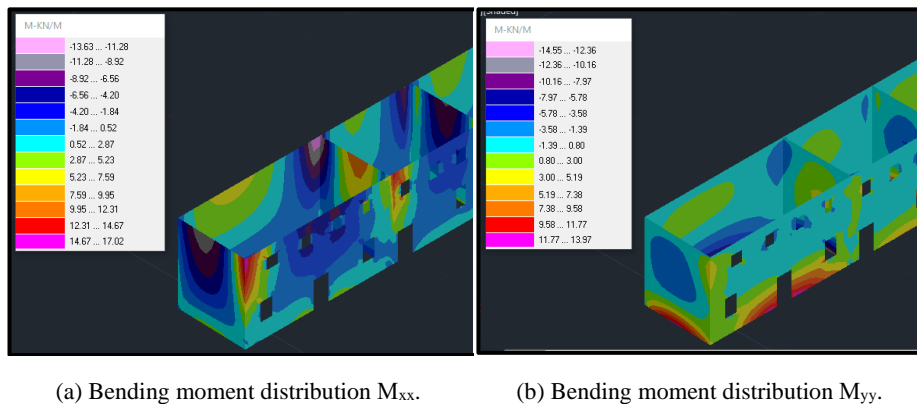
Fig. 3. Bending moment distribution for the seismic load combination $G+0.30Q+E_x+0.30E_y$.

It is observed that the largest values of out-of-plane bending moments about the vertical axis are developed at the connections with the transverse walls, while the largest values of out-of-plane bending moments about the horizontal axis are developed at the base of the walls.

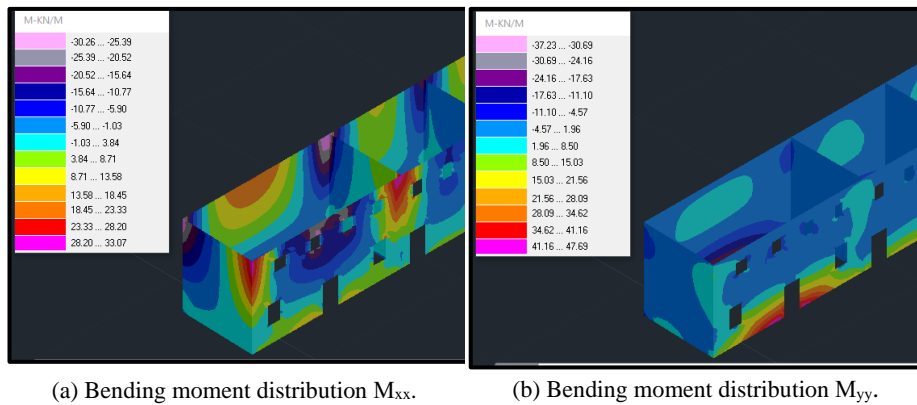
Fig. 1. Bending moment distribution for the seismic load combination $G+0.30Q+0.30E_x+E_y$.

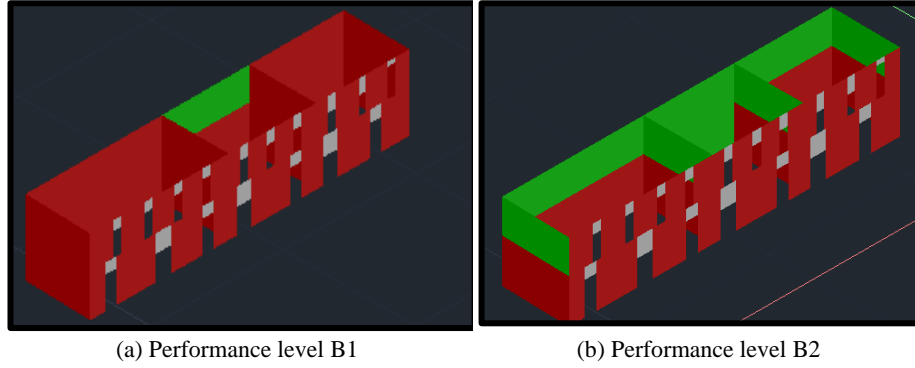
In Fig. 5a, the piers for which there is a deficiency are illustrated in red colour in the 3D model. Therefore, when evaluating the seismic behaviour of the building using the method of the global behaviour factor q and taking as an assessment target the

performance level B1, it is concluded that the building is not sufficient and should be strengthened.

The influence of the performance level on the seismic assessment results of the building was then investigated. The performance level B2 was selected and new elastic analyses were carried out based on the global behaviour factor (q) for $q = 1.5$. Fig. 5b illustrates in colour the piers for which there is inadequacy, which are obviously less than in the analysis for performance level B1 (Fig. 5a). By adopting a less stringent performance objective, i.e. a 50% probability of exceeding the seismic action in 50 years, on the basis of which the seismic action is reduced by about 40%, the more favourable behaviour of the masonry is evident, mainly in out-of-plane bending.

Fig. 5. Colour representation of inadequacies of the piers (green: adequacy, red: inadequacy).

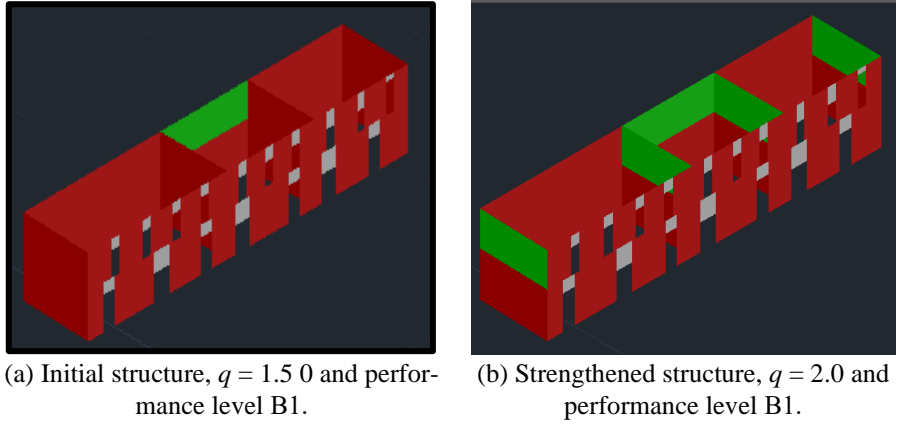
Fig. 6 illustrates in red colour the piers that fail in the original and the strengthened structure, respectively, for performance level B1. From Tables 5 to 7 and Fig. 6, it is observed that the failure indices for in-plane shear action for most of the piers have been significantly reduced after the interventions, however, shear failures of masonry remain. The same conclusion is reached for the out-of-plane action.

Significantly improved behaviour of the masonry appears mainly in the crown of the walls and in particular in out-of-plane bending for plane of failure perpendicular to the bedjoints. This can be attributed to the strengthening of the diaphragm function of the roof. Overall, despite the significant improvement observed in the failure indices, the building still exhibits deficiencies.

Fig. 6. Colour representation of failed piers (green: adequacy, red: inadequacy).

The behaviour of the structure against earthquake can also be improved by strengthening the stiffness of the building's diaphragm. The construction of a perimeter ring beam and a reinforced concrete slab at the roof is investigated. The installation of a second additional floorboard in the mezzanine, oriented perpendicular to that of the existing floorboard, is being considered. In the analysis of the strengthened structure, according to the Greek Code for Structural Interventions of Masonry Structures, the behaviour factor (q) can be taken equal to 2.0.

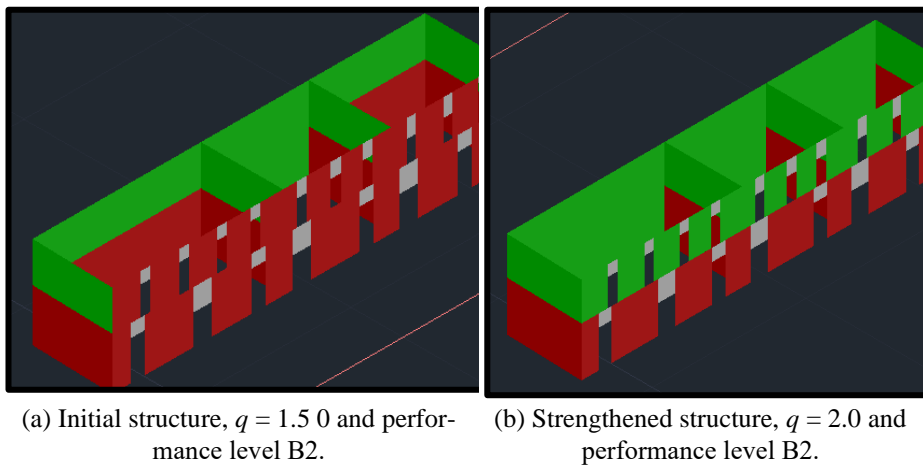
Fig. 7. Colour representation of failed piers (green: adequacy, red: inadequacy).

As with the original building, the behaviour of the strengthened building was investigated for performance level B2, i.e. for an earthquake with a 50% probability of exceedance in 50 years. In Fig. 7, the piers that fail in the original and the strengthened structure, respectively, for performance level B2 are shown in colour in the 3D model.

As shown by the analysis of the strengthened building, for performance level B2, failure occurs only for in-plane shear actions, in the face piers and in the piers along the transverse direction (short side) of the building, only for the ground floor level. The favourable function of the diaphragm at the crown of the building is evident, where no pier shows deficiency in out-of-plane bending.

The strengthened structure is still inadequate regarding in-plane shear, even if grout injection and the diaphragm insertion improved the behaviour of the structure. Other methods that could be applied for strengthening of the structure could be the application of a layer of shotcrete with added reinforcement mesh to the walls which would increase both out-of-plane and in-plane strength, the application of fibre reinforced polymer sheets to the walls, or the application of fibre reinforced mortar jacketing. These methods would significantly increase the shear capacity of the walls, however, since the examined structure is a listed building, all of these methods should be approved and take listed building consent for repair works from the appropriate authorities.
