Seismic Assessment and Proposal for Interventions of a Historical Masonry Building in Rhodes

In this study, an evaluation of a historical masonry building, located in Rhodes, is carried out based on the Greek Code for Structural Interventions of Masonry Structures. Specifically, it is checked whether the minimum requirements of its load-bearing capacity are met both during the assessment and during its redesign, after the proposed interventions. Under certain conditions, the minimum load-bearing capacity requirements for the assessment and redesign of an existing structure may be reduced compared to the provisions of the current design codes for new structures.

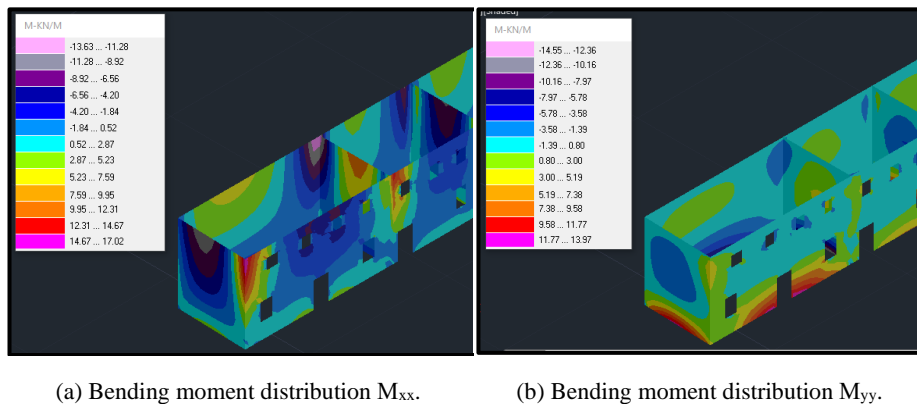
Fig. 3. Bending moment distribution for the seismic load combination $G+0.30Q+E_x+0.30E_y$.

It is observed that the largest values of out-of-plane bending moments about the vertical axis are developed at the connections with the transverse walls, while the largest values of out-of-plane bending moments about the horizontal axis are developed at the base of the walls.

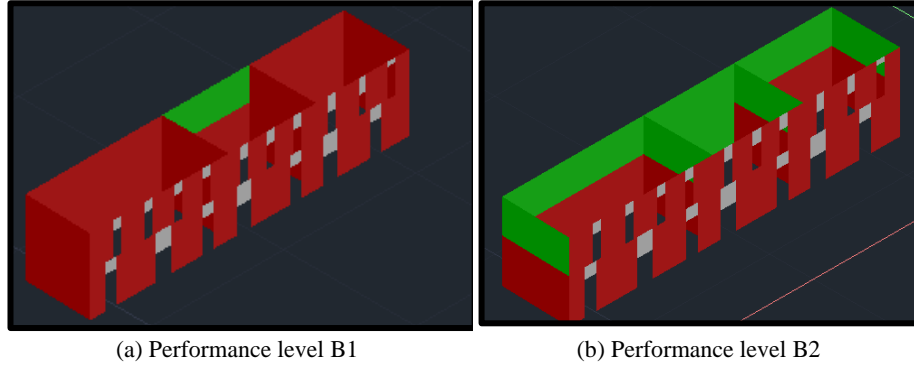
In Fig. 5a, the piers for which there is a deficiency are illustrated in red colour in the 3D model. Therefore, when evaluating the seismic behaviour of the building using the method of the global behaviour factor q and taking as an assessment target the

performance level B1, it is concluded that the building is not sufficient and should be strengthened.

The influence of the performance level on the seismic assessment results of the building was then investigated. The performance level B2 was selected and new elastic analyses were carried out based on the global behaviour factor (q) for $q = 1.5$. Fig. 5b illustrates in colour the piers for which there is inadequacy, which are obviously less than in the analysis for performance level B1 (Fig. 5a). By adopting a less stringent performance objective, i.e. a 50% probability of exceeding the seismic action in 50 years, on the basis of which the seismic action is reduced by about 40%, the more favourable behaviour of the masonry is evident, mainly in out-of-plane bending.

However, in this case more frequent and more extensive damage are expected for the same earthquake.

Fig. 5. Colour representation of inadequacies of the piers (green: adequacy, red: inadequacy).
