Seismic Assessment and Proposal for Interventions of a Historical Masonry Building in Rhodes

Andromachi Eleftheriou¹, Aristidis Papachristidis² and Constantinos Repapis¹

Abstract. The aim of this study is the seismic assessment of a historical twostorey masonry building, located in the city of Rhodes and the investigation of intervention ways to strengthen the building and improve the mechanical characteristics of its materials. The 3DR.PESSOS software was used for the simulation and analysis of the structure. For the evaluation of the seismic behaviour of the building, an elastic static analysis (lateral force analysis) was carried out based on the Greek Code for Structural Interventions of Masonry Structures. Elastic static analysis methods with global behaviour factor (q) or local ductility indices (m) were applied for performance levels B1 and B2. From the analyses and the code checks it was concluded that the building is vulnerable to in-plane and outof-plane actions. For this reason, methods of intervention are being investigated to increase the diaphragm function of the building and to improve the mechanical characteristics of the masonry.

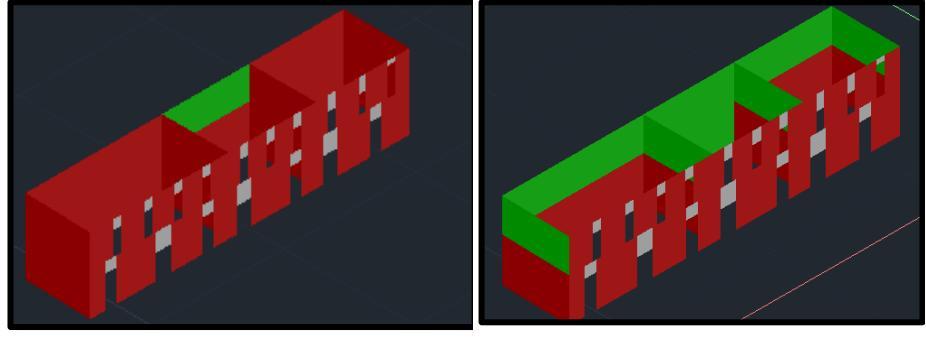
Fig. 5. Colour representation of inadequacies of the piers (green: adequacy, red: inadequacy).

In Fig. 5a, the piers for which there is a deficiency are illustrated in red colour in the 3D model. Therefore, when evaluating the seismic behaviour of the building using the method of the global behaviour factor q and taking as an assessment target the

performance level B1, it is concluded that the building is not sufficient and should be strengthened.

The influence of the performance level on the seismic assessment results of the building was then investigated. The performance level B2 was selected and new elastic analyses were carried out based on the global behaviour factor (q) for q = 1.5. Fig. 5b illustrates in colour the piers for which there is inadequacy, which are obviously less than in the analysis for performance level B1 (Fig. 5a). By adopting a less stringent performance objective, i.e. a 50% probability of exceeding the seismic action in 50 years, on the basis of which the seismic action is reduced by about 40%, the more favourable behaviour of the masonry is evident, mainly in out-of-plane bending.

However, in this case more frequent and more extensive damage are expected for the same earthquake.

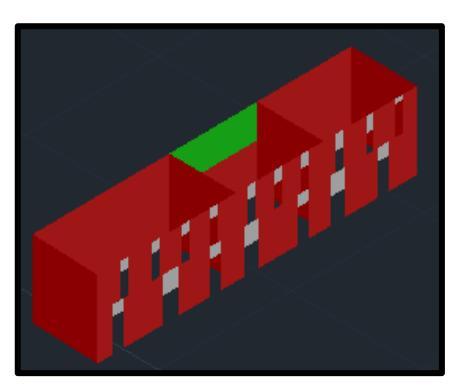
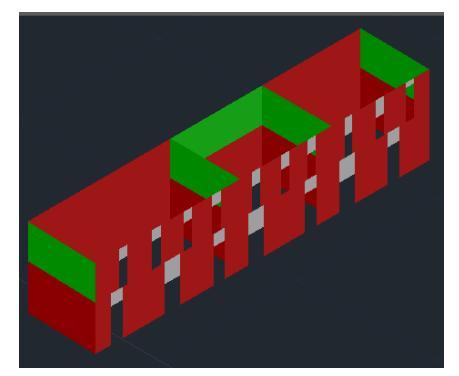
Fig. 6. Colour representation of failed piers (green: adequacy, red: inadequacy).

Fig. 6 illustrates in red colour the piers that fail in the original and the strengthened structure, respectively, for performance level B1. From Tables 5 to 7 and Fig. 6, it is observed that the failure indices for in-plane shear action for most of the piers have been significantly reduced after the interventions, however, shear failures of masonry remain. The same conclusion is reached for the out-of-plane action.

Significantly improved behaviour of the masonry appears mainly in the crown of the walls and in particular in out-of-plane bending for plane of failure perpendicular to the bedjoints. This can be attributed to the strengthening of the diaphragm function of the roof. Overall, despite the significant improvement observed in the failure indices, the building still exhibits deficiencies.

Grout injection is an effective method for strengthening masonry walls. This technique involves low-pressure injection of fine hydraulic lime grout into cracks, voids, and cavities within the masonry, aiming to create a more homogenous structure. This method was initially investigated to increase the compressive strength of the masonry. The new compressive strength of the strengthened masonry was calculated based on equation 8.2 of the Greek Code for Structural Interventions of Masonry Structures [3],

The behaviour of the structure against earthquake can also be improved by strengthening the stiffness of the building's diaphragm. The construction of a perimeter ring beam and a reinforced concrete slab at the roof is investigated. The installation of a second additional floorboard in the mezzanine, oriented perpendicular to that of the existing floorboard, is being considered. In the analysis of the strengthened structure, according to the Greek Code for Structural Interventions of Masonry Structures, the behaviour factor (q) can be taken equal to 2.0.

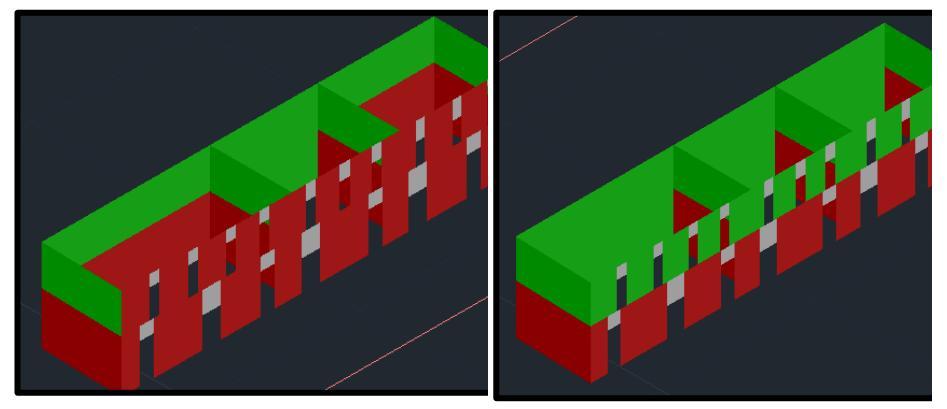
Fig. 7. Colour representation of failed piers (green: adequacy, red: inadequacy).

As with the original building, the behaviour of the strengthened building was investigated for performance level B2, i.e. for an earthquake with a 50% probability of exceedance in 50 years. In Fig. 7, the piers that fail in the original and the strengthened structure, respectively, for performance level B2 are shown in colour in the 3D model.

As shown by the analysis of the strengthened building, for performance level B2, failure occurs only for in-plane shear actions, in the face piers and in the piers along the transverse direction (short side) of the building, only for the ground floor level. The favourable function of the diaphragm at the crown of the building is evident, where no pier shows deficiency in out-of-plane bending.

In conclusion, the method of homogenising the masonry mass with grout injections and increasing its compressive strength, in terms of in-plane shear action, does not achieve adequacy in all the piers of the structure, however, the seismic behaviour of the masonry is clearly improved. At the same time the contribution of the diaphragm at the crown level is decisive in out-of-plane flexural failure.

The strengthened structure is still inadequate regarding in-plane shear, even if grout injection and the diaphragm insertion improved the behaviour of the structure. Other methods that could be applied for strengthening of the structure could be the application of a layer of shotcrete with added reinforcement mesh to the walls which would increase both out-of-plane and in-plane strength, the application of fibre reinforced polymer sheets to the walls, or the application of fibre reinforced mortar jacketing. These methods would significantly increase the shear capacity of the walls, however, since the examined structure is a listed building, all of these methods should be approved and take listed building consent for repair works from the appropriate authorities.

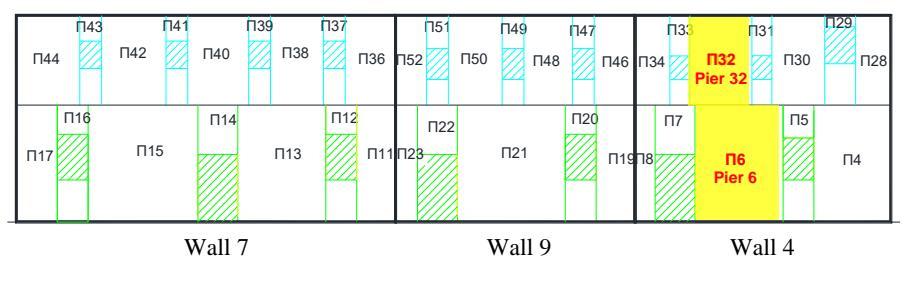
Fig. 8. Numerical representation of piers, for levels 1 and 2.

Detailed calculations in vertical loads, in-plane and out-of-plane bending moment and shear check of piers 6 and 32 are presented below. Piers 6 and 32 are highlighted in yellow in Fig. 9.

The in-plane shear check, according to the global behaviour factor method and for load combination G+0.30Q+Ex+0.30Ey, is presented in detail for pier 6 (Fig. 8).

Therefore, the failure index is $\lambda = V_{sd} / V_{Rd} = 3.59 > 1$, that is the capacity of the pier is inadequate.

Therefore, the failure index is $\lambda = M_{sd,y} / M_{Rd2,o} = 4.07 > 1$, meaning that the capacity of the pier is not adequate.
