ENGINEERING GEOLOGICAL BEHAVIOUR OF VOLCANIC FORMATIONS. REFERENCES TO INSTABILITY PHENOMENA AND TOWN PLANNING IN LESVOS ISLAND, GREECE.

Saroglou H.¹

Engineering Geologist, M.Sc., PhD

*Geotechnical Dept., School of Civil Engineering, National Technical University of Athens,
7-9 Iroon Polytechniou Str., 15780, Zografou. tel. 210 7722440, e-mail: saroglou@central.ntua.gr*

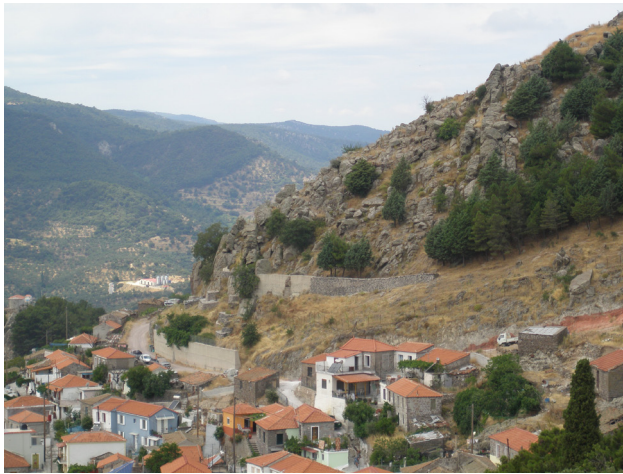
Fig. 2. Rock slope overhanging the village of Stypsi where rockfalls have occurred.
Εικ. 2. Πλαγιά ανάντι του χωριού Στύψη στην οποία έχουν εκδηλωθεί καταπτώσεις.

Characteristic rock failures in the form of rockfalls are encountered in the village of Stypsi (Fig. 2) and the protruding rock tower in the city of Petra, where the monastery Koimisi of Theotokos is founded. Toppling failures are encountered along the national road near the village of Ipsilometopo, where andesitic lavas with vertical cooling joints outcrop (Fig. 3).

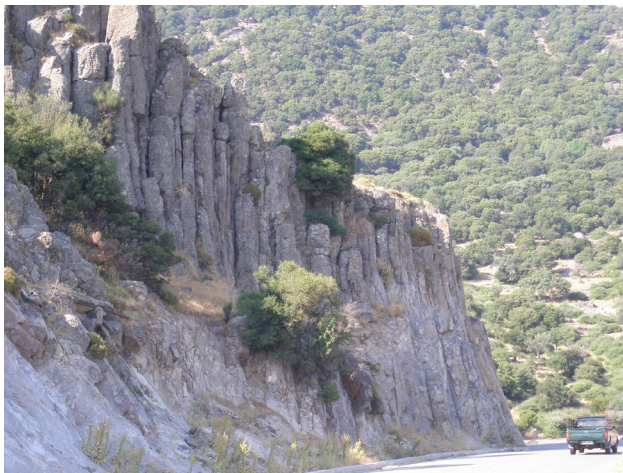
Fig. 3. Slope in andesitic lavas, prone to toppling failure.
Εικ. 3. Πρανές σε ανδεδαιτικές λάβες, αστοχία υπό μορφή ανατροπής.

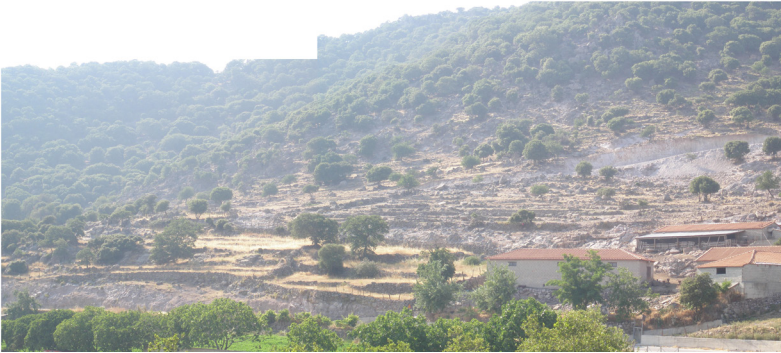
Fig. 4. Area with instability phenomena in tuffs and extremely weathered andesites.

As stated earlier, soil instabilities in the broader area are found in the weathered profiles of lavas and pyroclastic formations. Such a landslide occurred in the study area (near Stypsi village in December 1968 in the tuff and the weathered upper parts of the andesitic formations, which are practically clay soil formations with some rock blocks (Fig. 4). The slide caused a movement over a length of 60 m, with a vertical displacement of 1.0 m at the national road. The landslide had an area of 5 acres as reported by Katsikatsos (1969). The slope where the landslide occurred has an angle of 20-22° dipping to SE. The area of the slide consist of pyroclastic tuffs and totally weathered andesites, having a high per-

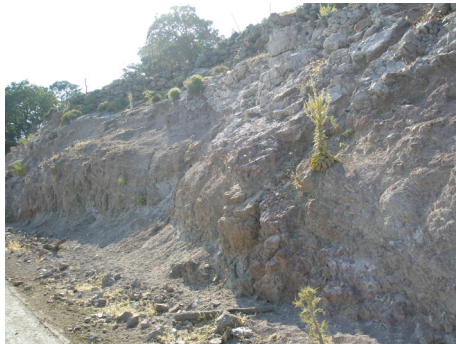
Fig. 5. Close view of tuffs and extremely weathered andesites in the site of the examined slope failure.

centage of clay minerals (Fig. 5). These are overlain by massive andesite rocks of the upper lava unit, which due to their fracturing, result in the formation of contact springs along their base. Along the slipped area, springs are encountered until today with generally low outflow (3 - 5 m³/h).

In area 2, the weathering grade of the tuffs and andesites is V to VI having a soil like behavior. The original structure of the andesitic rock is retained in very few places, in the form of small core-stones within the clay soil mass (Fig. 5).

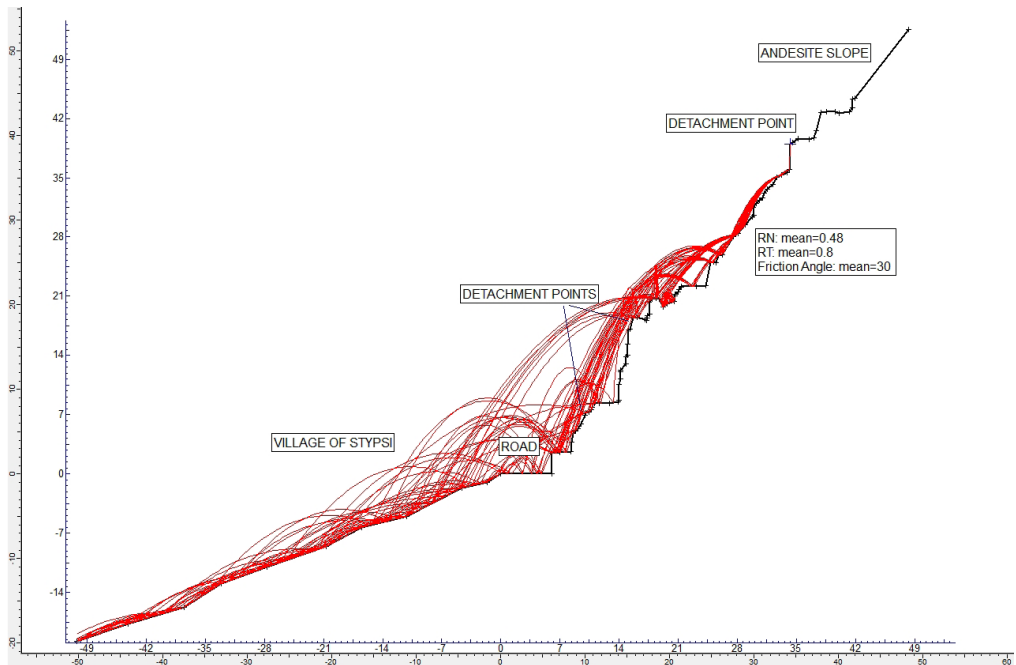
Fig. 6. Rockfall analysis for the slope of Stypsi village.

A rockfall analysis was performed in order to study the phenomenon using Rocfall software (Rocscience Ltd.). The slope section for the analysis was taken from Andronopoulos and Koukis (1979). The coefficients of restitution of the andesites were considered equal to $R_n = 0.63$ and $R_t = 0.85$, based on relevant experience (Richards et. al., 2001). The analysis was performed, considering different heights of the detachment of the rocks (ranging between 9 and 40 m). Additionally, since the normal coefficient decreases with the increase of weathering, a set of analysis were carried out using different weathering grades of the rock slope. Saroglou et. al. (2010) have proposed a correlation between the normal coefficient of restitution, R_n , and the Schmidt

hammer value, described by the equation $R_n = 0.0086 \cdot SHV + 0.19$. Based on the Schmidt hammer values shown in Tab. 2, the coefficient was reduced as the weathering grade increased. More specifically, R_n was calculated equal to 0.58 for weathering grade II and 0.48 for grade III. The tangential coefficient is less dependant on the hardness of the bouncing surface, therefore it was only reduced from 0.85 to 0.80. The friction angle was reduced from 32 to 30 degrees. No initial velocity of the falling rocks was considered. The resulting kinetic energy at the slope foot (at the upper end of the village) was found to increase substantially with the height of the detachment point, while it reduced significantly with increasing weathering degree, as shown in Fig. 7.

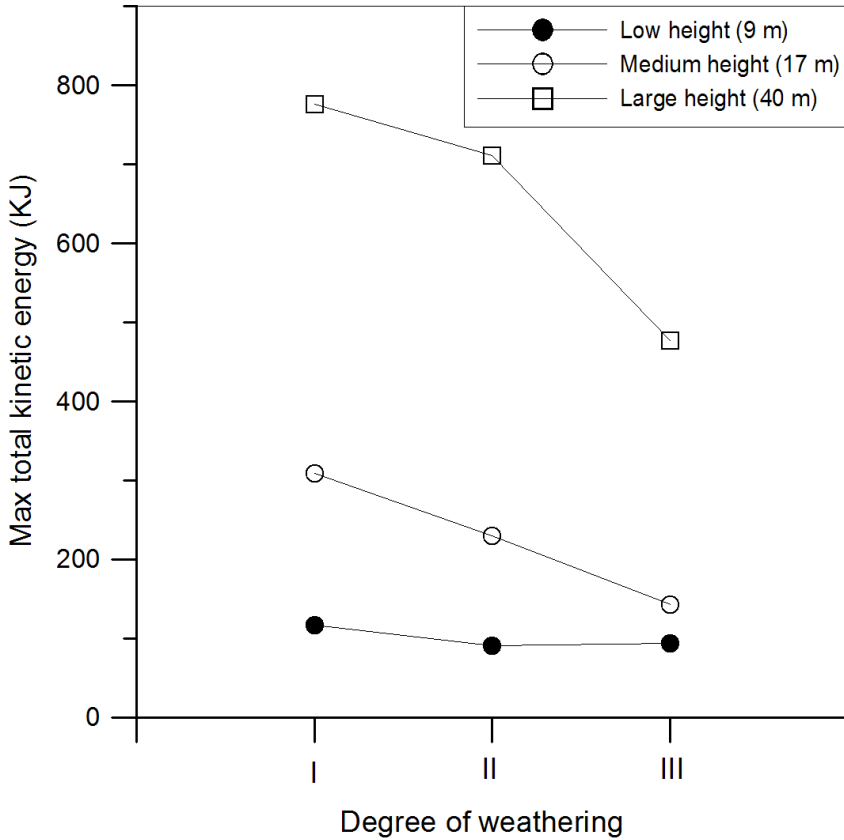
Fig. 7. Variation of maximum total kinetic energy related to weathering degree

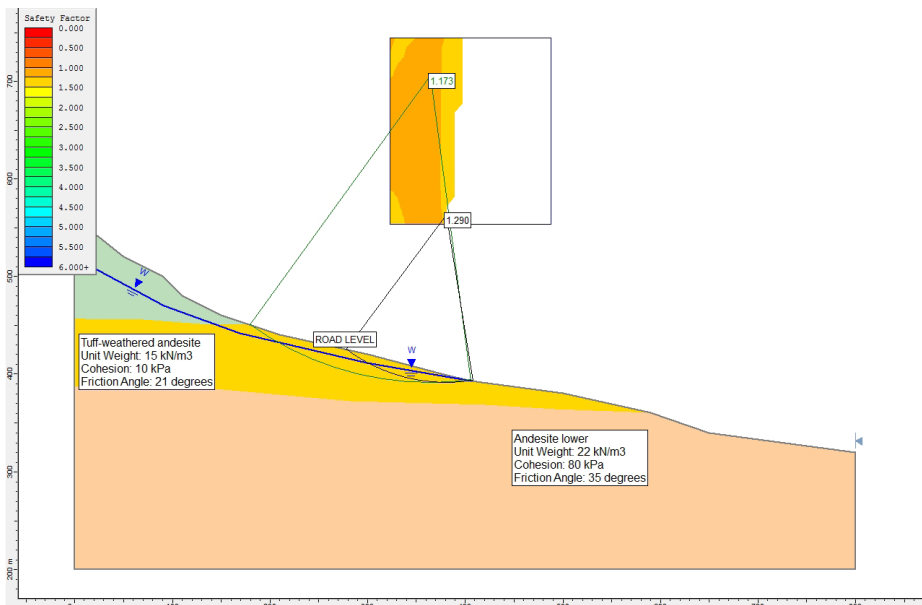
Fig. 8. Slope stability analysis at the landslide site of a slope near Stypsi village.

The stability analysis was performed verifying that the geometry of the sliding surface coincides with the field observations and description given by Katsikatos (1969). The analysis was performed with Slide software (Rocscience Ltd.). The factor of safety for saturated conditions was calculated equal to 1.17 (as shown in Fig. 8), while for drained conditions it was found equal to 1.89. This implies that failure occurred under un-drained conditions. The factor of safety under seismic loading was calculated equal to 1.25. It was also investigated that if the slide occurred at lower elevation the factor of safety would be slightly higher due to the lower slope angle.
