PRELIMINARY RESULTS REGARDING THE ROCK FALLS OF DECEMBER 17, 2009 AT TEMPI, GREECE

Abstract

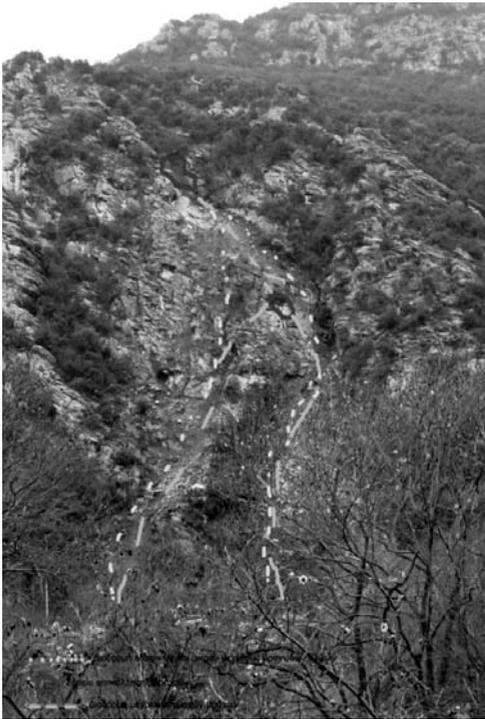
Fig. 3: Fall track of the boulders (red circles indicate the source area and green lines show the path).

On December 17, 2009 large size slope instability took place at the area of Tempi, central Greece resulting to one casualty and the permanent close of the national road Athens-Thessaloniki. In particular a large block was detached from a high up to 70 meters and moved downward (figure 2). During its fall the initial boulder triggered the detachment of smaller rocks, creating a combination of rock falls and rock slides. As it is shown in figure 3, the fall track of this failure is separated into two paths.

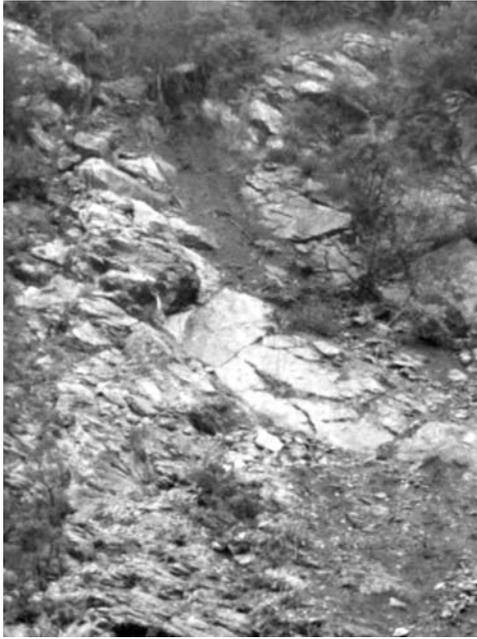
Fig. 6: The initiation of the slope failure originated as sliding along the joint 350/47.

Three main tectonic systems are found in the area, given in Table 2. In the area where the failure was generated most unstable conditions of rock slopes are related to planar weaknesses. Wedge failures most likely where line of intersection of two fracture planes dips $< \phi$ and daylight in slope. The studied failure started by the sliding of a big block along the joint 350/47 (Fig. 6) which activated and drifted smaller geomaterials, down slope, toward the road (Fig. 7). The bedding of the crystalline limestone is $110/10$ (Fig. 8). The related stability analysis of the slope is given in Fig. 9.

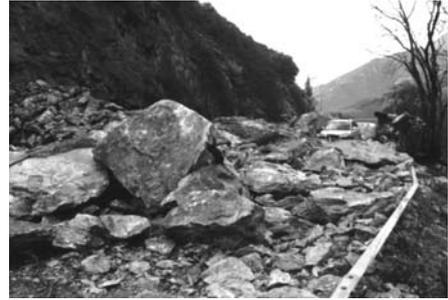
Fig. 7: Boulders on the road.

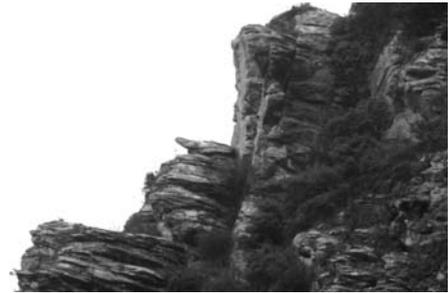
Fig. 8: Bedding 110/10 and fault 20/80.
