EVALUATING THE TRIGGERING FACTORS OF THE ROCK FALLS OF 16TH AND 21ST DECEMBER 2009 IN NEA FOKEA, CHALKIDIKI, NORTHERN GREECE

Christaras B.¹, Syrides G.¹, Papathanassiou G.¹, Chatzipetros A.¹,
Mavromatis T. ¹. Pavlides Sp.¹

Abstract

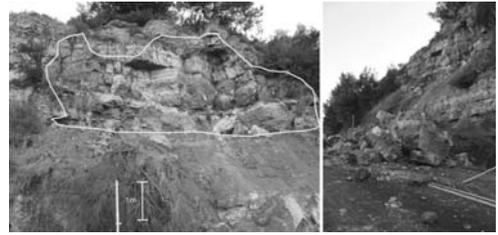
Fig. 4: Source area of the December 21, 2009 rock falls.

However, few days later, on Monday morning of December 21st, a larger scale slope failure happened. As shown in figure 4, boulders with volume ranging from 2 to 15m³ fell on the road from a height of 10 meters, causing the permanent closure of the country road. A few hours after the second slope failure, a field survey took place in order to examine the rock falls and evaluate the triggering factors.

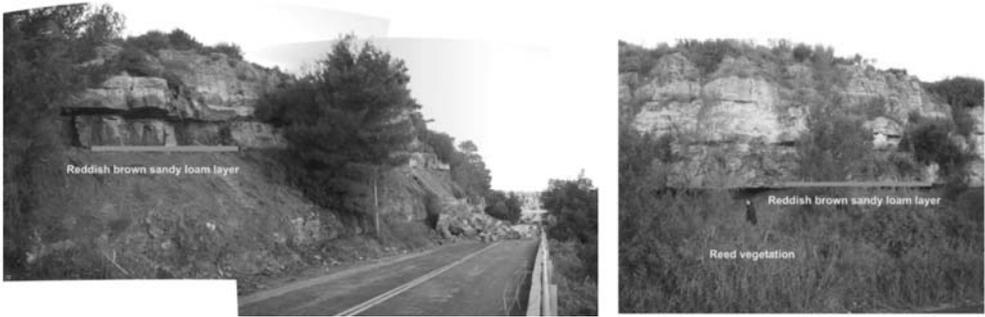
Fig. 7. The layer of reddish-brown sandy loam is slowly washed out by the percolating water from the overlying limestone (note the beginning of undercutting). The water favors thick reed vegetation. It is a matter of time this slow process to undercut the limestone causing a rockfall in this place in the future.

It is remarkable that within the limestone numerous vertical cracks allow the percolating water to pass downwards, but the intercalation of reddish-brown sandy layer (bed 3) between the limestone beds causes the drying up of the water from the superimposed limestone along this contact. As a result, thick reed vegetation appears along and below the contact. It is also remarkable that this bed of reddish sandy loam prevents water from percolating in the lower strata, resulting to the dryness of contact between the base of the limestone (Trilophos Fm.) and the top of the red beds (Triglia Fm.).

the unstable conditions that were created these specific two days (16th and 21st of December 2009), thus concluding that in both cases the rock falls were generated by the undercut of the reddish brown sandy loam bed.
