FLOOD HISTORY ANALYSIS AND ITS CONTRIBUTION TO FLOOD HAZARD ASSESSMENT. THE CASE OF MARATHONAS, GREECE

Diakakis M.¹

¹ Department of Geology and Geoenvironment, National and Kapodistrian University of Athens 15784 Athens, Greece, diakakism@geol.uoa.gr

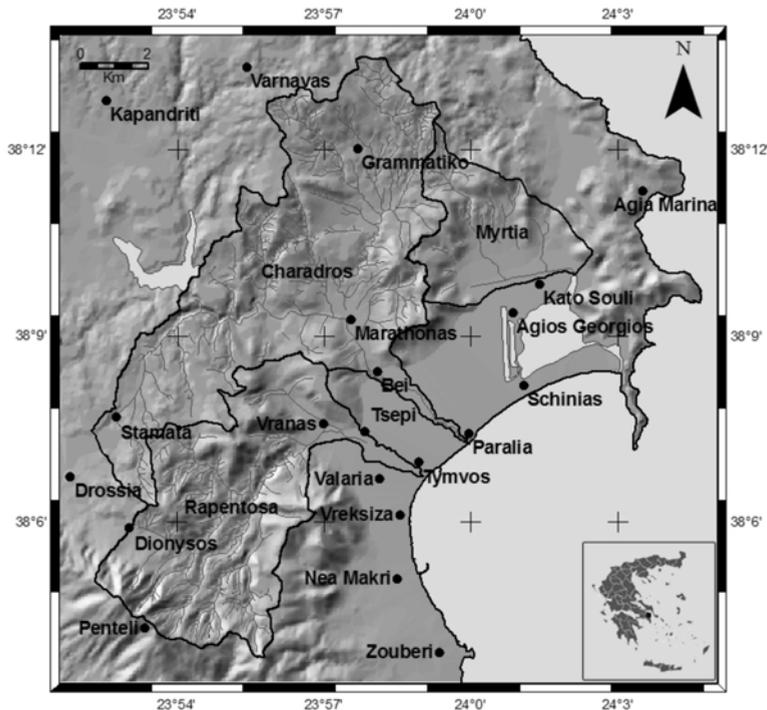
Fig. 1: Map showing the three catchments, the drainage network and the main settlements and landmarks. At the north east part of the map Myrtia borders with Charadros, which in turn borders with Rapentosa catchment from the south.

The southernmost catchment (37,5 km²) is drained by Rapentosa torrent and borders with Nea Makri from the south and with Charadros catchment from the north. The drainage network reaches the north side of Penteli and Dionysos and runs off, forming a steep gorge, into Marathonas plain and through Vranas settlement. At present the torrent is drained at the last part of its course by an artificial underground waterway. Bordering from the north with Rapentosa, Charadros is the largest of the 3 catchments, even though its drainage area was reduced to 60,2 km² after the construction of Marathonas' dam in 1929. It reaches the sea at the central part of the plain, passing between Kotroni and Stavrokoraki hills and through the modern village of Marathonas. The third and smallest catchment (15,2 km²) is drained by Myrtia torrent, a poorly developed drainage network which flows into a marsh, lying on the north-east part of the plain. The water, leaving the hilly area drains into artificial channels until it reaches the swamp and subsequently the sea through a manmade canal. All three catchments are dry for most of the year.

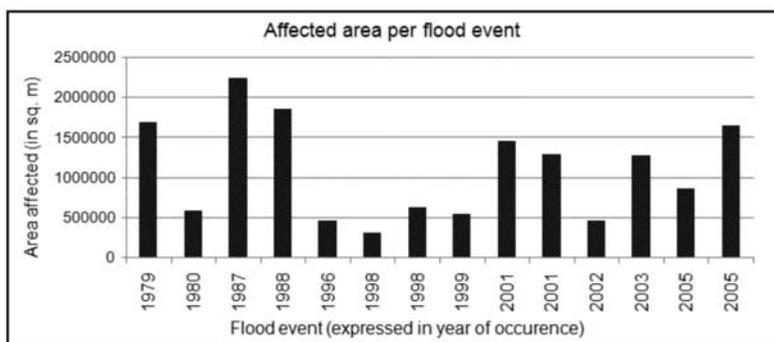
Fig. 2: Chart showing the fluctuation of affected areas in square metres through the years, for each flood event. In horizontal axis, events are expressed in year of occurrence.

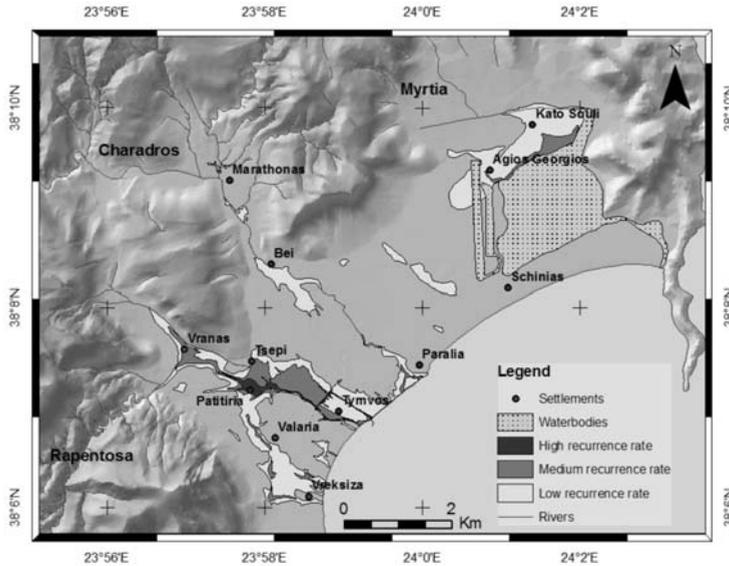
Fig. 3: Map showing the areas that flooded during last 30 years. High recurrence rate represents areas that flooded 10 to 14 times in 30 years. Medium recurrence rate stand for locations that flooded 5 to 9 times and low recurrence rate areas that flooded 1 to 4 times in the same period.

Flooding has a higher repetition rate in Rapentosa torrent (13 events in 30 years) than in Charadros (7 events in 30 years) and Myrtia catchment (6 events in 30 years). Data analysis, as described in 4.1, showed explicitly the areas with higher recurrence rate. Figure 3 illustrates these areas with a ranking based on the number of events suffered in 30 years. Thus, high recurrence rate represents areas that flooded 10 to 14 times during this period, whereas medium recurrence rate locations that flooded 5 to 9 times and low recurrence rate areas 1 to 4 times. According to this process high recurrence rate locations can be identified at Patitiria and Tymvos and medium rate areas at Valaria and Agios Georgios.
