Ζητήματα της αρχιτεκτονικής αναπαράστασης των μνημείων στο ιερό του Αμυκλαίου Απόλλωνα

Themistocles Bilis, Maria Magnisali

Issues Concerning the Architectural Reconstruction of the Monuments of the Sanctuary of Apollo Amyklaios

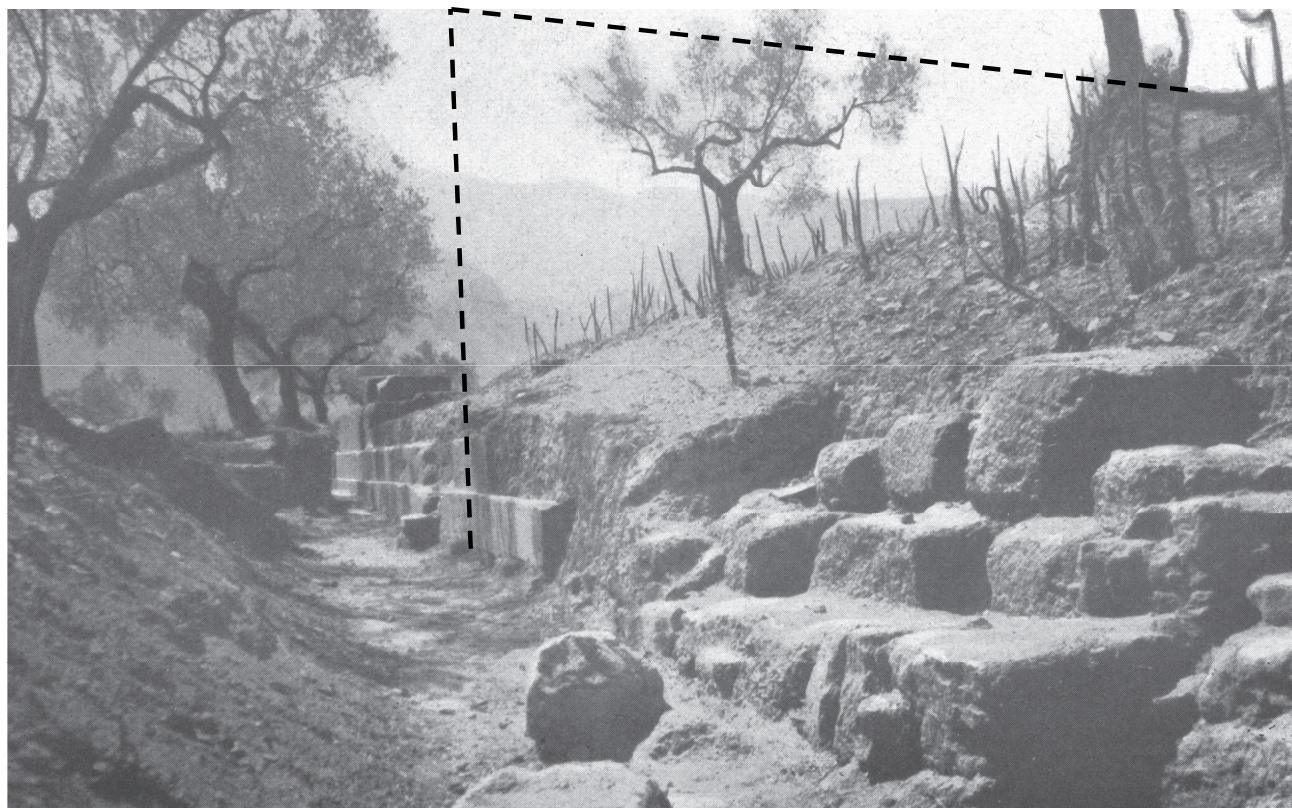
Fig. 1. Amykles, Apollo Sanctuary, *peribolos* (view from south), 1920.
The black dot line indicates the height of the structure during antiquity.
