Τόμ. 43 (2022)

Νέα δεδομένα για την Παναγία Σκριπού στη Βοιωτία

RECENT EVIDENCE ABOUT THE CHURCH OF PANAGIA SKRIPOU IN BOEOTIA

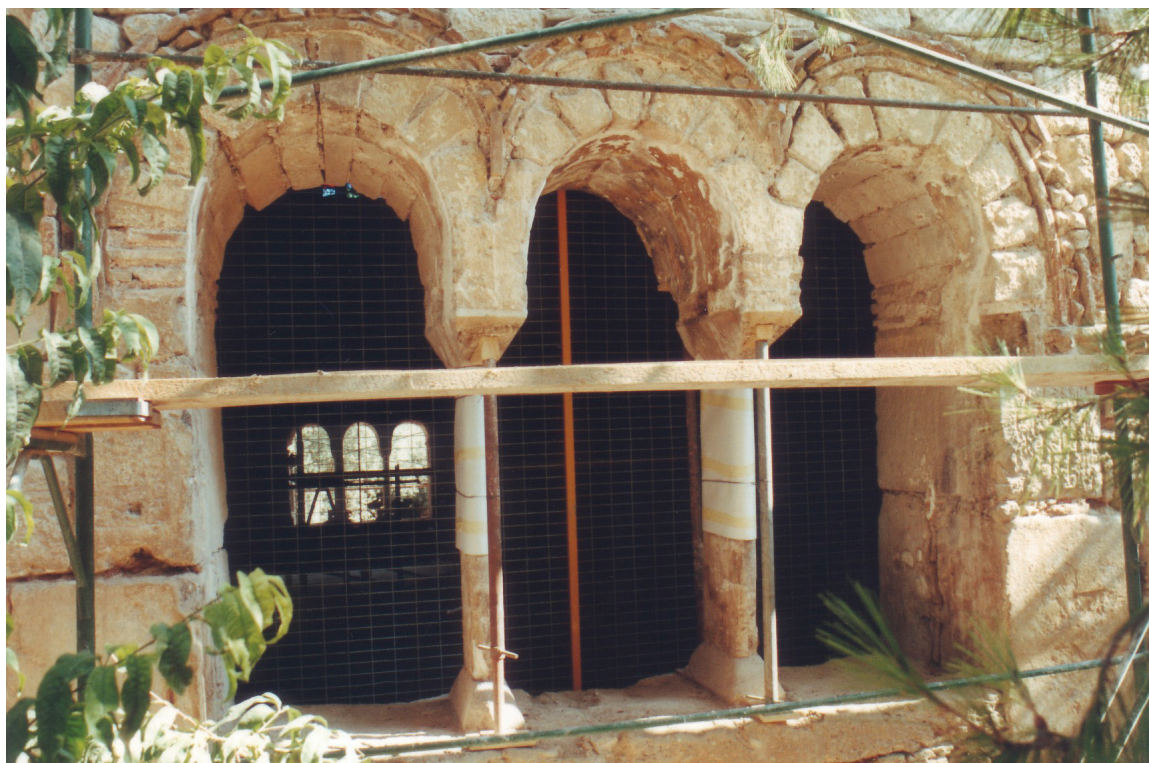
The demolition of the fillings revealed the original arched openings, damaged by differential settlement but intact. The window arches were constructed of stone voussoirs,

Fig. 2. Panagia Skripou. View of the south transept window after works.

The lobes of the bilobed windows of the narthex and the trilobed ones of the transept are supported by slender marble colonettes (Fig. 2). They carry impostes with splayed ends decorated with rosettes and vine leaves in low relief. The jambs of the trilobed windows or the colonettes bear no marks of fixed panels. They were probably shut with wooden moving coverings. Unfortunately the tie beams or the thresholds, on which they would have been fixed, are all missing⁷.

Η διάνοιξη των κτισμένων παραθύρων και θυρών αποκάλυψε τα αρχικά τοξωτά ανοίγματα, πληγωμένα από τη διαφορική καθίζηση αλλά σχετικά ανέπαφα (Εικ. 2). Τα τόξα των παραθύρων ήταν κατασκευασμένα από πέτρινους τοξόλιθους, συνήθως σε δεύτερη χρήση, και περιβάλλονται από οδοντωτές ταινίες (Εικ. 3). Μόνο τα ανατολικά παράθυρα των παραβημάτων ήταν από πλίνθους (Εικ. 4). Ως κατώφλια των θυρών χρησιμοποιήθηκαν πλάκες από υπόλευκο μάρμαρο σε δεύτερη χρήση. Σώζονται εγκοπές για τους στροφείς των θυρών, που σε συνδυασμό με αντίστοιχες αυλακώσεις στους ελκυστήρες χρησιμοποιήθηκαν για τη στερέωση των φύλλων της πόρτας.

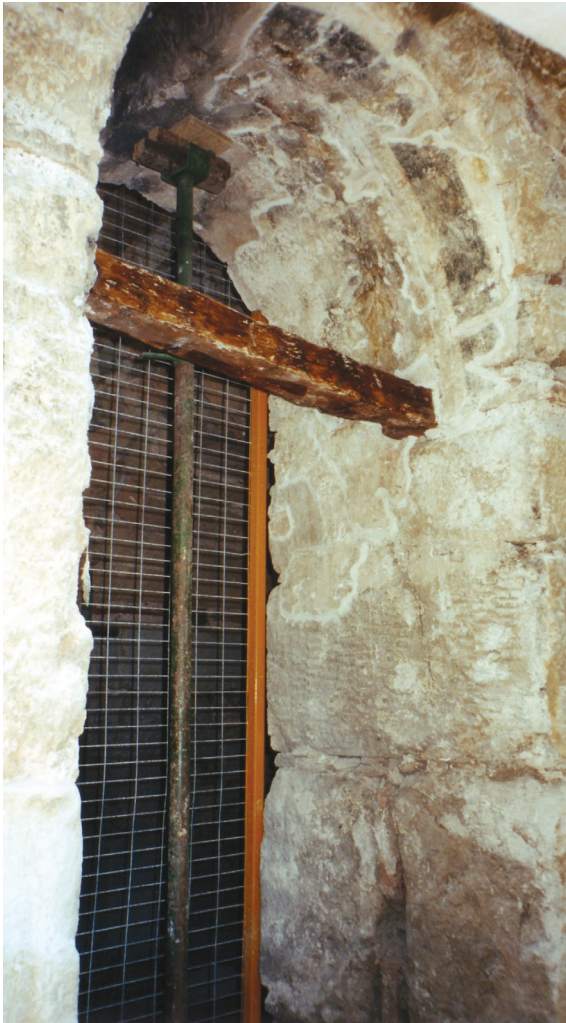
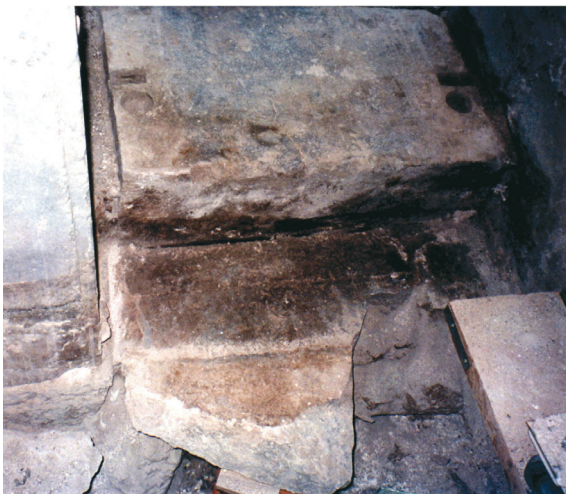
Fig. 6. Panagia Skripou. Narthex, south door. (a) The remaining timber tie-beam and the frescoes covering the walls. (b) The threshold of the south door with parts of the original marble floor.

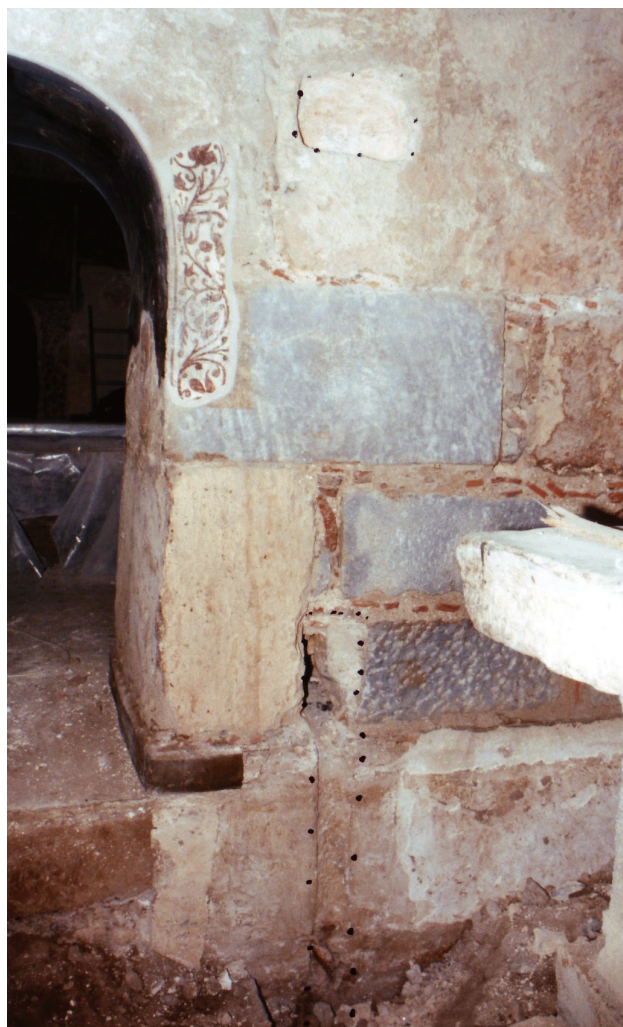
The cleaning of the walls from plaster damaged by fire revealed that on the side walls of the prothesis and the diakonikon at a distance of 3.45 m from the western end of the arch, there were shallow vertical grooves dug into the wall 8-10 cm wide and 106 cm high (Figs 5, 7). Above the height of 90 cm the groove widens to 16 cm. The lowest end corresponds to the level of -0.54 m. It is now safe to assume that the original floor of the entire sanctuary was at this level. In a straight line above the groove at a distance of 1.40 m, there is a rectangular hole measuring 25×25 cm. Grooves or recesses in a similar position were not observed on the walls of the holy bema.

The above recesses were undoubtedly constructed to secure the initial marble iconostasis directly against the wall. The vertical groove was used for the closure slabs and the rectangular ones above for the architraves. It gives the total height of 2.70 m for the templon. The fact that no similar traces were found for the holy bema templon, can only mean that it was located at a more pronounced position, at the end of the side walls, probably flush with the exterior face of the arch and it is now hidden behind the concrete buttresses¹⁴.

Fig. 7. Panagia Skripou. Grooves cut on the side walls of Saint Peter's chapel to attach the marble screen.

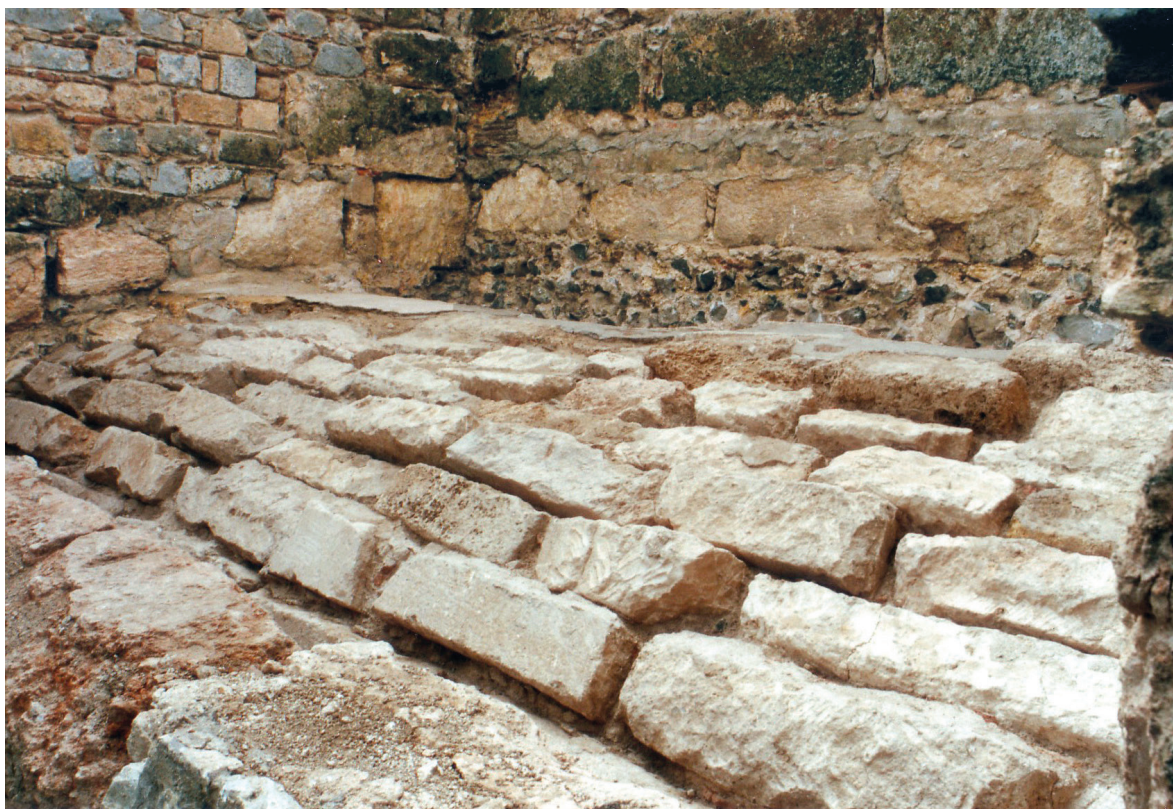
The removal of the roof tiles revealed no actual surprises. The barrel vaults covering the corner bays, the western cross arm and the narthex were undisturbed. They were constructed with large stone voussoirs in second use, placed with their long sides along the axis of the dome and left unfinished (Fig. 8).

Fig. 8. Panagia Skripou. View of the roof of Saint Peter's chapel.
