Δελτίον ΧΑΕ 43 (2022), Περίοδος Δ'

### Νέα δεδομένα για την Παναγία Σκριπού στη Βοιωτία

## RECENT EVIDENCE ABOUT THE CHURCH OF PANAGIA SKRIPOU IN BOEOTIA

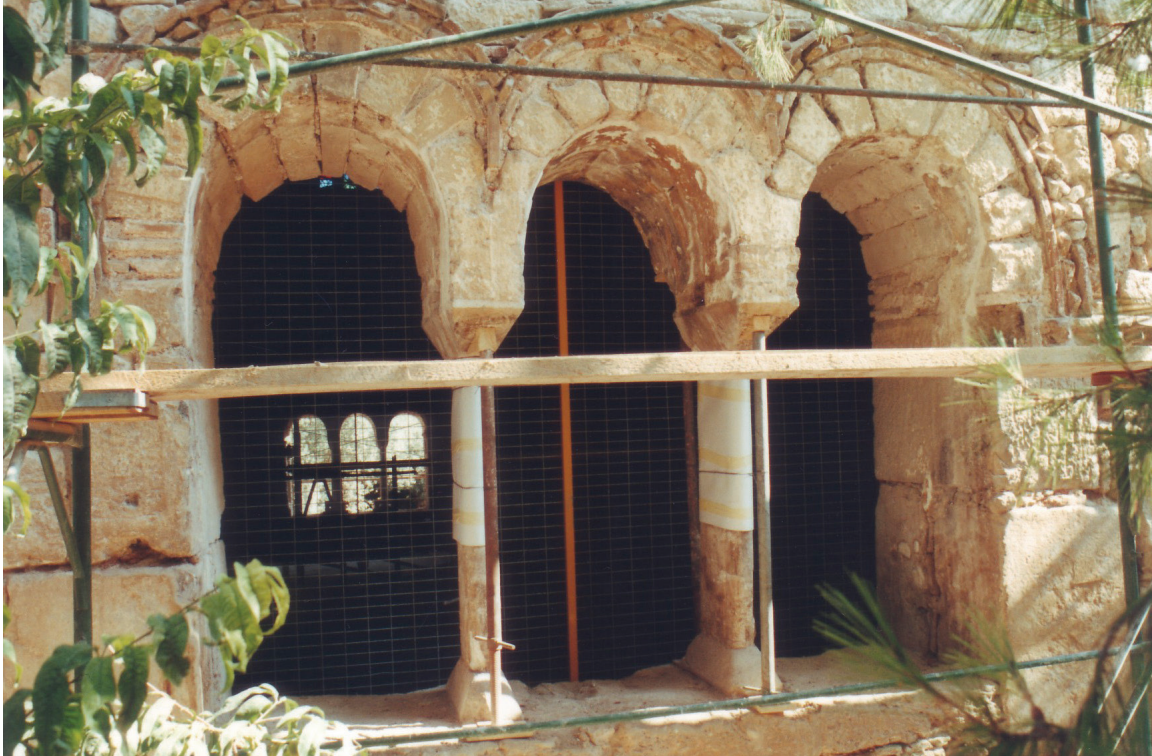
outlined by rows of dentils (Figs 2, 3). Only the east windows of the parabemata were made of bricks (Fig. 4)<sup>5</sup>. A timber tie-beam passes through the springing of all the lower-level openings. It survived intact only at the south door of the narthex, but its remains are visible in all openings (Figs 5, 6). Reused slabs of whitish ancient marble were used as thresholds of the doors. At the door jambs and most of the windows, poorly preserved frescoes reach the outer edge of the openings<sup>6</sup>. It is obvious that the intrados

Fig. 2. Panagia Skripou. View of the south transept window after works.

The lobes of the bilobed windows of the narthex and the trilobed ones of the transept are supported by slender marble colonettes (Fig. 2). They carry impostes with splayed ends decorated with rosettes and vine leaves in low relief. The jambs of the trilobed windows or the colonettes bear no marks of fixed panels. They were probably shut with wooden moving coverings. Unfortunately the tie beams or the thresholds, on which they would have been fixed, are all missing<sup>7</sup>.

Η διάνοιξη των κτισμένων παραθύρων και θυρών αποκάλυψε τα αρχικά τοξωτά ανοίγματα, πληγωμένα από τη διαφορική καθίζηση αλλά σχετικά ανέπαφα (Εικ. 2). Τα τόξα των παραθύρων ήταν κατασκευασμένα από πέτρινους τοξόλιθους, συνήθως σε δεύτερη χρήση, και περιβάλλονται από οδοντωτές ταινίες (Εικ. 3). Μόνο τα ανατολικά παράθυρα των παραβημάτων ήταν από πλίνθους (Εικ. 4). Ως κατώφλια των θυρών χρησιμοποιήθηκαν πλάκες από υπόλευκο μάρμαρο σε δεύτερη χρήση. Σώζονται εγκοπές για τους στροφείς των θυρών, που σε συνδυασμό με αντίστοιχες αυλακώσεις στους ελκυστήρες χρησιμοποιήθηκαν για τη στερέωση των φύλλων της πόρτας.

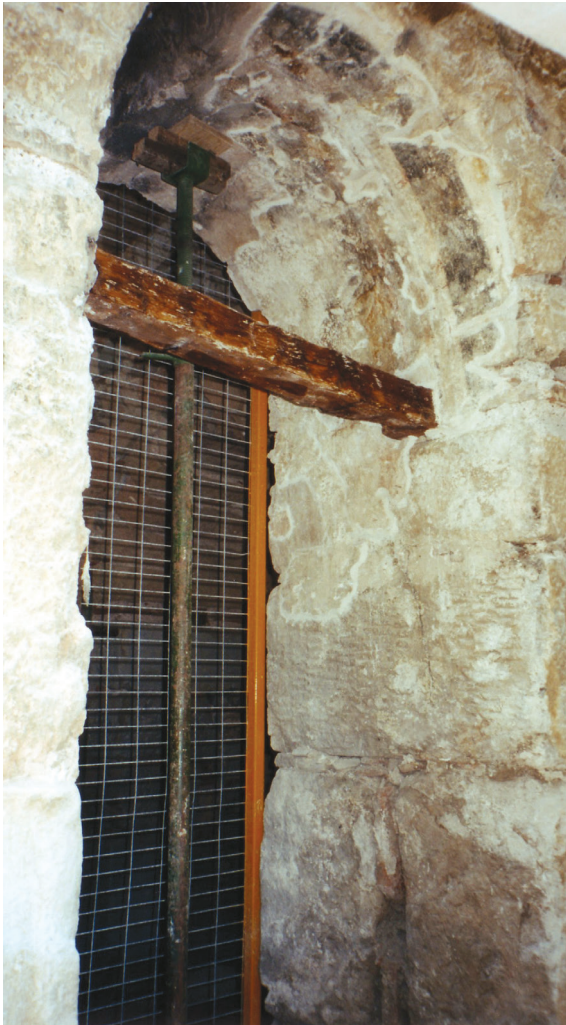
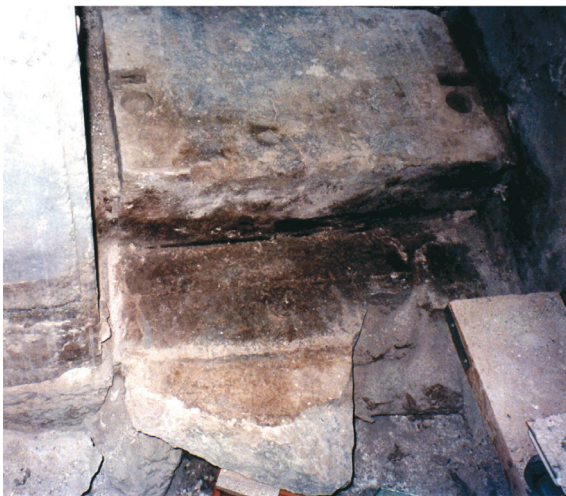
Fig. 6. Panagia Skripou. Narthex, south door. (a) The remaining timber tie-beam and the frescoes covering the walls. (b) The threshold of the south door with parts of the original marble floor.

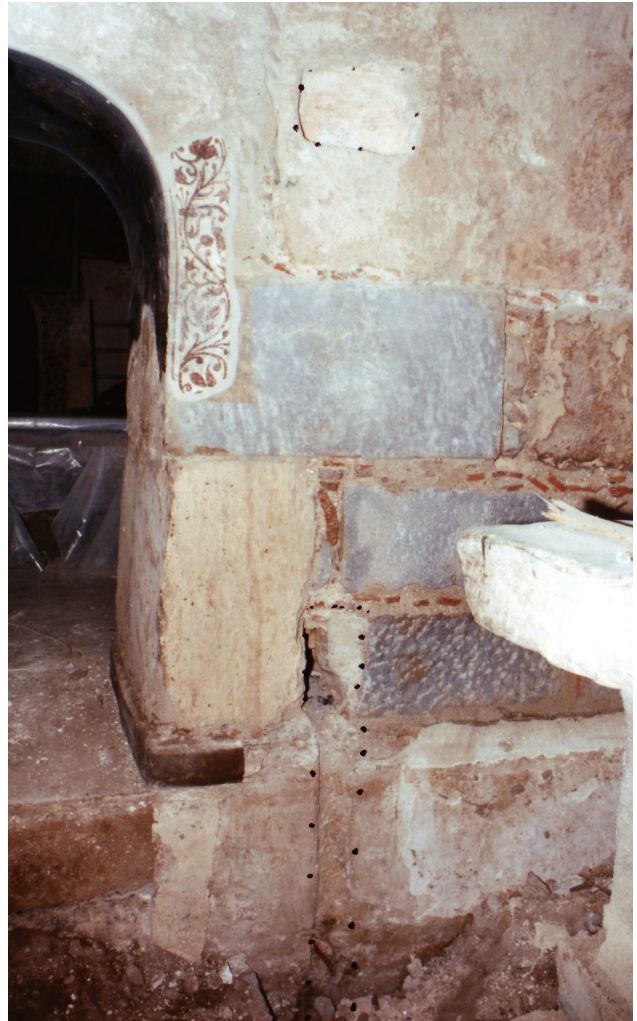
The cleaning of the walls from plaster damaged by fire revealed that on the side walls of the prothesis and the diakonikon at a distance of 3.45 m from the western end of the arch, there were shallow vertical grooves dug into the wall 8-10 cm wide and 106 cm high (Figs 5, 7). Above the height of 90 cm the groove widens to 16 cm. The lowest end corresponds to the level of -0.54 m. It is now safe to assume that the original floor of the entire sanctuary was at this level. In a straight line above the groove at a distance of 1.40 m, there is a rectangular hole measuring 25×25 cm. Grooves or recesses in a similar position were not observed on the walls of the holy bema.

The above recesses were undoubtedly constructed to secure the initial marble iconostasis directly against the wall. The vertical groove was used for the closure slabs and the rectangular ones above for the architraves. It gives the total height of 2.70 m for the templon. The fact that no similar traces were found for the holy bema templon, can only mean that it was located at a more pronounced position, at the end of the side walls, probably flush with the exterior face of the arch and it is now hidden behind the concrete buttresses<sup>14</sup>.

Fig. 7. Panagia Skripou. Grooves cut on the side walls of Saint Peter's chapel to attach the marble screen.

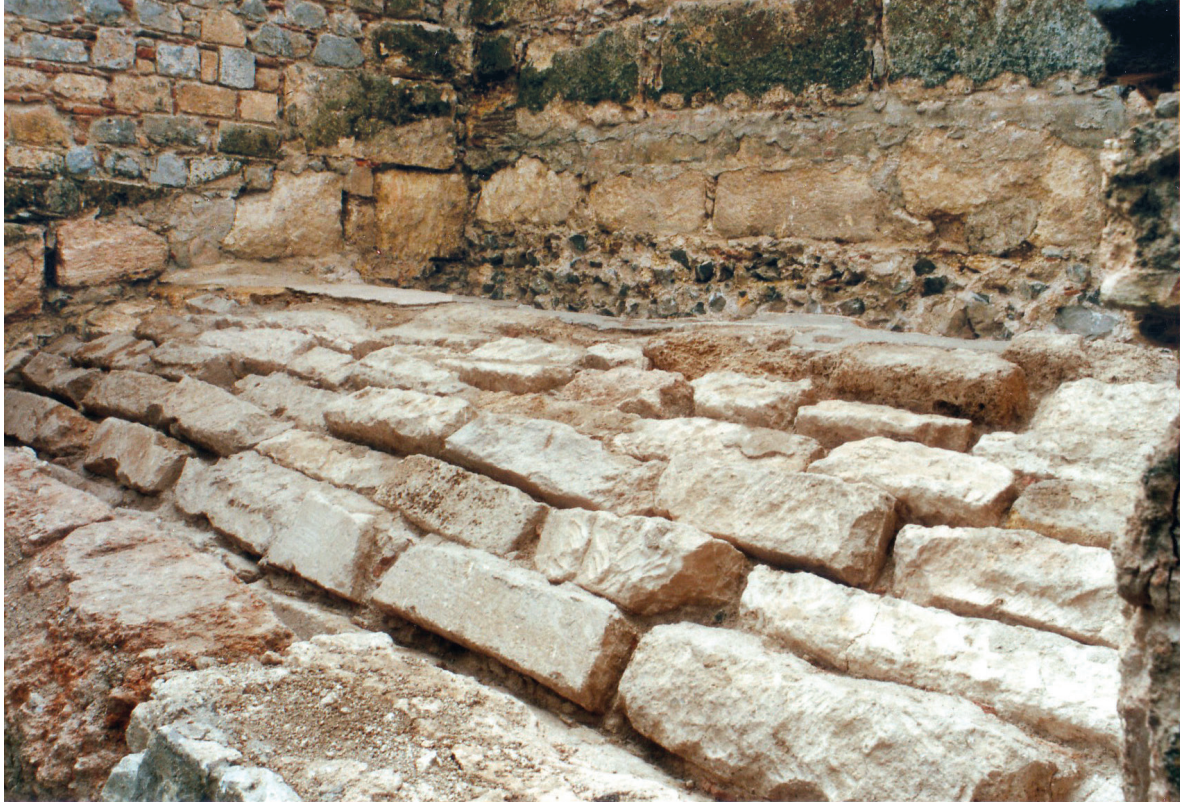
The removal of the roof tiles revealed no actual surprises. The barrel vaults covering the corner bays, the western cross arm and the narthex were undisturbed. They were constructed with large stone voussoirs in second use, placed with their long sides along the axis of the dome and left unfinished (Fig. 8).

Fig. 8. Panagia Skripou. View of the roof of Saint Peter's chapel.
