Δελτίον της Χριστιανικής Αρχαιολογικής Εταιρείας

Νέα δεδομένα για την Παναγία Σκριπού στη Βοιωτία

RECENT EVIDENCE ABOUT THE CHURCH OF PANAGIA SKRIPOU IN BOEOTIA

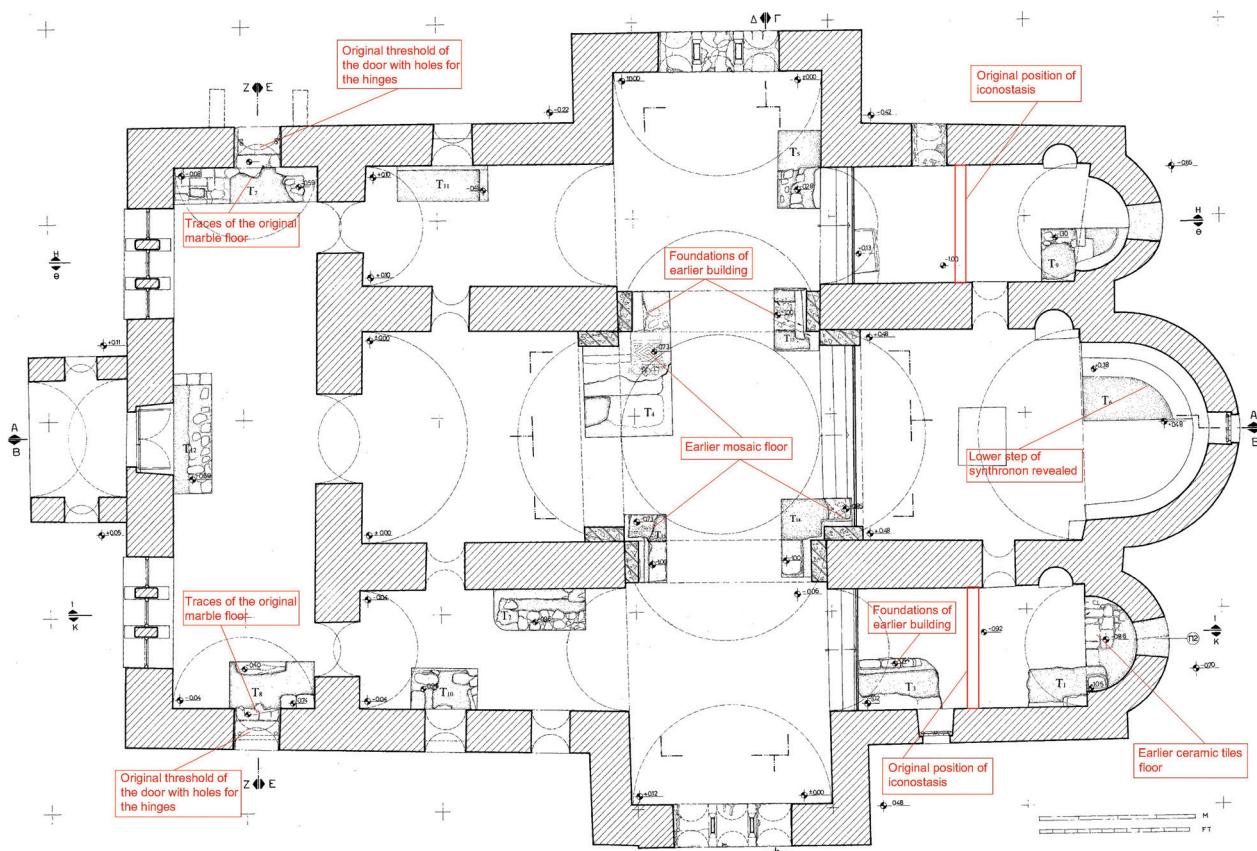
Fig. 1. Panagia Skripou. Plan with the findings of the excavations.

In brief, archaeological research (Fig. 1) concentrated on: (a) unblocking all the built-up openings: the north and south two-light windows of the upper tier of the narthex, as well as the doors beneath them, the trilobed windows at the end of the cross's arms, and the single-light windows of the prothesis and the diakonikon; (b) soundings made in different places of the floor of the naos to examine its foundations, while the entire holy bema was excavated; (c) the remaining plaster that was damaged by the fire, which was removed, apart from the frescoes (mostly in the bema and the diakonikon); (d) the tiles covering the roofs, which were removed, and the structure of the vaulting was revealed.

Trenches were excavated in the floor of the Panagia church¹³ (see above Fig. 1). At a depth of 15cm below the thresholds of doors, traces of the original marble floor were revealed, consisting of whitish marble 7-8cm thick, with polished upper surfaces (Fig. 6). The thresholds of doors are about only 10 cm higher than the present floor level, which means that the original floor would have been located slightly lower than the modern one.

Η αρχαιολογική έρευνα επικεντρώθηκε σε: (α) διάνοιξη όλων των φραγμένων ανοιγμάτων· (β) ανασκαφικές τομές σε διάφορα σημεία του δαπέδου του χυρίων ναού και στο ιερό βήμα (Εικ. 1)· (γ) αφαίρεση υπολειπόμενου επιχρύσιματος, εκτός από τα σημεία που σώζονταν τοιχογραφίες· (4) αφαίρεση των κεραμιδιών που κάλυπταν τις στέγες, και αποκάλυψη της δομής των θόλων και του τρούλου.

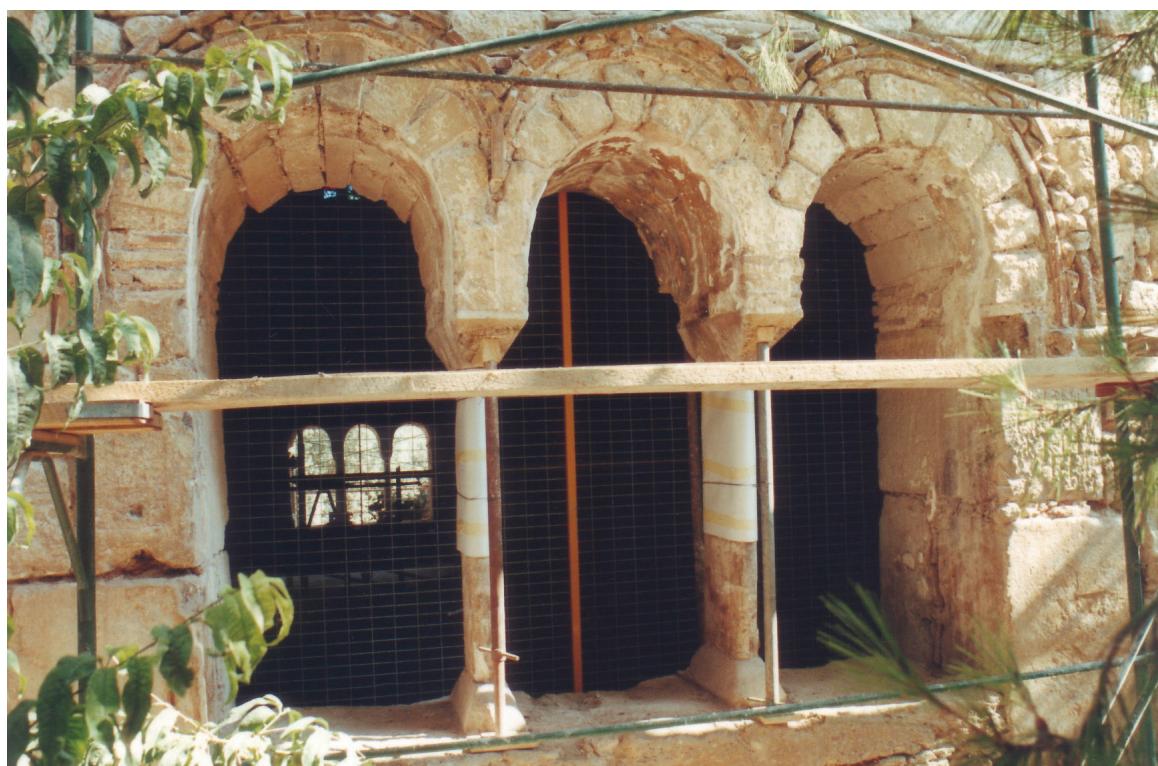
Fig. 2. *Panagia Skripou*. View of the south transept window after works.

outlined by rows of dentils (Figs 2, 3). Only the east windows of the parabemata were made of bricks (Fig. 4)⁵. A timber tie-beam passes through the springing of all the lower-level openings. It survived intact only at the south door of the narthex, but its remains are visible in all openings (Figs 5, 6). Reused slabs of whitish ancient marble were used as thresholds of the doors. At the door jambs and most of the windows, poorly preserved frescoes reach the outer edge of the openings⁶. It is obvious that the intrados

The lobes of the bilobed windows of the narthex and the trilobed ones of the transept are supported by slender marble colonettes (Fig. 2). They carry imposts with splayed ends decorated with rosettes and vine leaves in low relief. The jambs of the trilobed windows or the colonettes bear no marks of fixed panels. They were probably shut with wooden moving coverings. Unfortunately the tie beams or the thresholds, on which they would have been fixed, are all missing⁷.

Η διάνοιξη των κτισμάτων παραθύρων και θυρών αποκάλυψε τα αρχικά τοξωτά ανοίγματα, πληγωμένα από τη διαφορική καθίξηση αλλά σχετικά ανέπαφα (Εικ. 2). Τα τόξα των παραθύρων ήταν κατασκευασμένα από πέτρινους τοξόλιθους, συνήθως σε δεύτερη χρήση, και περιβάλλονται από οδοντωτές ταινίες (Εικ. 3). Μόνο τα ανατολικά παράθυρα των παραθημάτων ήταν από πλίνθους (Εικ. 4). Ως κατώφλια των θυρών χρησιμοποιήθηκαν πλάκες από υπόλευκο μάρμαρο σε δεύτερη χρήση. Σώζονται εγκοπές για τους στροφείς των θυρών, που σε συνδυασμό με αντίστοιχες αυλακώσεις στους ελκυστήρες χρησιμοποιήθηκαν για τη στερέωση των φύλλων της πόρτας.

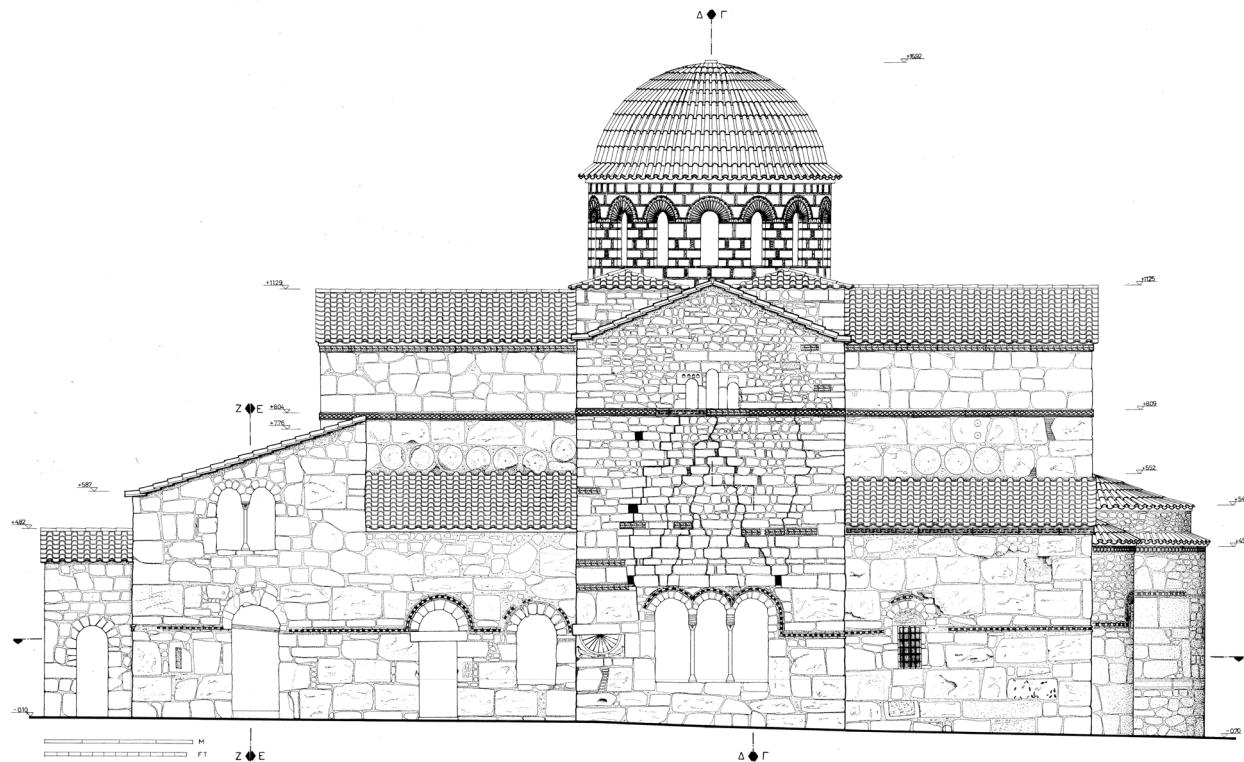
Fig. 3. *Panagia Skripou*. South elevation.

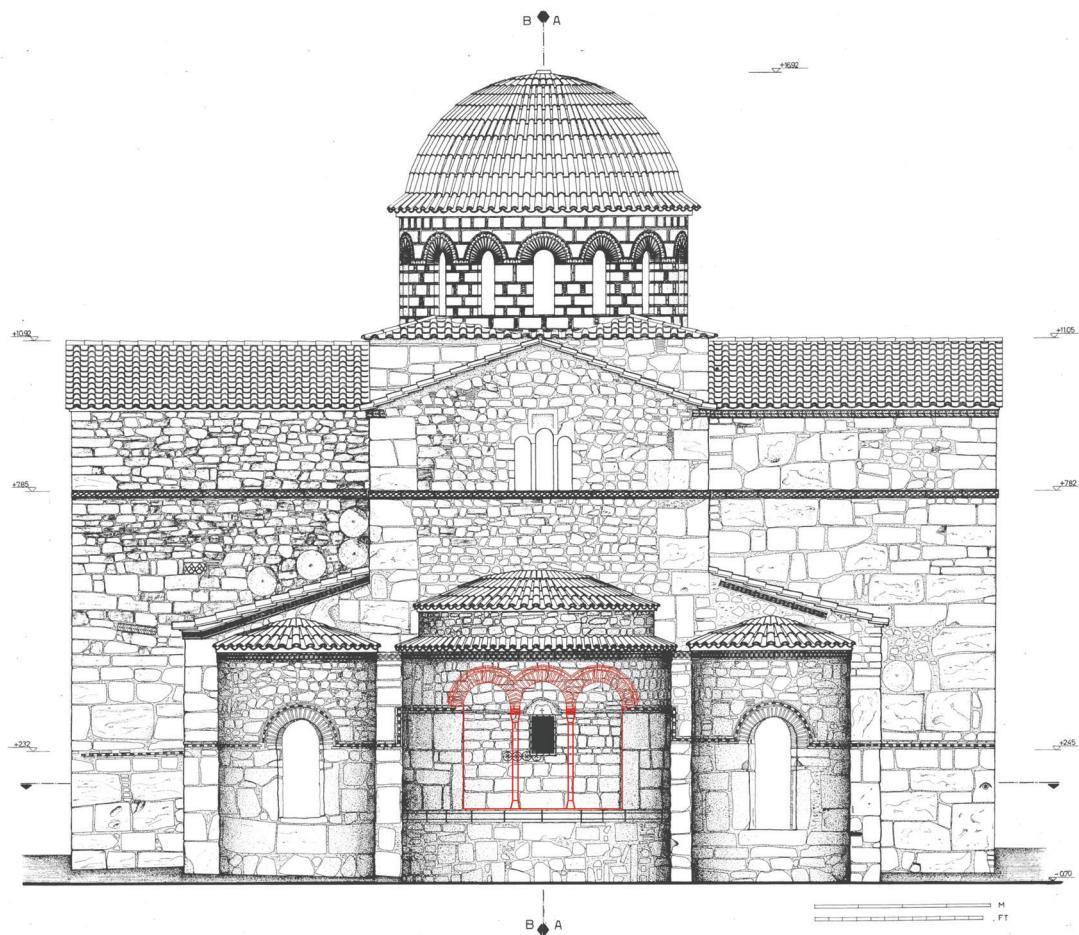
Fig. 4. Panagia Skripou. East elevation. The proposed graphical reconstruction of the apse window in red.

The apse window has been greatly disturbed since only the jambs remain. However, if we assume that the window was trilobed with its lobes equal to the eastern windows of the parabemata, then we can represent graphically the apse window (see Fig. 4). The arches were probably made of brick for the same reason as the windows of the parabemata⁸. The form fully corresponds to the respective trilobed windows of other 9th-10th-century monuments, such as the ones of Episkopi in Skyros⁹, in the church in Zourtsa at Phigaleia¹⁰, the Transfiguration of the Saviour in Koropi¹¹ and probably Episkopi in Eurytanía¹².

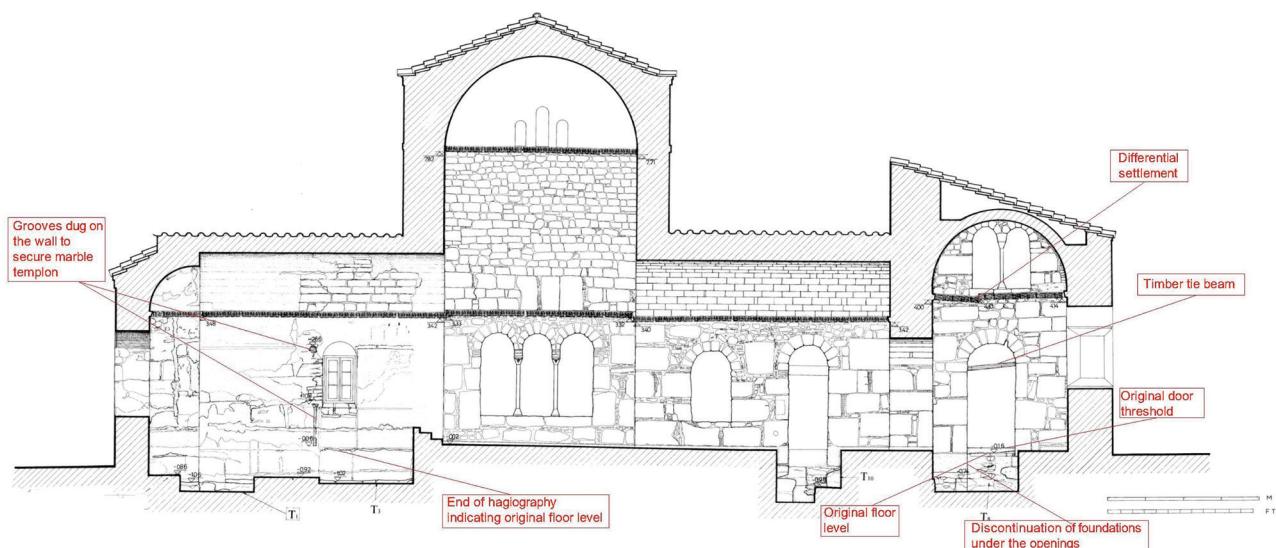
Fig. 5. Panagia Skripou. Longitudinal section through the south chapel.

the doors and the arches connecting the internal spaces, the foundations were discontinued (Fig. 5), despite the fact that they all belonged to the same building phase. This shows the builders' great lack of expertise, which was probably the reason for the repeated collapses of different parts due to past earthquakes. The differential settlement between the lighter narthex and the heavier church is obviously the reason for the distortion of the north and south upper tier windows, as well as of other openings.

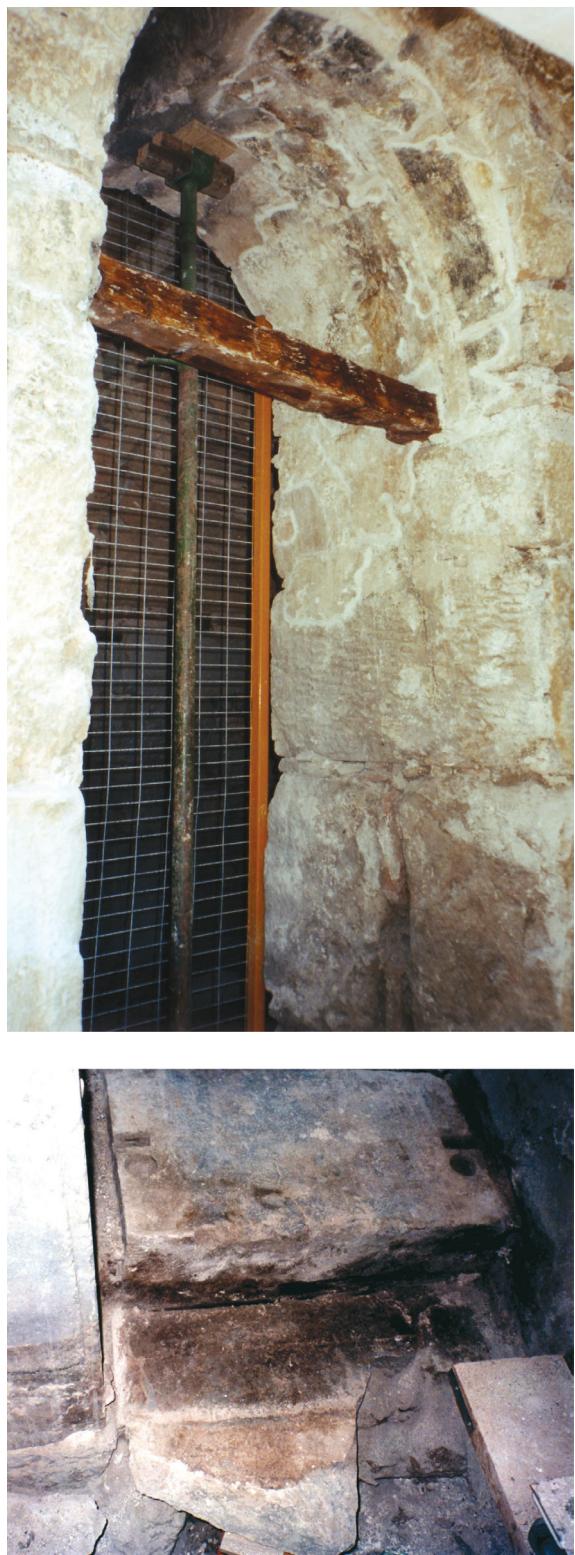
Fig. 6. Panagia Skripou. Narthex, south door. (a) The remaining timber tie-beam and the frescoes covering the walls. (b) The threshold of the south door with parts of the original marble floor.

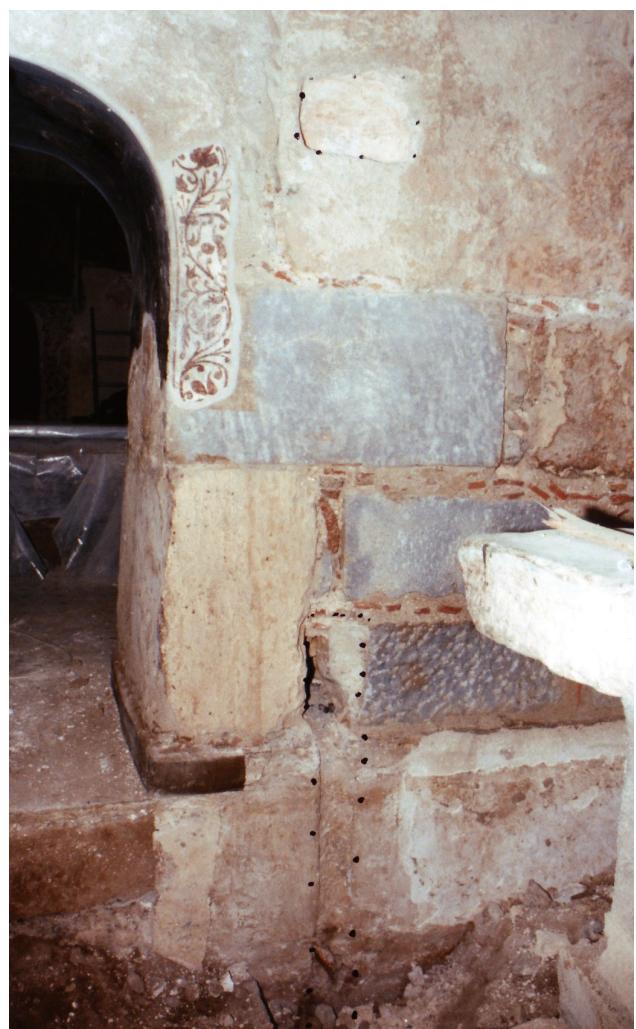
Fig. 7. Panagia Skripou. Grooves cut on the side walls of Saint Peter's chapel to attach the marble screen.

The cleaning of the walls from plaster damaged by fire revealed that on the side walls of the prothesis and the diakonikon at a distance of 3.45 m from the western end of the arch, there were shallow vertical grooves dug into the wall 8-10 cm wide and 106 cm high (Figs 5, 7). Above the height of 90 cm the groove widens to 16 cm. The lowest end corresponds to the level of -0.54 m. It is now safe to assume that the original floor of the entire sanctuary was at this level. In a straight line above the groove at a distance of 1.40 m, there is a rectangular hole measuring 25×25 cm. Grooves or recesses in a similar position were not observed on the walls of the holy bema.

The above recesses were undoubtedly constructed to secure the initial marble iconostasis directly against the wall. The vertical groove was used for the closure slabs and the rectangular ones above for the architraves. It gives the total height of 2.70 m for the templon. The fact that no similar traces were found for the holy bema templon, can only mean that it was located at a more pronounced position, at the end of the side walls, probably flush with the exterior face of the arch and it is now hidden behind the concrete buttresses¹⁴.

Στους λαμπάδες των θυρών και των περισσοτέρων παραθύρων διατηρήθηκαν τοιχογραφίες σε πολύ κακή κατάσταση, που φτάνουν στο εξωτερικό άκρο των ανοιγμάτων (Εικ. 7). Είναι προφανές ότι τα εσωτερικά

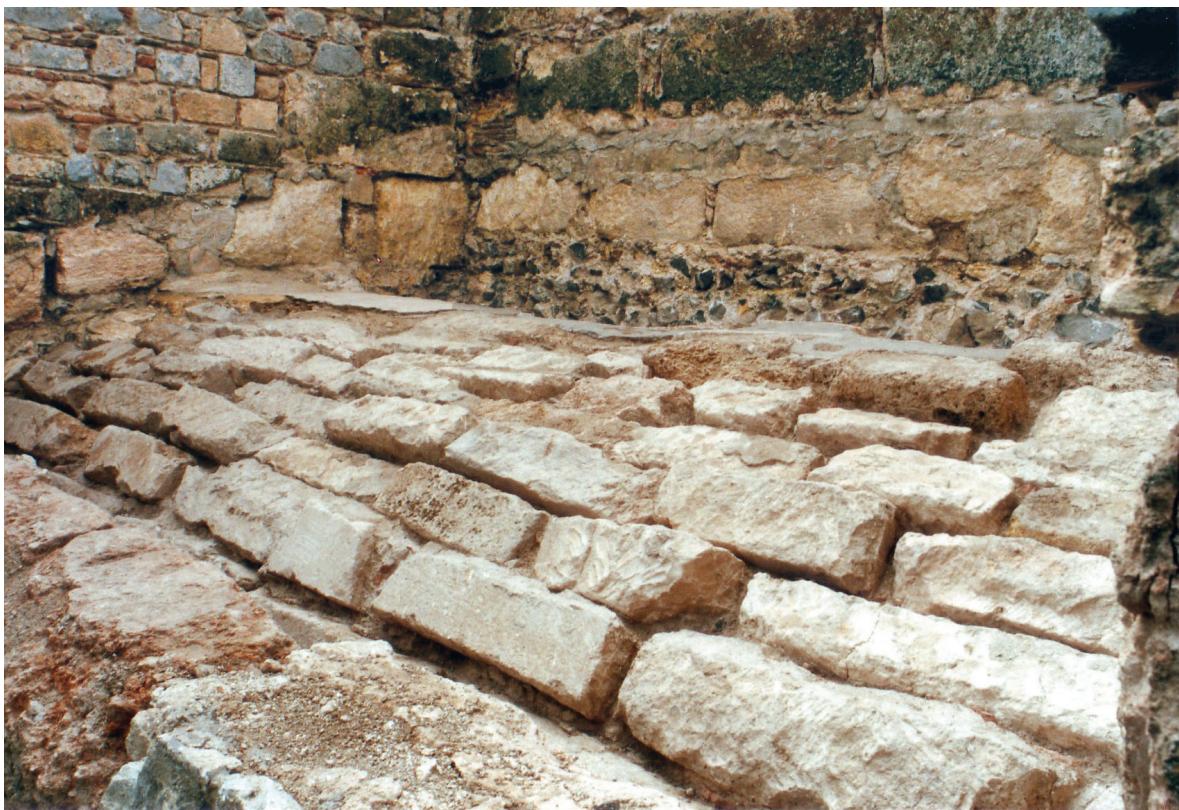
Fig. 8. Panagia Skripou. View of the roof of Saint Peter's chapel.

The removal of the roof tiles revealed no actual surprises. The barrel vaults covering the corner bays, the western cross arm and the narthex were undisturbed. They were constructed with large stone voussoirs in second use, placed with their long sides along the axis of the dome and left unfinished (Fig. 8).

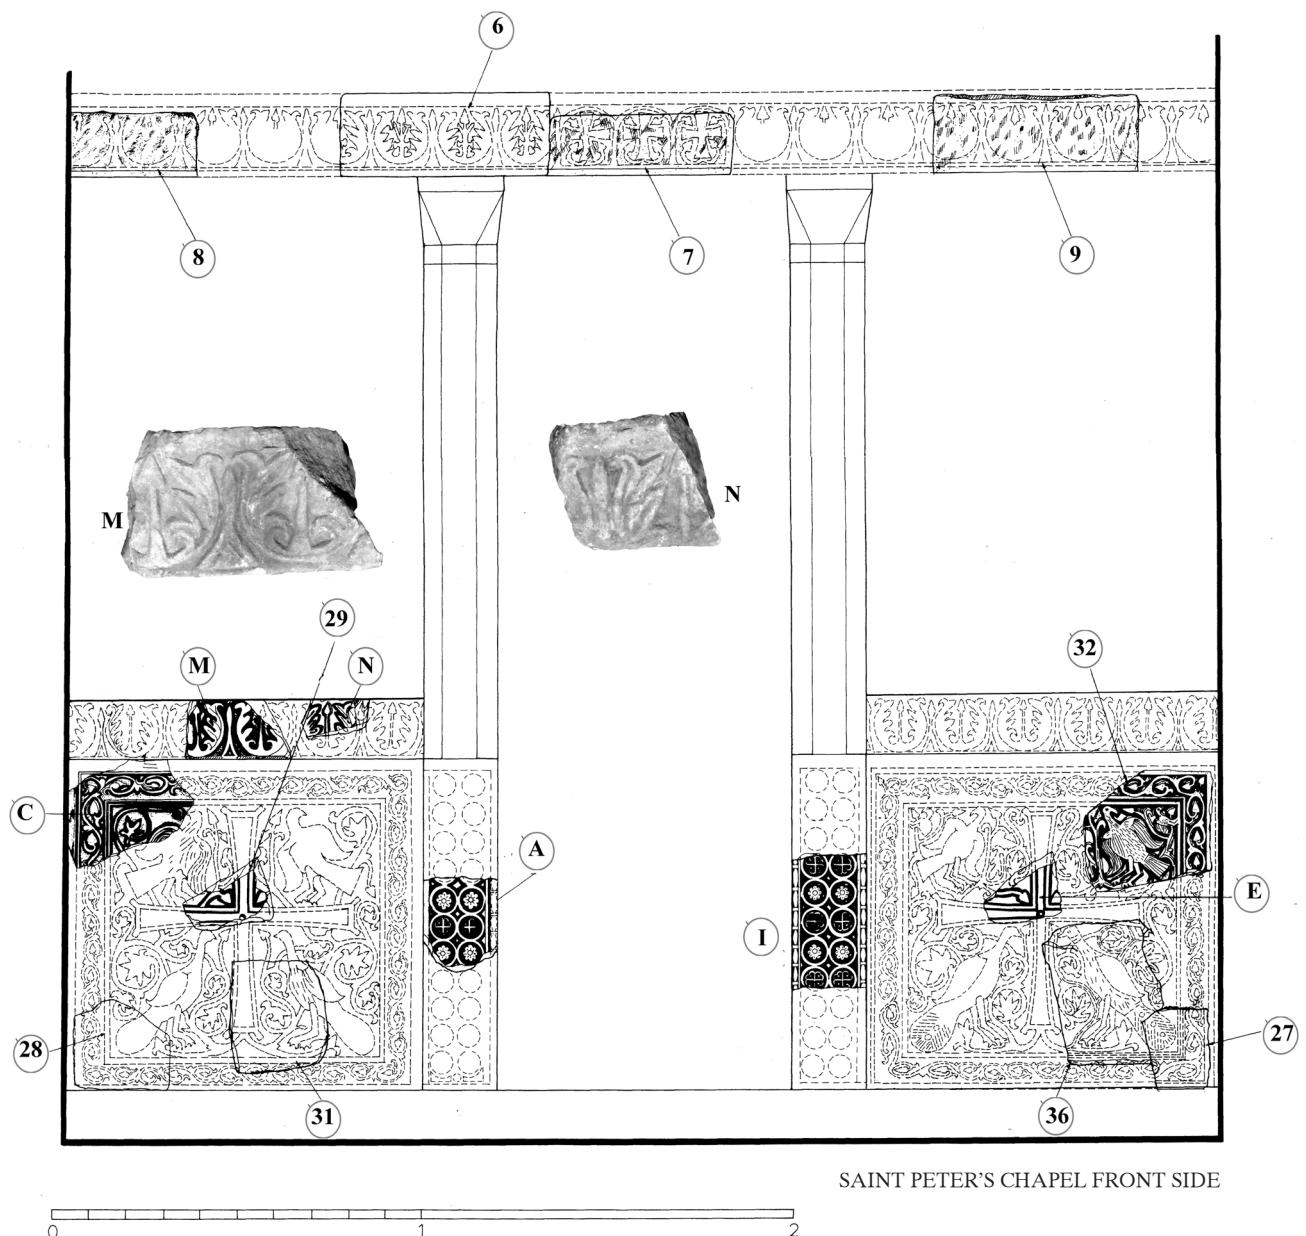
Fig. 9. Panagia Skripou. Saint Peter's marble screen. Front side. Marble pieces of the screen discovered randomly presented (marble members recorded by Megaw are marked with a number, extant ones in heavier line, missing in dashed. Newly discovered ones are marked with letters).

After discovering more fragments of the marble templon and determining its exact position, we can have a clearer picture of its original form (see Fig. 9). Megaw had two main concerns about the form of the screen: its height and its position. Both have been accurately established. The position of the templon of the parabemata was anticipated by Megaw and other scholars³¹ since he had hypothesized that the chapels would need the space of a holy bema and a naos, even in very small scale, to accommodate the liturgy, but it had not been proven until now³².

Στα πλευρικά τοιχώματα της πρόθεσης και του διακονικού, σε απόσταση 3,45 μ. από το δυτικό άκρο της αψίδας, υπήρχαν ρηγές κάθετες εγκοπές που είχαν σκαφτεί στον τοίχο για να στερεωθεί το τέμπλο. Εγκοπές ή εσοχές σε παρόμοια θέση δεν παρατηρήθηκαν στους τοίχους του βήματος. Νέα μαρμάρινα τμήματα του τέμπλου ανακαλύφθηκαν αλλάζοντας ελαφρώς τη γραφική αποκατάσταση του που προτάθηκε από τον Megaw τη δεκαετία του '60 (Εικ. 9).
