Δελτίον ΧΑΕ 43 (2022), Περίοδος Δ'

Νέα δεδομένα για την Παναγία Σκριπού στη Βοιωτία

RECENT EVIDENCE ABOUT THE CHURCH OF PANAGIA SKRIPOU IN BOEOTIA

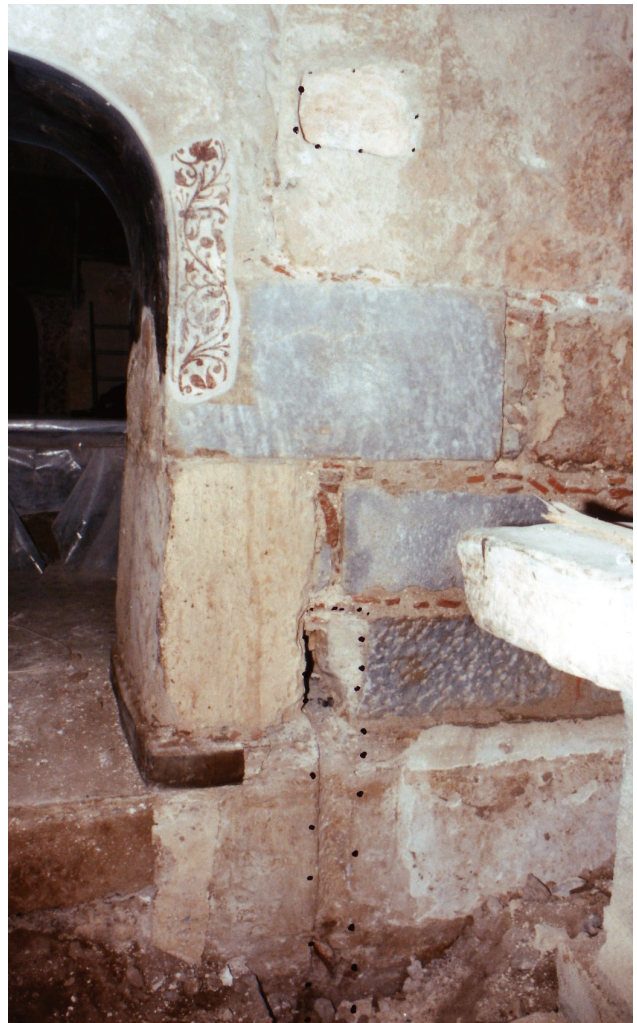
Fig. 7. Panagia Skripou. Grooves cut on the side walls of Saint Peter's chapel to attach the marble screen.

The cleaning of the walls from plaster damaged by fire revealed that on the side walls of the prothesis and the diakonikon at a distance of 3.45 m from the western end of the arch, there were shallow vertical grooves dug into the wall 8-10 cm wide and 106 cm high (Figs 5, 7). Above the height of 90 cm the groove widens to 16 cm. The lowest end corresponds to the level of -0.54 m. It is now safe to assume that the original floor of the entire sanctuary was at this level. In a straight line above the groove at a distance of 1.40 m, there is a rectangular hole measuring 25×25 cm. Grooves or recesses in a similar position were not observed on the walls of the holy bema.

The above recesses were undoubtedly constructed to secure the initial marble iconostasis directly against the wall. The vertical groove was used for the closure slabs and the rectangular ones above for the architraves. It gives the total height of 2.70 m for the templon. The fact that no similar traces were found for the holy bema templon, can only mean that it was located at a more pronounced position, at the end of the side walls, probably flush with the exterior face of the arch and it is now hidden behind the concrete buttresses¹⁴.

Στα πλευρικά τοιχώματα της πρόθεσης και του διακονικού, σε απόσταση 3,45 μ. από το δυτικό άκρο της αψίδας, υπήρχαν ρηχές κάθετες εγκοπές που είχαν σκαφτεί στον τοίχο για να στερεωθεί το τέμπλο. Εγκοπές ή εσοχές σε παρόμοια θέση δεν παρατηρήθηκαν στους τοίχους του βήματος. Νέα μαρμάρινα τμήματα του τέμπλου ανακαλύφθηκαν αλλάζοντας ελαφρώς τη γραφική αποκατάσταση του που προτάθηκε από τον Megaw τη δεκαετία του '60 (Εικ. 9).
