Δελτίον ΧΑΕ 43 (2022), Περίοδος Δ'

Νέα δεδομένα για την Παναγία Σκριπού στη Βοιωτία

RECENT EVIDENCE ABOUT THE CHURCH OF PANAGIA SKRIPOU IN BOEOTIA

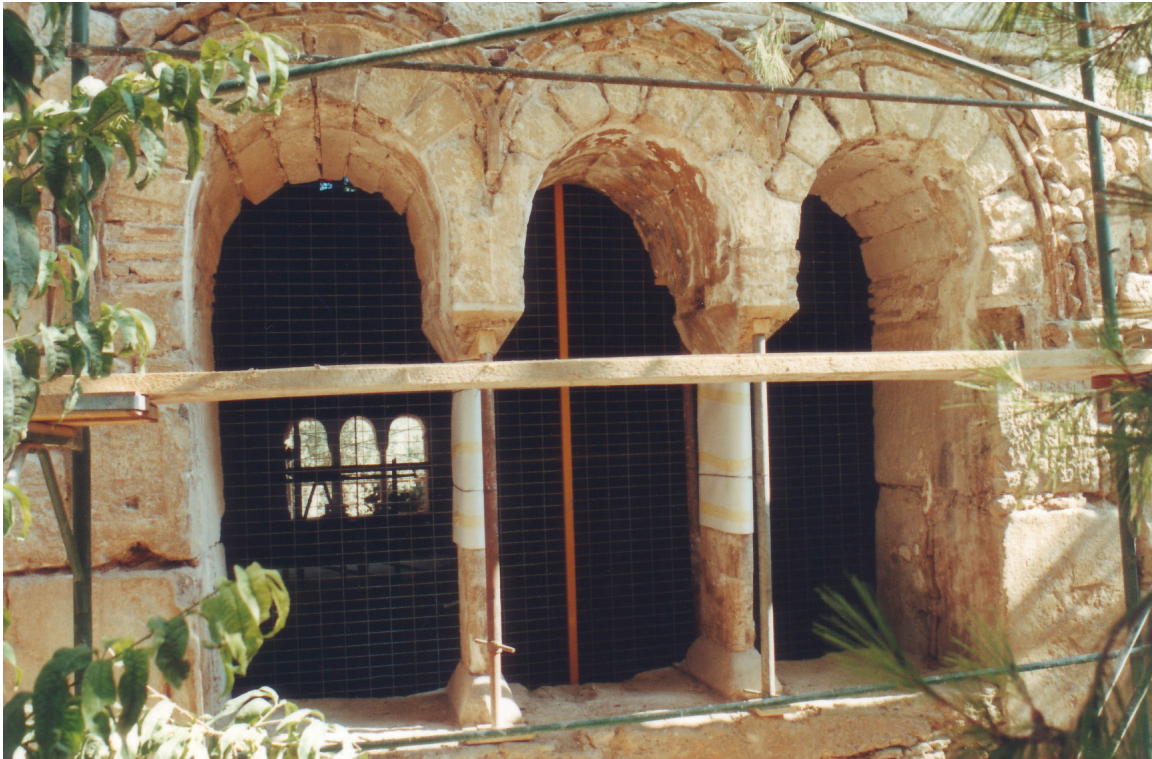
The demolition of the fillings revealed the original arched openings, damaged by differential settlement but intact. The window arches were constructed of stone voussoirs,

Fig. 2. Panagia Skripou. View of the south transept window after works.

The lobes of the bilobed windows of the narthex and the trilobed ones of the transept are supported by slender marble colonettes (Fig. 2). They carry impostes with splayed ends decorated with rosettes and vine leaves in low relief. The jambs of the trilobed windows or the colonettes bear no marks of fixed panels. They were probably shut with wooden moving coverings. Unfortunately the tie beams or the thresholds, on which they would have been fixed, are all missing⁷.

Η διάνοιξη των κτισμένων παραθύρων και θυρών αποκάλυψε τα αρχικά τοξωτά ανοίγματα, πληγωμένα από τη διαφορική καθίζηση αλλά σχετικά ανέπαφα (Εικ. 2). Τα τόξα των παραθύρων ήταν κατασκευασμένα από πέτρινους τοξόλιθους, συνήθως σε δεύτερη χρήση, και περιβάλλονται από οδοντωτές ταινίες (Εικ. 3). Μόνο τα ανατολικά παράθυρα των παραβημάτων ήταν από πλίνθους (Εικ. 4). Ως κατώφλια των θυρών χρησιμοποιήθηκαν πλάκες από υπόλευκο μάρμαρο σε δεύτερη χρήση. Σώζονται εγκοπές για τους στροφείς των θυρών, που σε συνδυασμό με αντίστοιχες αυλακώσεις στους ελκυστήρες χρησιμοποιήθηκαν για τη στερέωση των φύλλων της πόρτας.
