Δελτίον ΧΑΕ 43 (2022), Περίοδος Δ'

### Νέα δεδομένα για την Παναγία Σκριπού στη Βοιωτία

## RECENT EVIDENCE ABOUT THE CHURCH OF PANAGIA SKRIPOU IN BOEOTIA

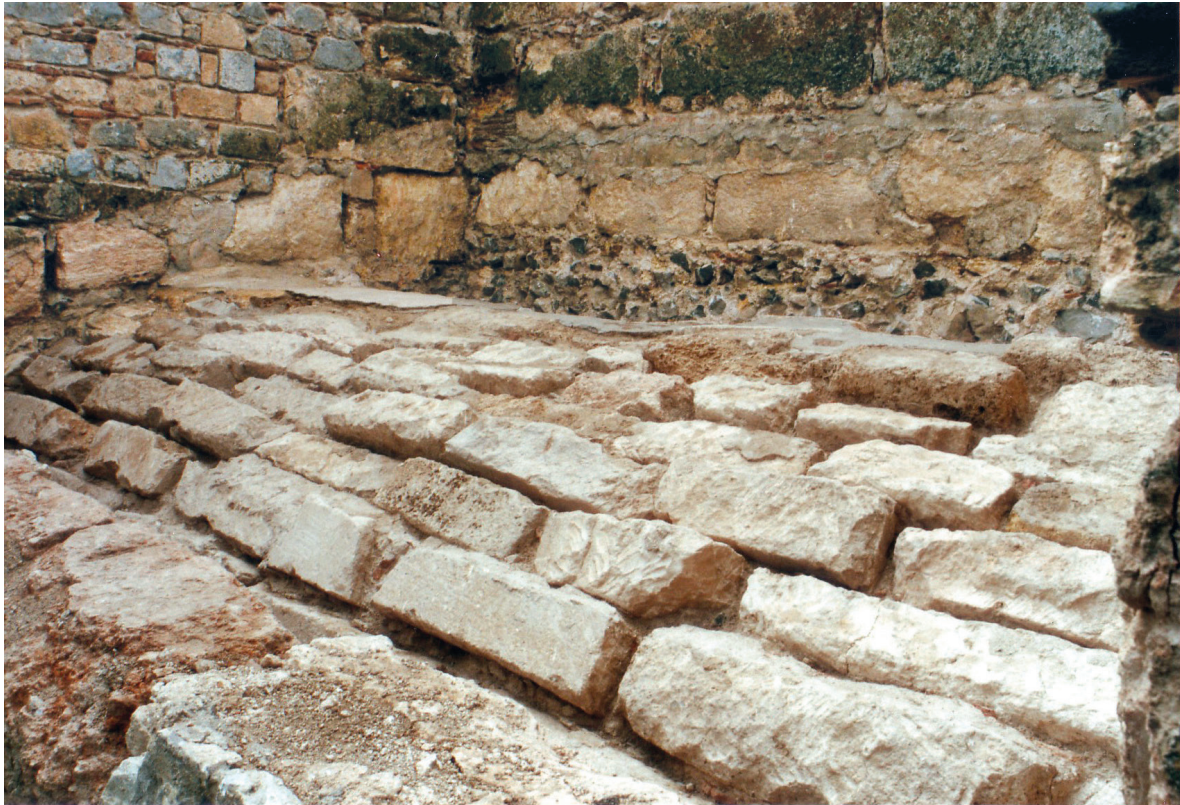
The removal of the roof tiles revealed no actual surprises. The barrel vaults covering the corner bays, the western cross arm and the narthex were undisturbed. They were constructed with large stone voussoirs in second use, placed with their long sides along the axis of the dome and left unfinished (Fig. 8).

Fig. 8. Panagia Skripou. View of the roof of Saint Peter's chapel.
