Η αρχιτεκτονική της Σωτείας Λυκοδήμου  
Αθηνών

*Charalambos BOURAS*

The Soteira Lykodemou at Athens. Architecture

## THE SOTEIRA LYKODEMOU AT ATHENS. ARCHITECTURE\*

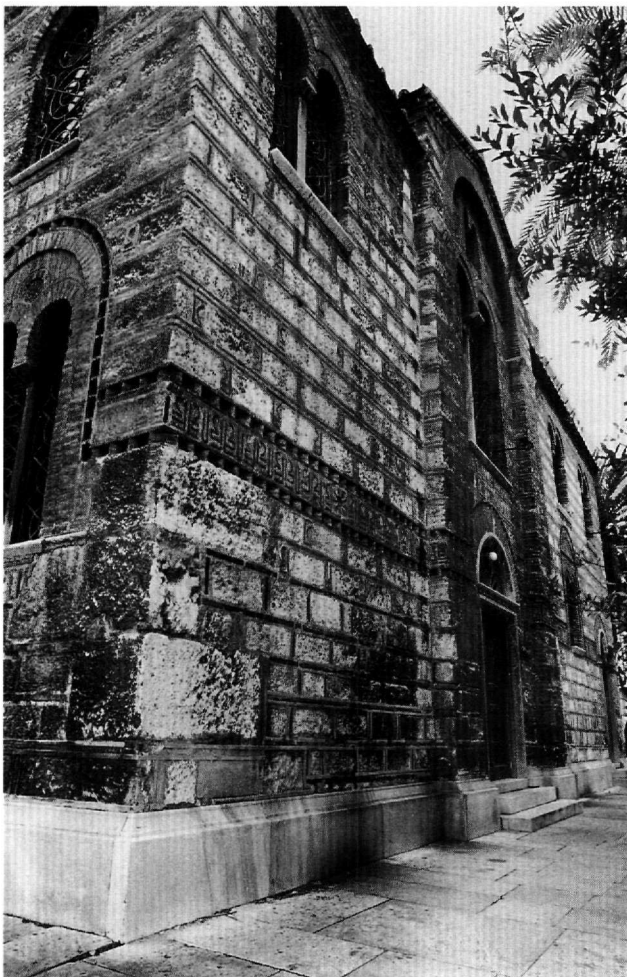
Fig. 1. The north façade looking west.

high chamfered marble crepis added by Vlasopoulos (Fig. 1) detracted from the monument's authenticity, and the old marble templon, the form of which is preserved by Lenoir<sup>33</sup>, appears to have been carried off before the work began<sup>34</sup>. The almost total destruction of the wall-paintings in the church (which will be discussed below) confirms the great scale of the removal of walls and vaults during Vlasopoulos's intervention.

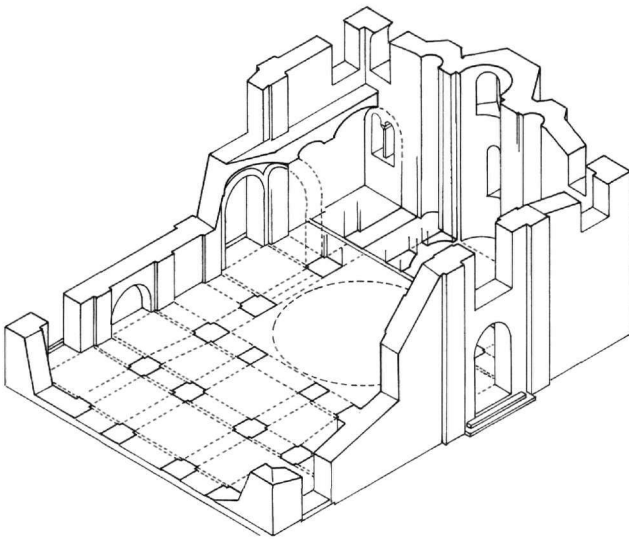
Fig. 3. Isometric section of the church, showing the existing original parts of the building, by C. Koliopoulos.

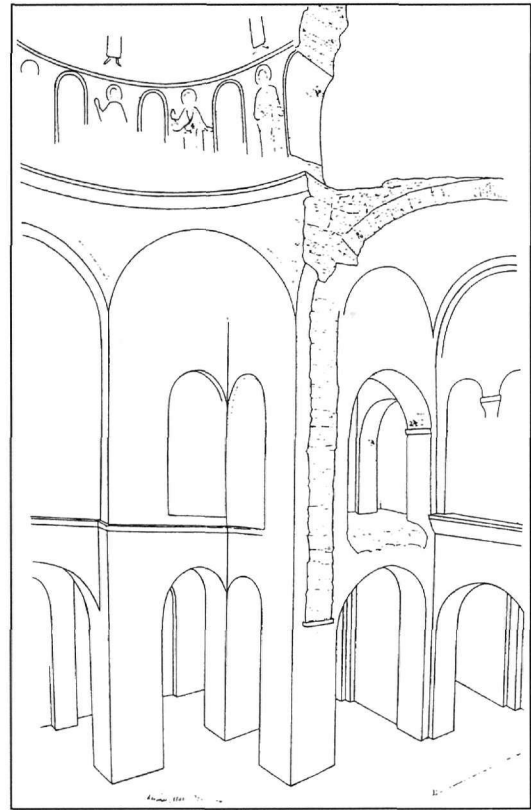
Fig. 7. Interior of naos facing north-west. P. Durand, no. 32.16, Hellenic Literary and Historic Archive (EΛIA).

The dome, then, did not have an internal tympanum, and the sixteen windows created around the edge of it penetrated its hemisphere. There was a low tympanum only on the exterior. From Durand's drawing 32/16 it can be calculated

that the two main axes of the nave coincided at the dome not with windows but with a section of wall between two windows. This feature further reveals the similarity of the dome of the Soteira with that of the katholikon of the monastery of Hosios Loukas. The breach created by the bomb must have been above the south-west pillar and, according to Couchaud, it destroyed two thirds of the dome. There was a painted strip above the window arches. In Durand's drawings, the thickness of the face of the arches bearing the dome can be made out, as well as that of the unified surface of the circumscribed sphere above them. Both were probably equal to the length of a brick.

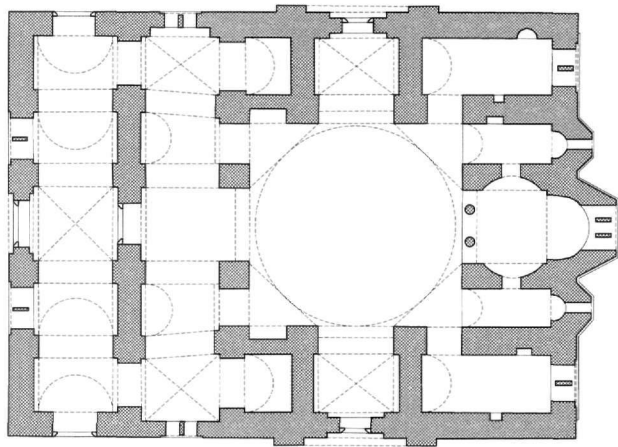
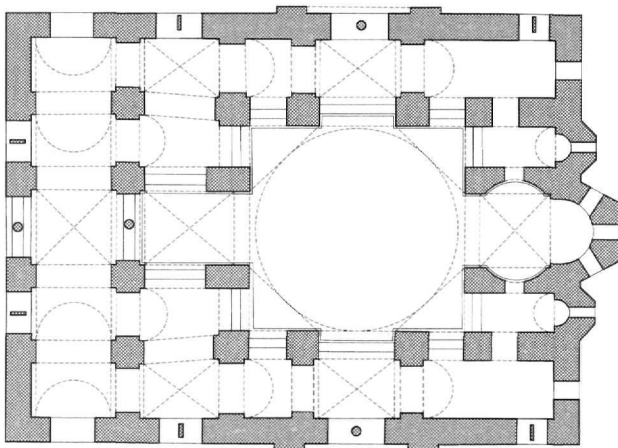
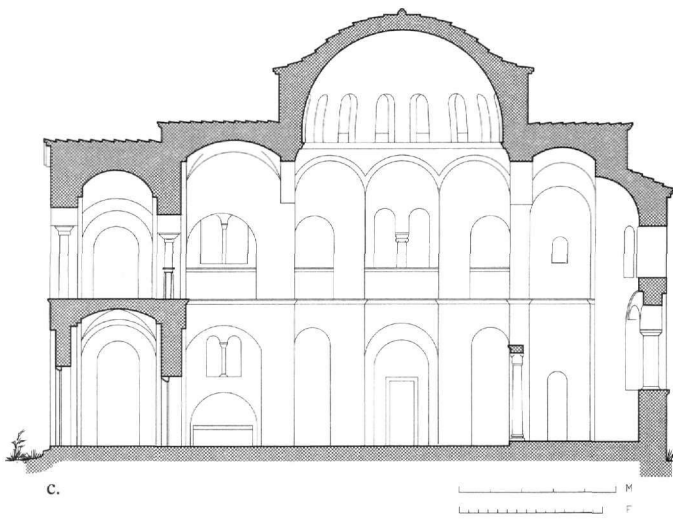
Fig. 8. Reconstruction of the church in its original form. a. Plan at ground level. b. Plan at gallery level. c. Longitudinal section.

The attempted restoration of the Soteira in the form it originally had (Fig. 8) and in the form it received after the 1705

earthquake is based on the assumptions that the measured drawing of the original dome by T. Vlasopoulos<sup>52</sup> was accurate and that the reconstruction followed it faithfully. It is only by making these assumptions that it is possible to use as a base the much later drawings of the plan and section of the present form of the Soteira by R. Schultz and S. Barnsley<sup>53</sup>, which, when checked, proved to have a satisfactory degree of accuracy<sup>54</sup>.

The galleries did not extend above the west arm of the cross, as erroneously indicated in a section drawing by Couchaud<sup>55</sup>. As in Hosios Loukas, they were confined to the area above the narthex and the side aisles. This is clearly attested by the chamfered cornice-cum-stylobate in Durand's drawing 32/16. Here there was a colonnette on the axis which had been replaced in this position by Vlasopoulos (Fig. 12). Neither of the side openings of the galleries facing on to the west arm were two-light windows with mullions, but plain arches, presumably with parapets at the bottom for safety reasons. A characteristic feature is that, as at Hosios Loukas, the galleries and the chamfered cornice were recessed by about 30 m. to the right and left above the two transverse arms, so as clearly to suggest the cruciform plan<sup>56</sup>. The reconstruction of the original form of the west façade of the church presents a more difficult problem. Couchaud drew and explicitly referred to three doors, which have no function, given that another two opened on to the narthex from the sides. Windows can be seen in Fauvel's sketch, made before the destruction, though higher than the arch of

the main door. It is equally probable, therefore, that there were two windows, one either side of the door, as in the katholikon of the monastery of Hosios Loukas. The upper line of all the façades is also unknown. Both Couchaud and Winstrup and Bindesbel drew a raised part with a flat roof in the position of the arms, but it is virtually certain that the roofs were originally pitched<sup>57</sup> and covered the barrel vaults or the cross vaults over the arms.

The large openings on the lateral axis of the church<sup>58</sup> are 1.83 m. wide on the ground floor. They presumably still have the original width, though this is disproportionately large for ordinary windows<sup>59</sup>. The corresponding openings on the upper storey are narrower. These, too, have presumably not been altered perceptibly, since the poros impostes of the pilasters at either side are still *in situ*. The openings did not have sills, like ordinary windows, but extended down to the floor of the galleries. The marble columns on the axis of the upper storey at present appear to be reconstructed.

It thus seems to be a reasonable hypothesis that the architectural solution was similar to the one applied in the case of the katholikon of Hosios Loukas, with two vertically articulated windows on the sides. In this case they were two-light windows, instead of the three-light windows of Hosios Loukas. That is, the same principle was followed in the interior of the church as in the opening on the axis of the gallery inside the church. The reconstruction above the two-light windows of the galleries is uncertain; here Couchaud drew a small window, also with two lights, while in Fauvel's sketch the tympanum is solid.

Similar questions arise in the case of the side openings of the narthex, both on the ground floor and in the galleries. They have the same width: 1.41 m. The upper opening was converted by Vlasopoulos into a two-light window, while the lower one remains a disproportionately large door.

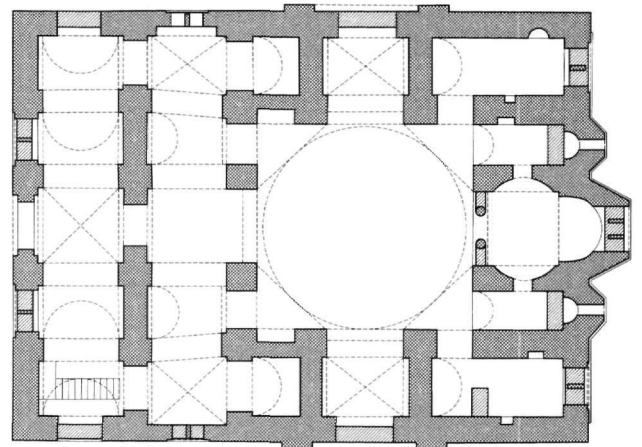
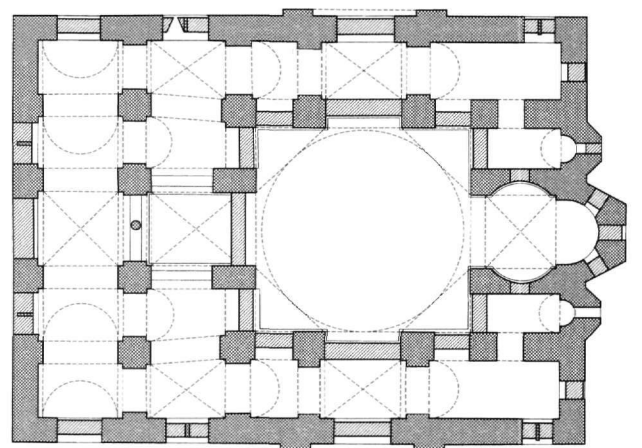
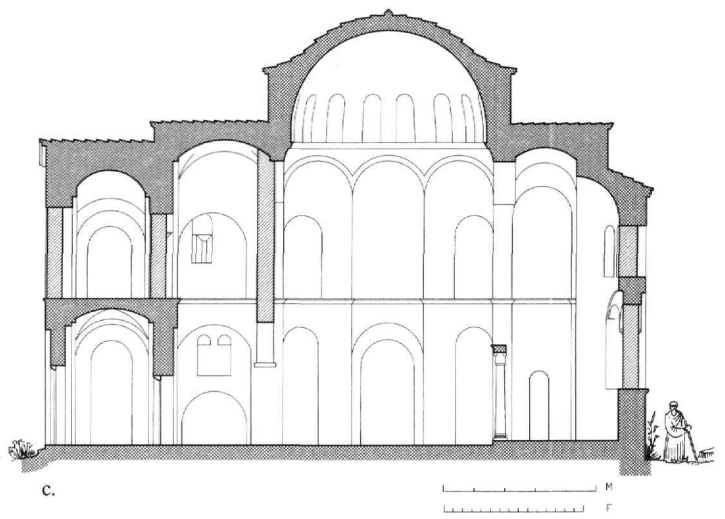
Fig. 9. Reconstruction of the church as in 1820. a. Plan at ground level. b. Plan at gallery level. c. Longitudinal section.

The reconstruction of the Soteira in the form it took after the repairs necessitated by the 1705 earthquake and before the Greek Uprising of 1821 (Fig. 9) is based on the same documentation, mainly on P. Durand's drawings.

Both drawings testify to the fact that all the arches opening

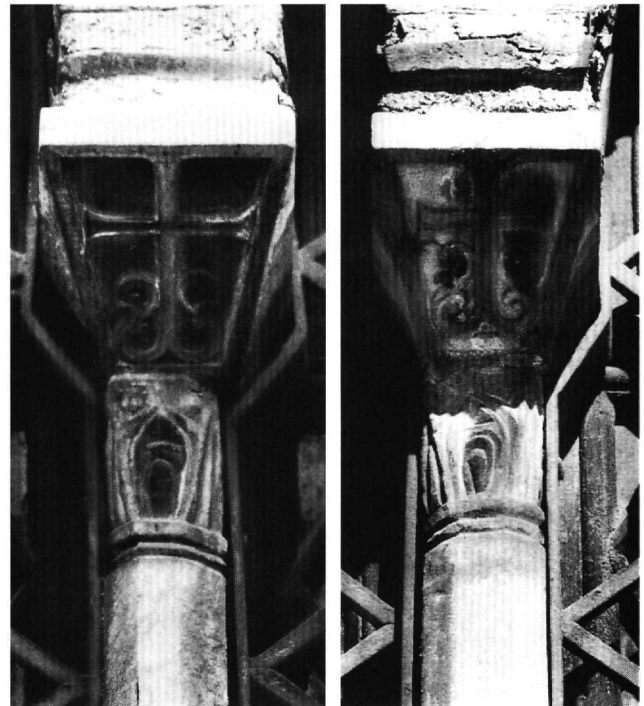
Fig. 10. The mullion capitals of the east façade windows. The imposts are modern (1850).

Very little survives of the sculptural decoration of the Soteira. Mullions are all that remain *in situ* of all the windows on the east side and of the two-light windows at the east end of the galleries (Figs. 10-11). As noted above, Vlasopoulos's restoration respected the axial column with its Ionic capital integral with the impost block (Fig. 12), a form common in the Early Christian period<sup>65</sup> though not unknown in the *katholikon* of the monastery of Hosios Loukas<sup>66</sup>. The decorative motifs of the capitals and impost blocks above the mullions are very simple and commonly found in the eleventh century (six-point rosettes and

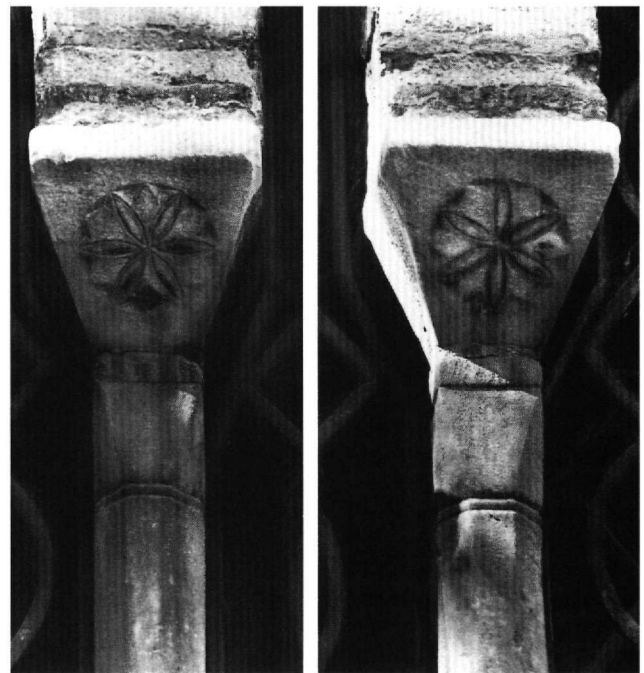
Fig. 11. The mullion capitals and imposts of the triple window of the bema apse.

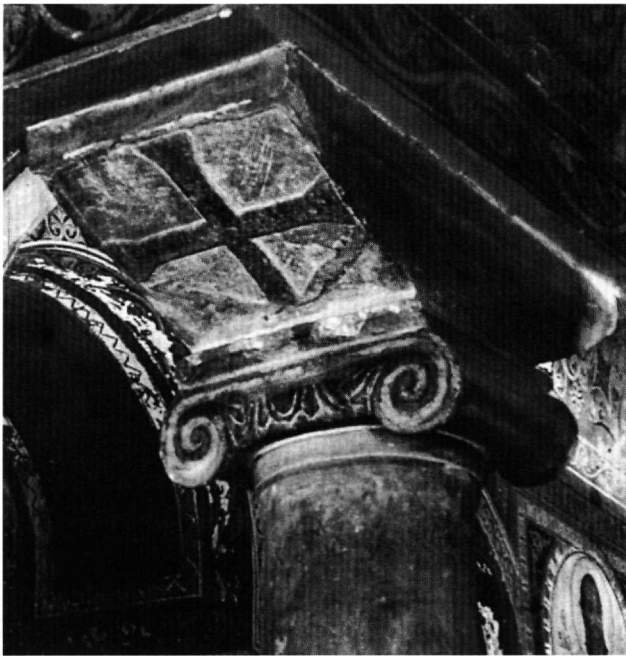
Fig. 12. Capital and impost of the colonette at the axis of the gallery.

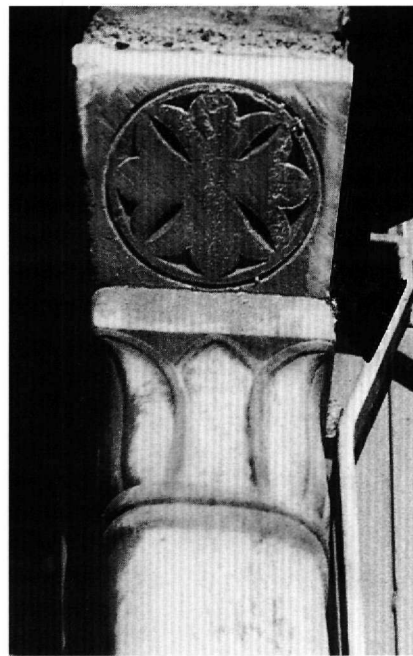
Fig. 13. Impost over a modern mullion on the south façade.

crosses) (Fig. 13). Unfortunately, none of the marble door-frames of the church survives. They were probably removed during the long period of its abandonment. The bowls in the tympana of the three-light window of the bema apse have been replaced by later small decorative disks.

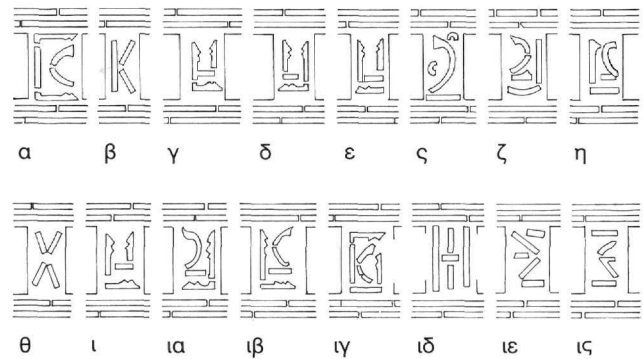
Fig. 14. Cut brick pseudo-cufic patterns.

The cufic and pseudo-cufic motifs on the walls of the Soteira have been treated directly or indirectly by G. Sotiriou<sup>75</sup>, A.H.S. Megaw<sup>76</sup>, G. Miles<sup>77</sup>, P. Vocotopoulos<sup>78</sup>, A. Frantz<sup>79</sup> and N. Nikonanos<sup>80</sup>. Depictions of them have already been published by Chr. Hansen<sup>81</sup>, A. Lenoir<sup>82</sup> and G. Lambakis<sup>83</sup>. Despite the destruction of a large part of the ceramic decoration, it is immediately apparent that the motifs of the individual cufic patterns and the system by which they were ap-
